Conditions at the Fukushima Daiichi Nuclear Power Station after the Earthquake of March 16 (Update 2)

< Reference document >
M a r c h 2 2 , 2 0 2 2
Tokyo Electric Power Company Holdings, Inc.
Fukushima Daiichi Decontamination &
Decommissioning Engineering Company

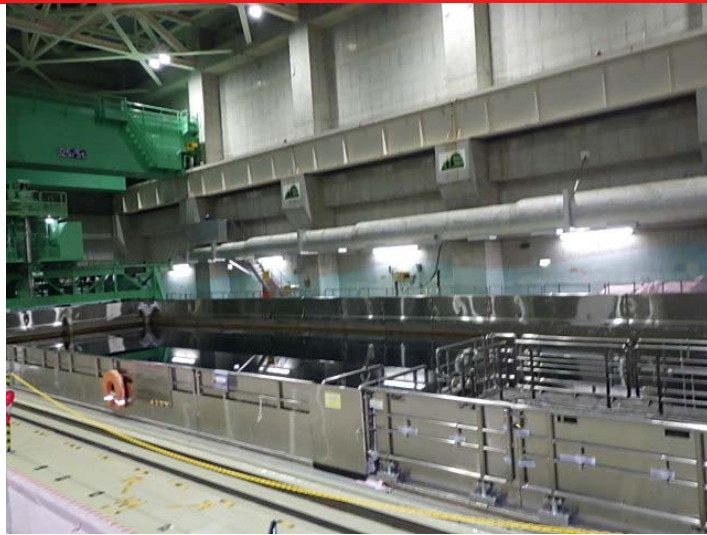
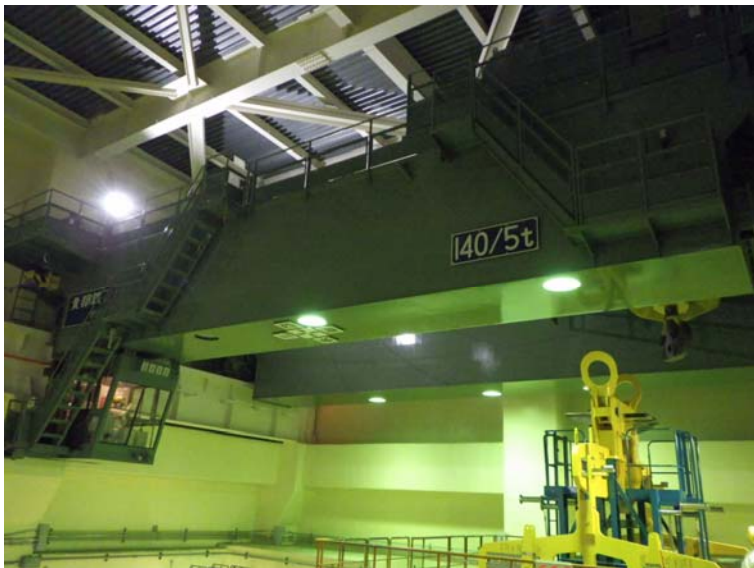
Ceiling crane in the cask loading/unloading area

- An operations check of the ceiling crane (currently undergoing inspection) in the common auxiliary operation building cask unloading/loading area found that the ceiling crane does not run back and forth.
- A visual inspection has found two cracks in the gear coupling covers for the running wheels.
- A thorough inspection will be performed to check for nonconformances with the running drive mechanism and electrical/control systems.
- A thorough inspection will be performed to check for nonconformances with the running drive mechanism and electrical/control systems. And, it has been confirmed that there are no problems with common pool fuel cooling

Situation after the earthquake
