Location of the detailed visual inspection of the perimeter of the pedestal and inspection schedule

Conditions around the pedestal opening (foundation) (from investigation on May 19 ①)

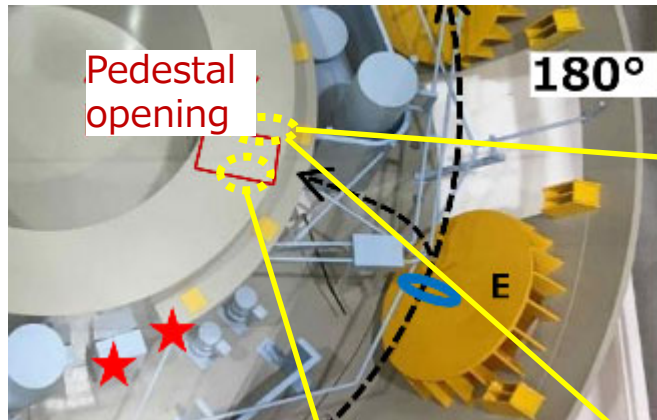
Photo 1. Conditions above the deposits at the opening of the pedestal (right side foundation)

- ✓ Pedestal rebar was found at the bottom the deposits
- ✓ At the top of the deposits we found the pedestal foundation intact

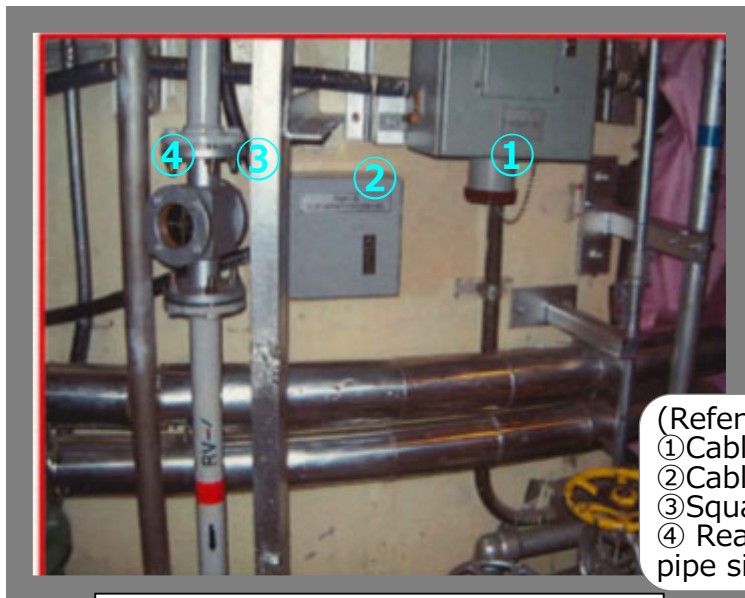
(Reference photo) conditions prior to the accident in 2011

- (Reference)
- ① Cable relay box (A)
 - ② Cable relay box (B)
 - ③ Square support box
 - ④ Reactor venting pipe sight glass
