Response to the Body Contamination That Occurred during the Cleaning of Additionally Installed ALPS Pipes

November 16, 2023

Tokyo Electric Power Company Holdings, Inc.

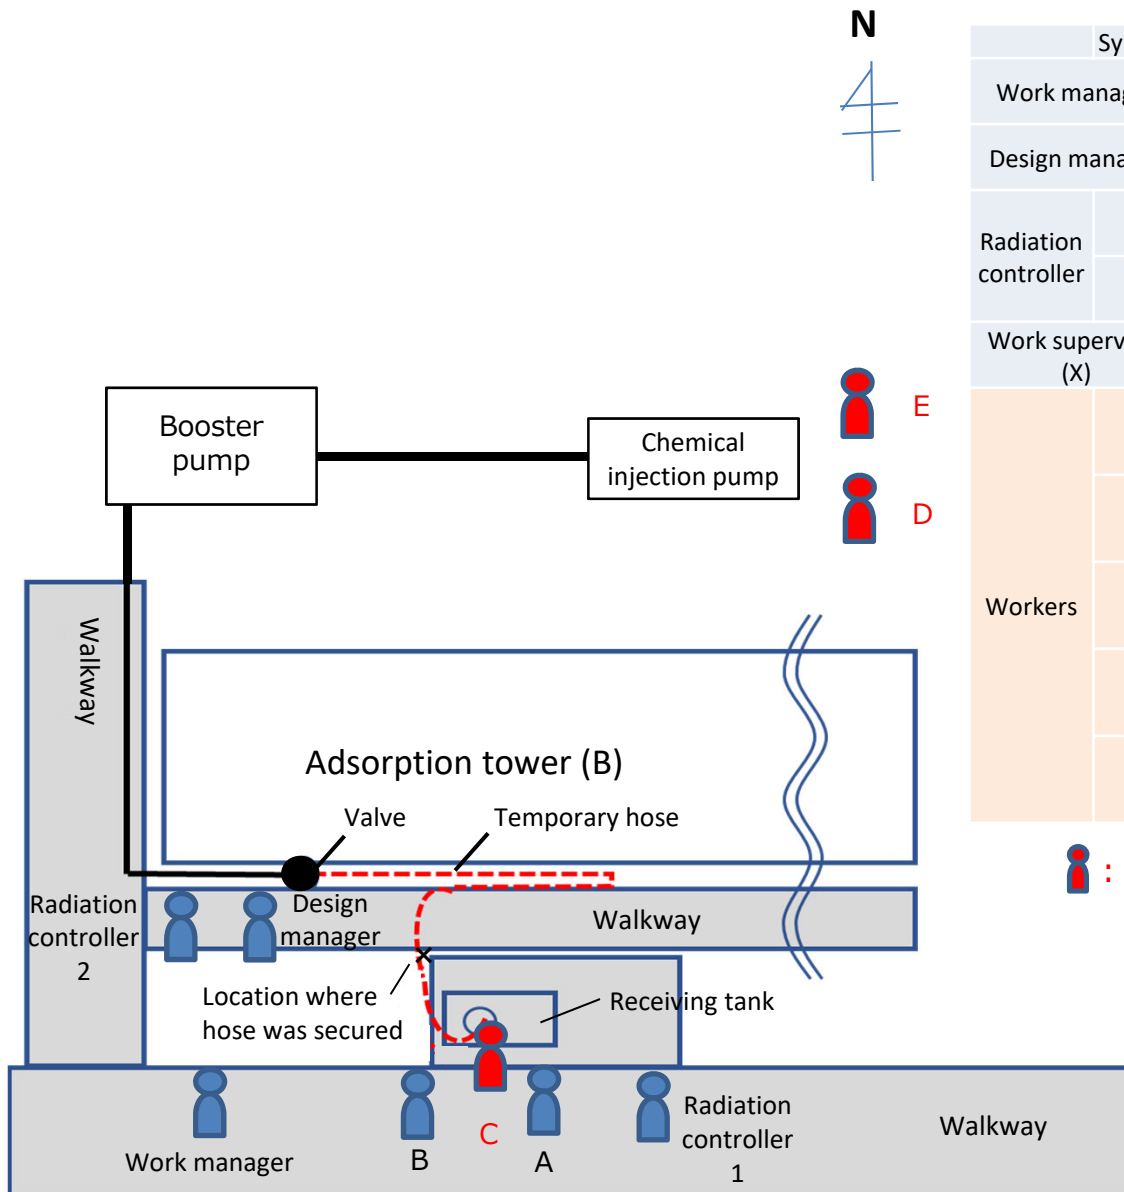
4.1 Work management system/worker assignments (Prior to the incident)

※ Workers A and B, who were monitoring the receiving tank (assistance), were wearing coveralls because it was assumed that they would not be subjected to body contamination on the day the task was being implemented.

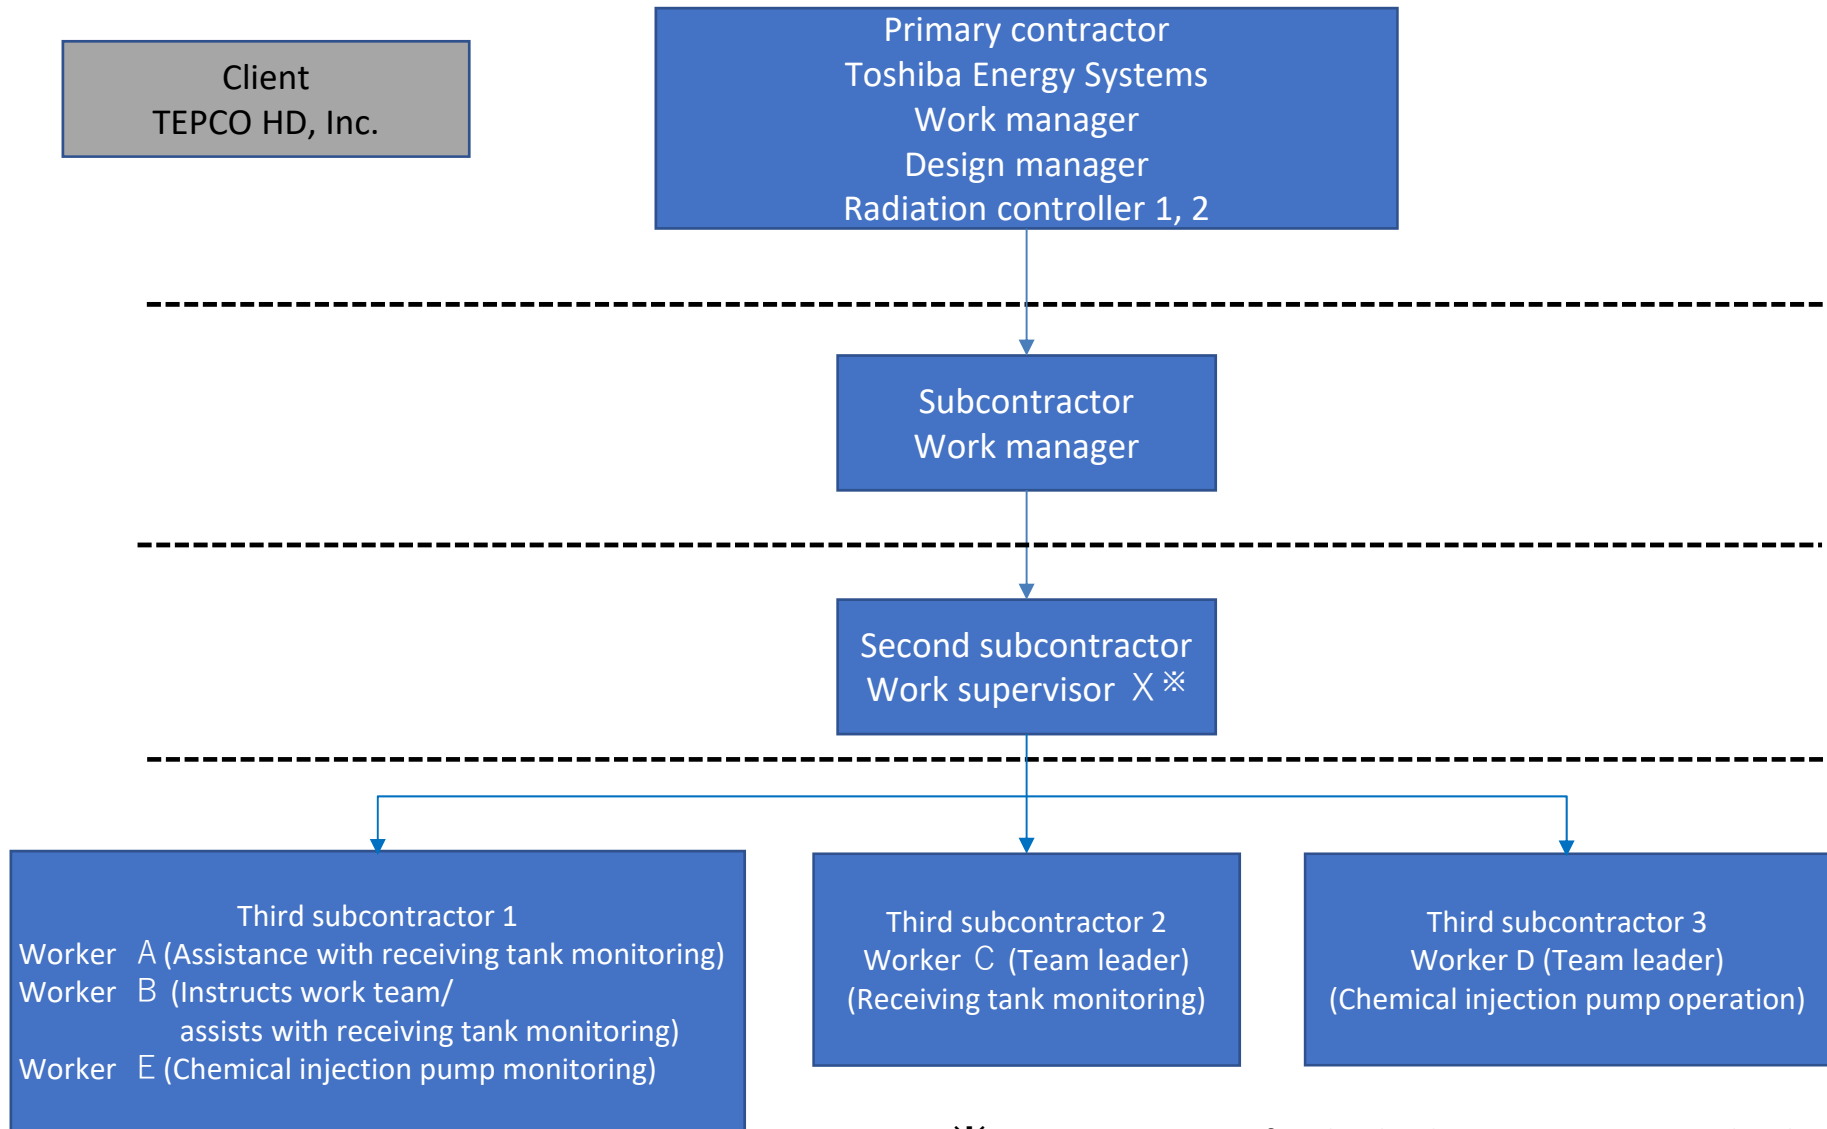
4.3 Contractor work assignments

※ Serves as proxy for third subcontractor 1 team leader (absent because he was patrolling a different worksite)

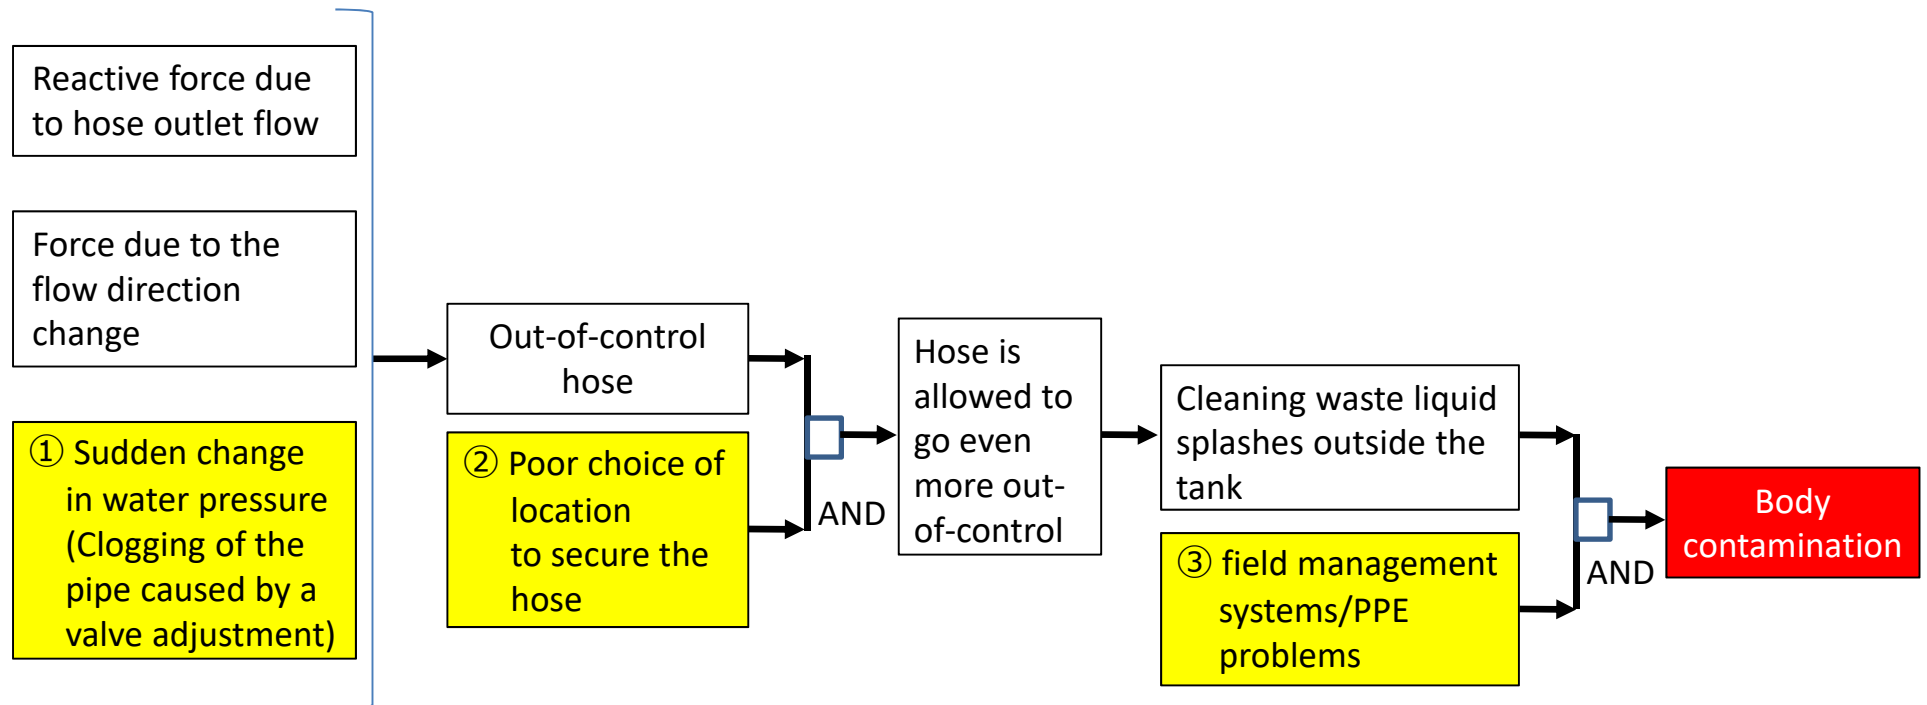
[Reference] Cause overview (Factor block diagram)

- There were 3 causes that led to the body contamination of workers as mentioned below.
- The 3 causes were ① Sudden change in water pressure (clogging of the pipe caused by valve adjustment), ② Poor choice of location to secure the hose, and ③ Insufficient field management and personal protective equipment. The combination of these factors resulted in the occurrence of the body contamination.

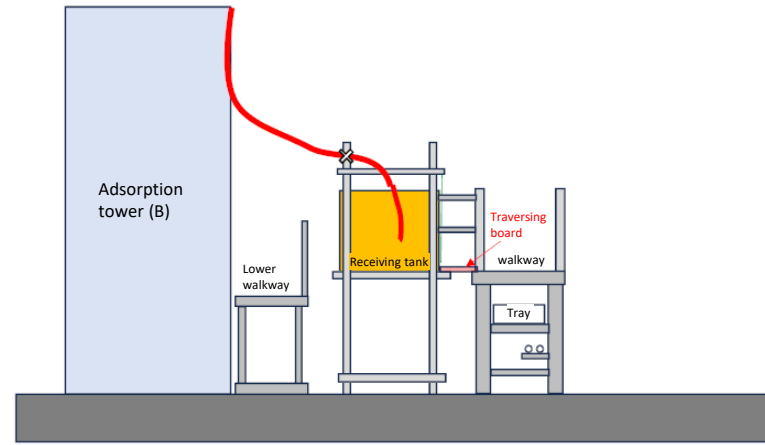
Cross-section (from direction A)

Water splashed on the floor
