Causes and Countermeasures for the Leak of Water Containing Radioactive Substances from the High Temperature Incinerator Building

February 15, 2024

TEPCO

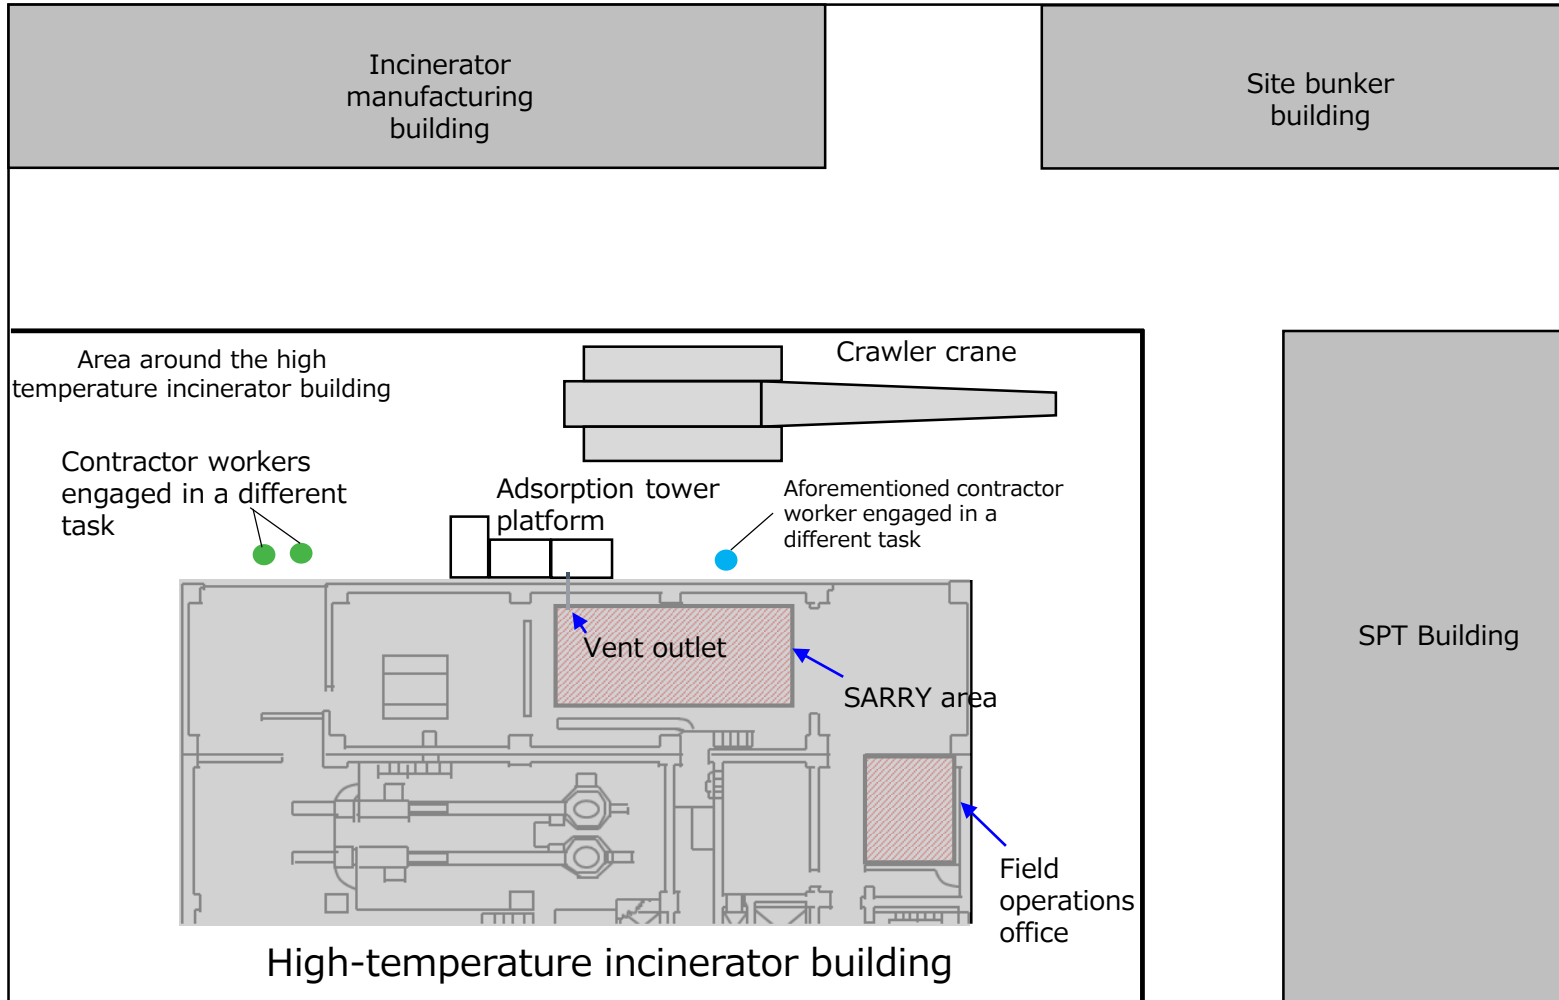
Diagram of the area outside the high-temperature incinerator building

【 Reference 2 】 Diagram showing the location of the workers that discovered the leak (outside the building)
