# Fukushima Daiichi Nuclear Power Station

## Unit 1 Primary Containment Vessel Internal Investigation (Non-submerged area)

### Causes and Countermeasures for Snake-like Robot Cable Issues

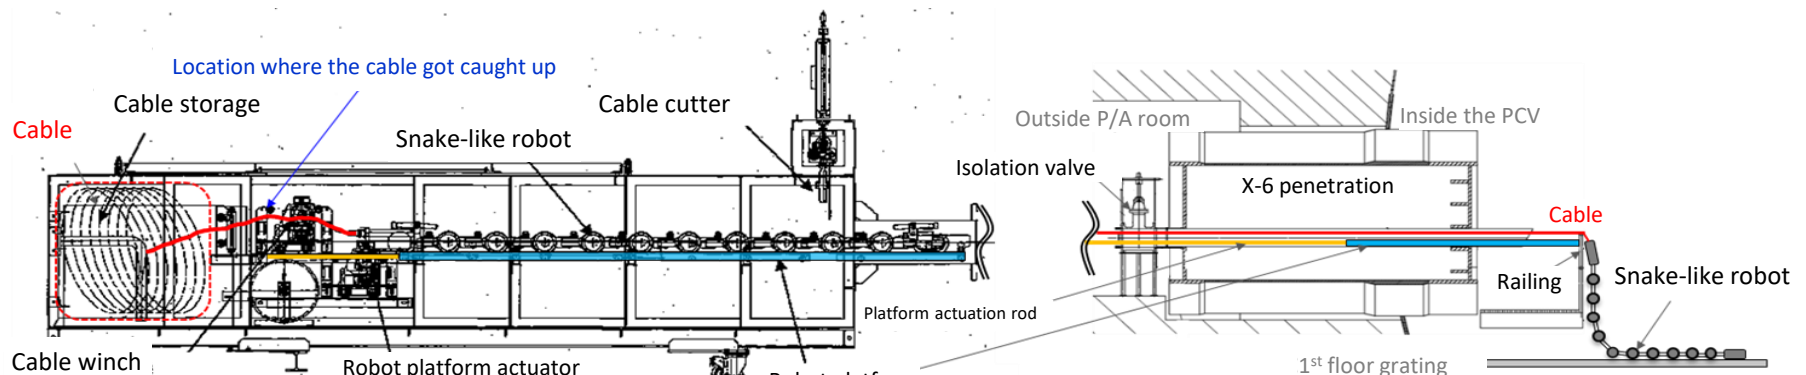
Diagram showing conditions when the event occurred

- After investigating the reason why we were not able to pay out the cable for the snake-like robot it was found that when the cable was being paid out, part of it wrapped around the installation bracket for the guide roller\* inside the sealed container thereby preventing the cable from being paid out to the PCV.
- Now that we have confirmed by March 8 that recurrence prevention measures are effective, we will implement the pedestal internal investigation using the small drones on March 14.
- We will move forward safely and carefully with these tasks so as to not impact the surrounding environment

- Usually, cable is routed through guide roller to the cable winch.
- In this case, cable route was different from the normal route due to the flexure in the cable. As a result, cable was caught in the installation bracket for the guide roller, unable to be paid out.

While the cable has always been monitored by cameras, we will add additional monitoring personnel who monitor only the cameras in order to strengthen monitoring of cable conditions and quickly detect signs of abnormalities. Furthermore, if signs of abnormalities are noticed, the instruction to halt the operation is given, and the procedures is clarified so that the cable winch is operated in a way that improves the situation.
