# Fukushima Daiichi Nuclear Power Station

## Unit 1 Primary Containment Vessel Internal Investigation (Non-Submerged Area)

### Status Inside the Pedestal

# Investigation Results on March 14 (Around the opening outside the pedestal)

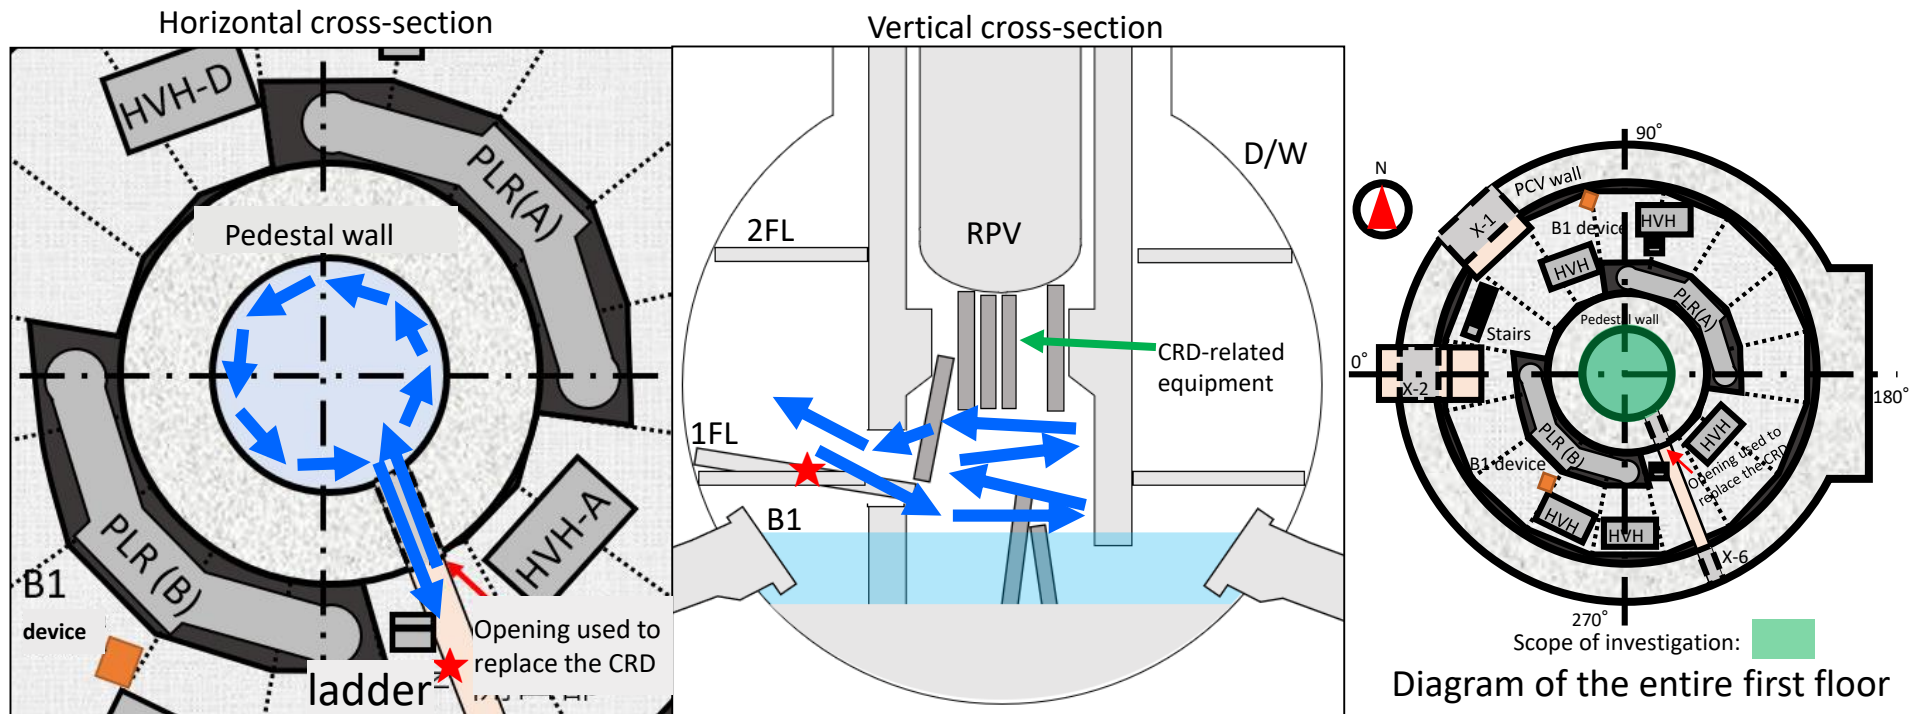
Enlarged view of the inside of the pedestal in the Unit 1 PCV first floor diagram

- The investigation of the inside of the pedestal will be conducted using the third and fourth drones
  - Investigation target: Inner walls of the pedestal, internal structures of the pedestal, and condition of the fallen CRD housing
  - Snake-like robot relays radio signals from around the CRD replacement rails
  - The third drone will be used to take as much footage of the inside of the pedestal as possible, and the fourth drone will be used to photograph places of interest found with the third drone
  - Upper structures will be photographed as much as possible, but since the camera is attached to the front of the drone, it will not be able to take pictures directly above it.
