# Unit 1 PCV Internal Investigation (Non-submerged area)

March 28, 2024

Tokyo Electric Power Company Holdings, Inc.

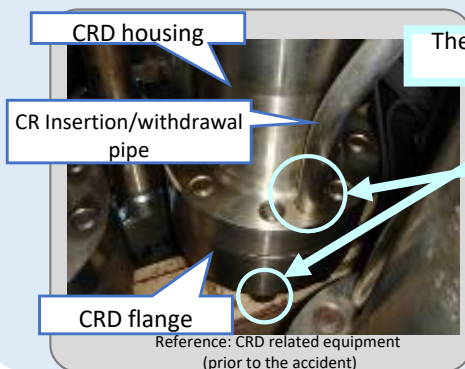
■ Photo ②: This photo shows the CRD housing that has been reversed from its original position. The insertion/withdrawal pipe is deformed.

The position of the bolt heads is upside down

The pipe is bent

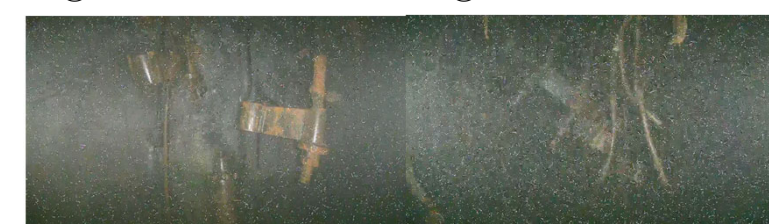
- We have observed fallen objects on the grating outside the pedestal, such as lead shielding mats, etc., that were seen in past investigations.
- There is a fallen object in front of the opening used to replace the CRD which is assumed to be the chain block used to hoist the CRD rails.
- Inside the pedestal, in addition to the vicinity of the opening used to replace the CRD, there are fallen structures on the wall side, which are assumed to be the CRD related equipment.

⑩ : Fallen structure D

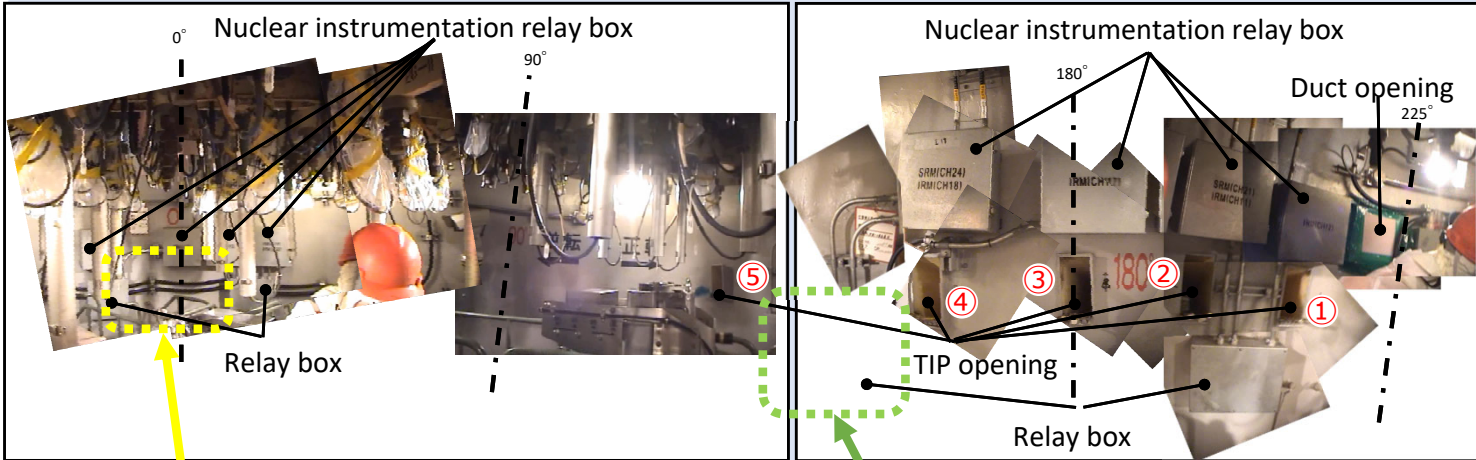
[Prior to the accident: during the periodic inspection] Inner pedestal wall (left: around 0°~90°, right: around 180°~225°)

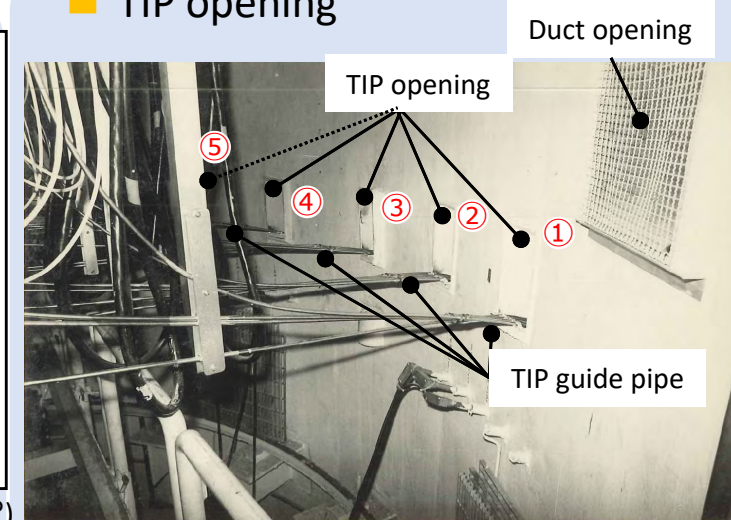
[Prior to the accident: during the construction] TIP opening (around 180°)

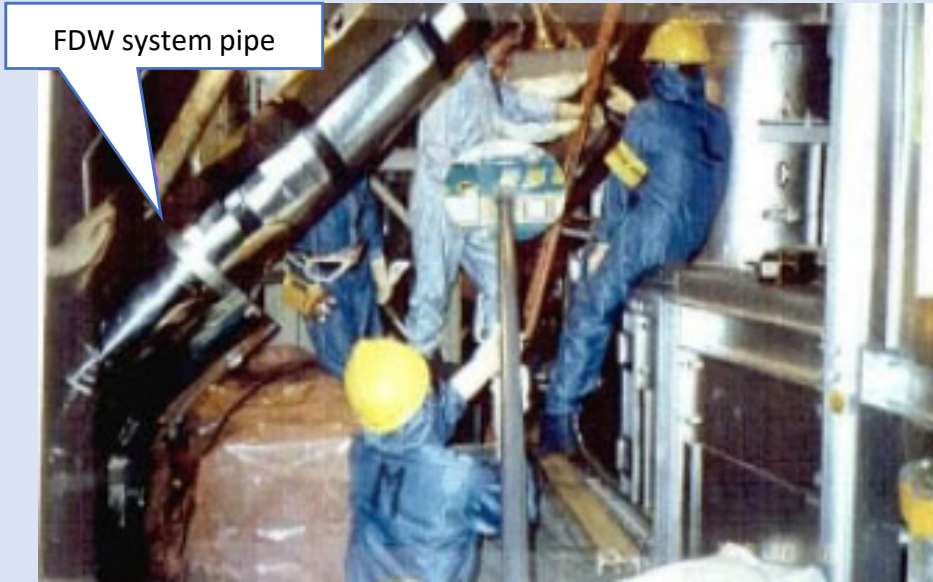
[Prior to the accident: during the periodic inspection] FDW system pipe

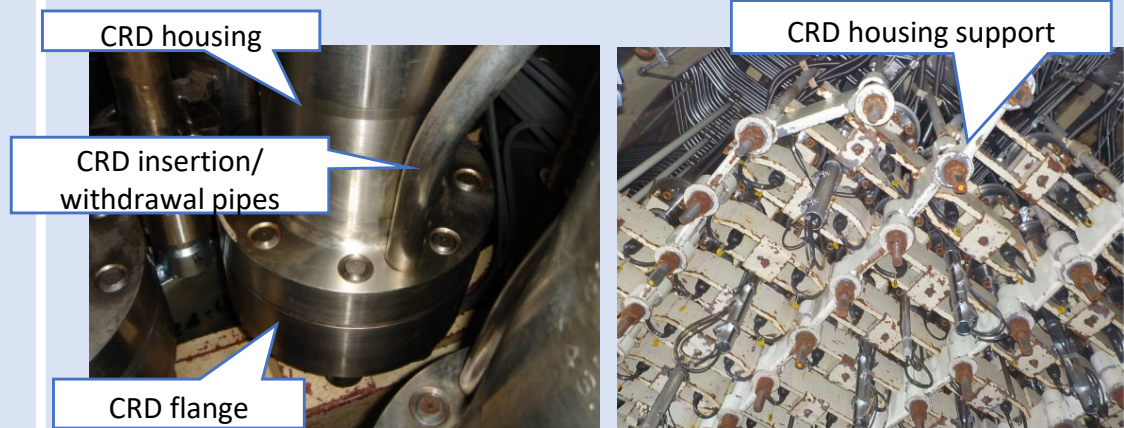
CRD related equipment

(left: during the periodic inspection prior to the accident, right: unit 5)

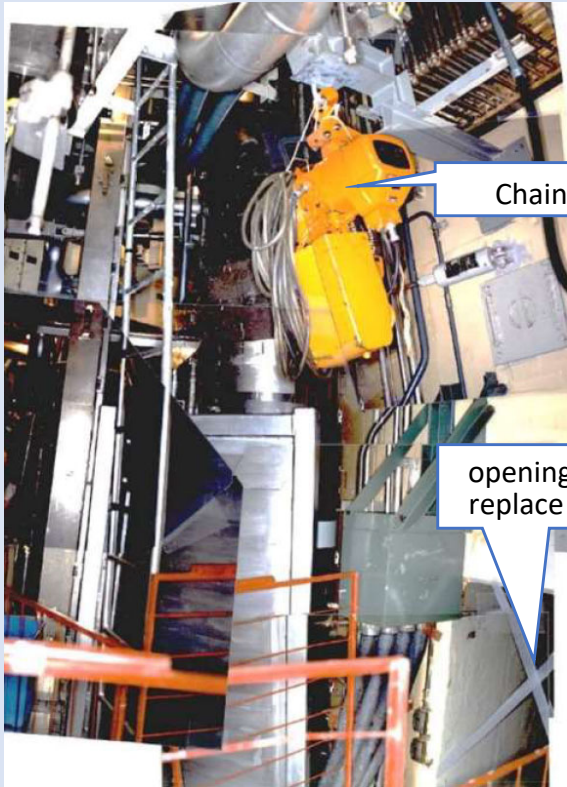
【 Prior to the accident: during the periodic inspection】  
Chain block in front of opening used to replace the CRD

Assumed to be chain block

In front of the opening used to replace the CRD (fallen chain block)

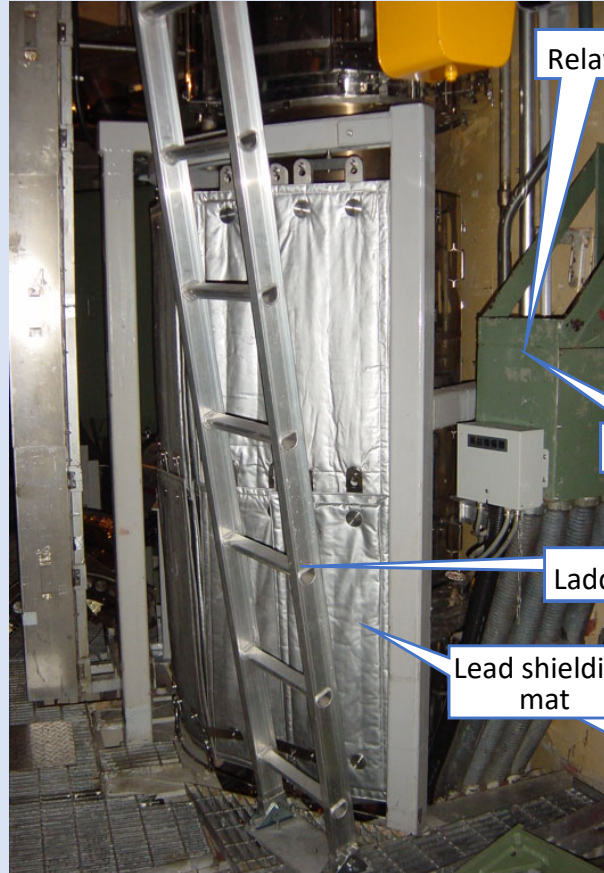
【 Prior to the accident: during the periodic inspection】  
Ladder and relay box

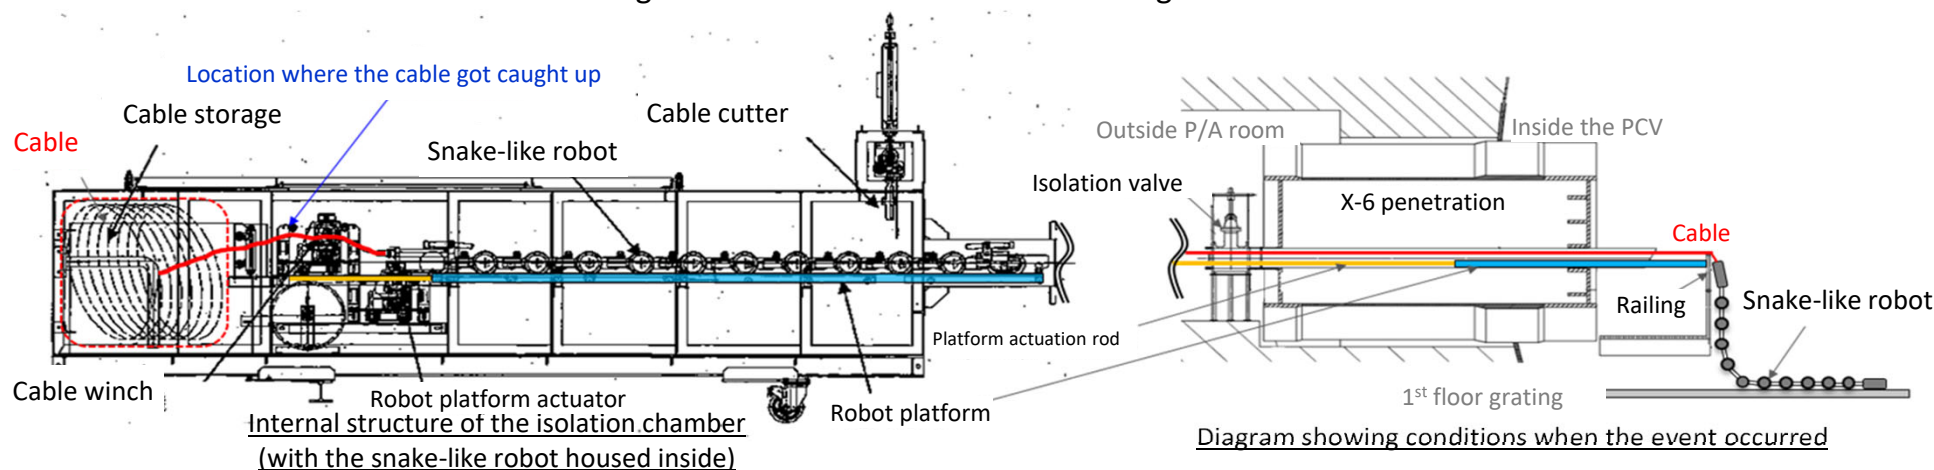
- After investigating the reason why we were not able to pay out the cable for the snake-like robot it was found that when the cable was being paid out, part of it wrapped around the installation bracket for the guide roller<sup>※</sup> inside the sealed container thereby preventing the cable from being paid out to the PCV.
- Now that we have confirmed by March 8 that recurrence prevention measures are effective, we will implement the pedestal internal investigation using the small drones on March 14.
- We will move forward safely and carefully with these tasks so as to not impact the surrounding environment

※ Guide roller : A roller that secures and guides the route from the cable storage to the cable winch.

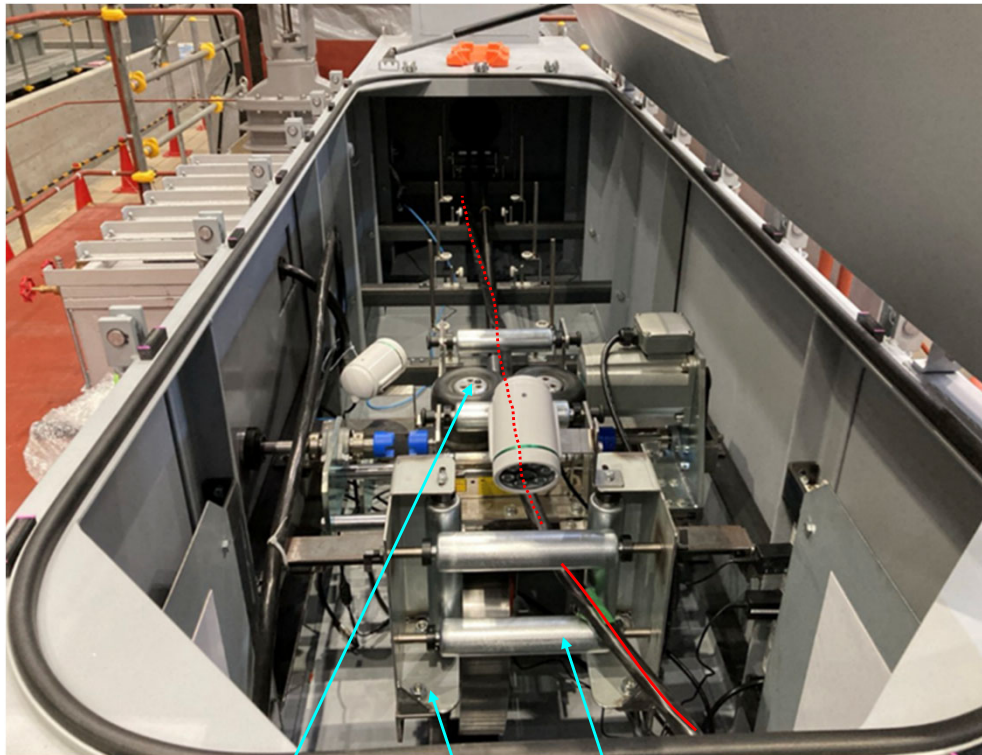
Normal conditions (photo taken during the mockup)

- Usually, cable is routed through guide roller to the cable winch.
- In this case, cable route was different from the normal route due to the flexure in the cable. As a result, cable was caught in the installation bracket for the guide roller, unable to be paid out.

Cable winch      Cable guide roller  
Guide roller installation bracket

While the cable has always been monitored by cameras, we will add additional monitoring personnel who monitor only the cameras in order to strengthen monitoring of cable conditions and quickly detect signs of abnormalities. Furthermore, if signs of abnormalities are noticed, the instruction to halt the operation is given, and the procedures is clarified so that the cable winch is operated in a way that improves the situation.
