Fukushima Daiichi Nuclear Power Station Unit 2 PCV Internal Investigation/ Preparation Status of Fuel Debris Trial Retrieval

April 25, 2024

International Research Institute for Nuclear Decommissioning
Tokyo Electric Power Company Holdings, Inc.

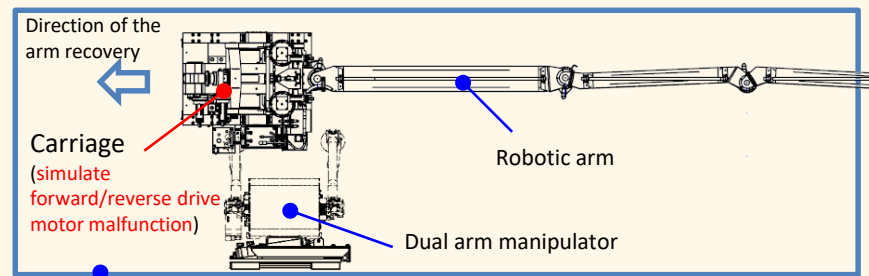
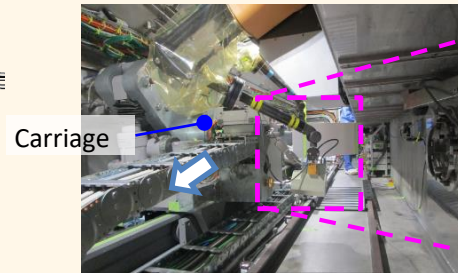
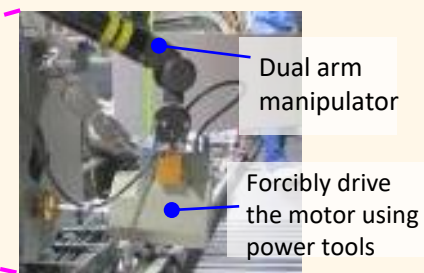
Emergency retrieval test simulating carriage (forward/reverse drive motor) malfunction

- Using dual arm manipulator equipped by power tools, malfunctioned motor is forcibly driven to move back the carriage and retrieve the arm.
- It was confirmed that the arm can be withdrawn back into the enclosure.

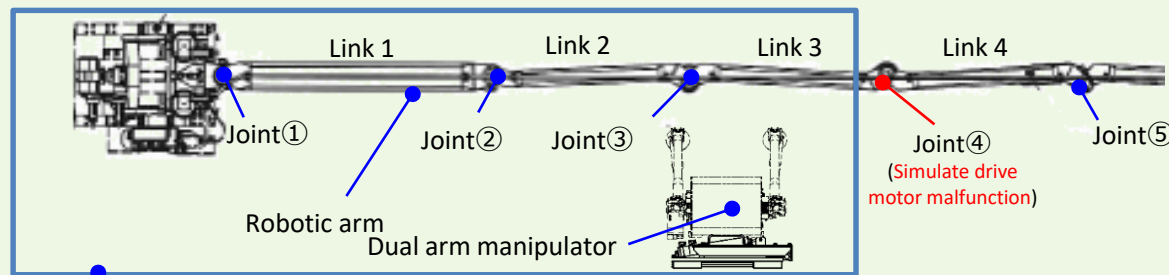
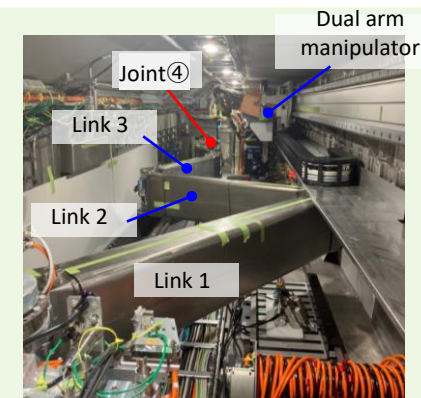
Emergency retrieval test simulating malfunction of link (joint ④ axis drive motor)

Retrieval (Links being folded)

- It was confirmed that the arm can be retrieved back into the enclosure by remotely releasing joint 4 clutch and remotely operating other operable axes and withdrawing (folding) the link using the dual manipulator.

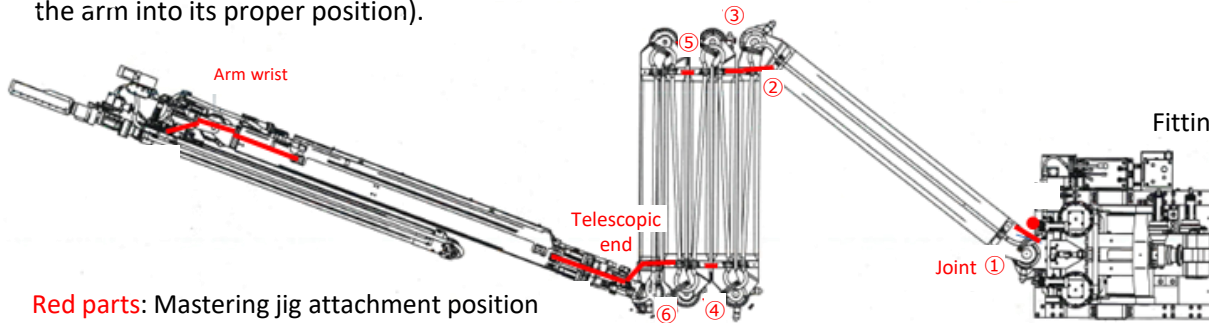
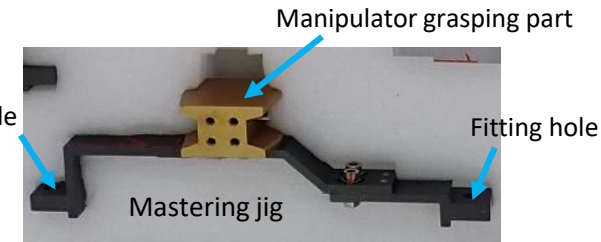
Red parts: Mastering jig attachment position

There is a protrusion on the arm that lines up with a hole on the mastering jig.

- After the arm was withdrawn into the enclosure, a test to examine the user-friendliness of the mastering process using the double arm manipulator was conducted, and it was discovered that improvements are needed to both visibility and the jig itself.
 - Visibility improvement: The camera on the double manipulator arm will be changed to improve visibility
 - Jig improvement: The fitting hole will be fitted with a guide in order to make mastering jig attachment easier

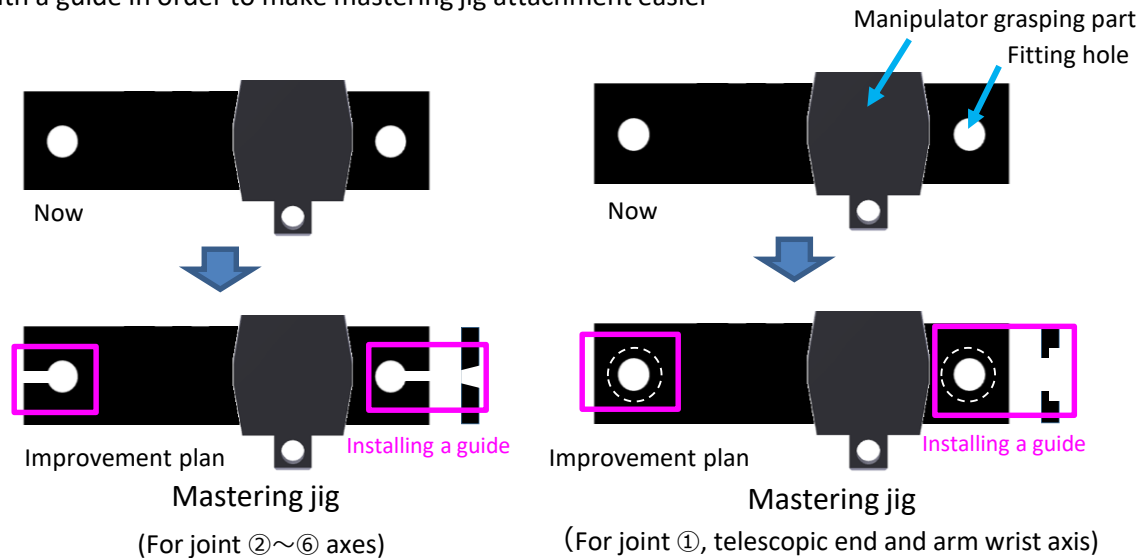
(For joint ②~⑥ axes)

(For joint ①, telescopic end and arm wrist axis)

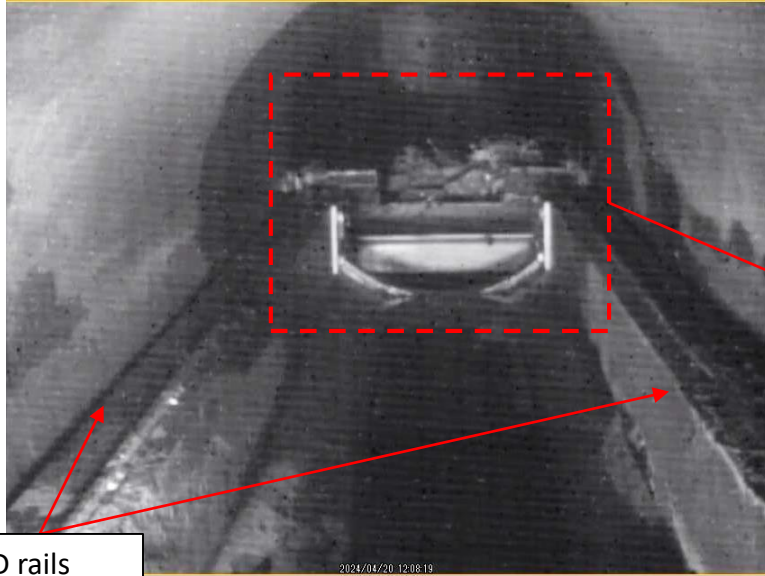
CRD rails

- The cables on top of the CRD rail platform deck plate on the outside of the X-6 penetration (PCV side) and part of the deck plate are being cut away/removed.

Even if the CRD rail platform was to fall, it would only fall approximately 25cm, and a dust assessment if it was to fall has confirmed that there would be no impact.

CRD rail platform
*Part of the deck plate will be removed. The area within the blue dotted line will be removed using the robotic arm

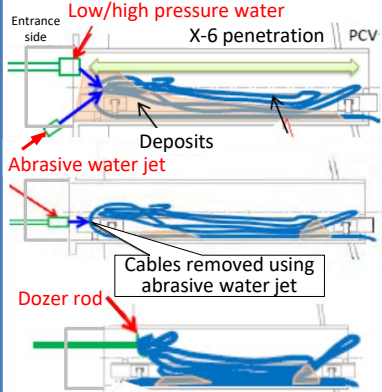
Removing deposits/cables from inside the X-6 penetration

- Deposits pushed with low/high-pressure water
- Cables removed with Abrasive water jet
- Cables pushed with dozer rod

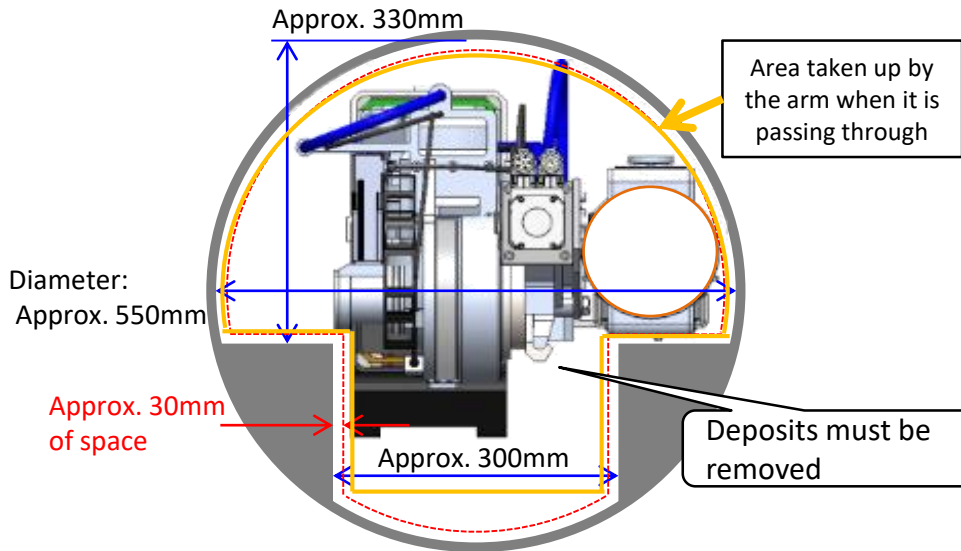
Robotic arm

(cross-section of the X-6 penetration when the arm is passing through)

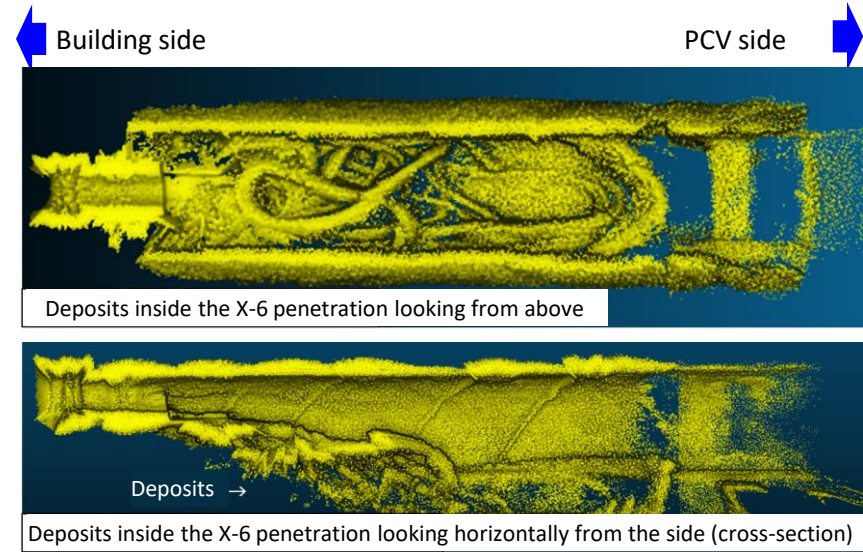
From a 3-D scan taken in October 2020

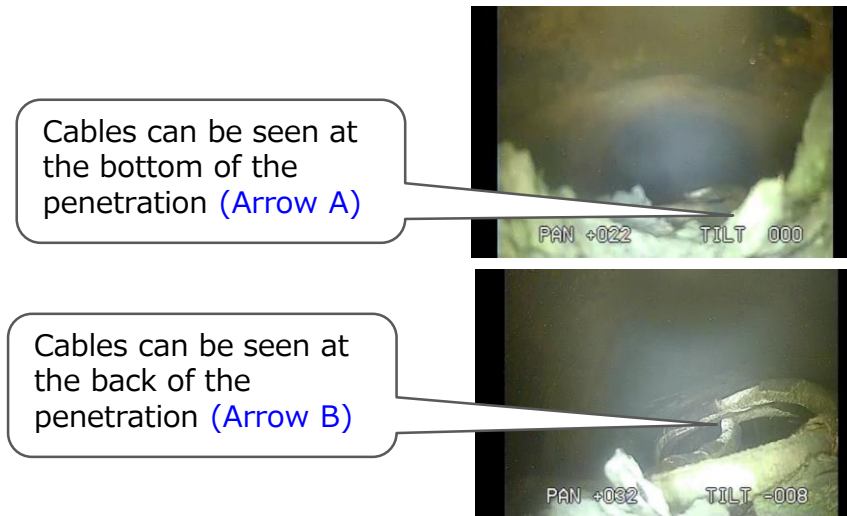
Conditions in January 2017 (camera inserted through hole open for X-6 penetration investigation equipment)

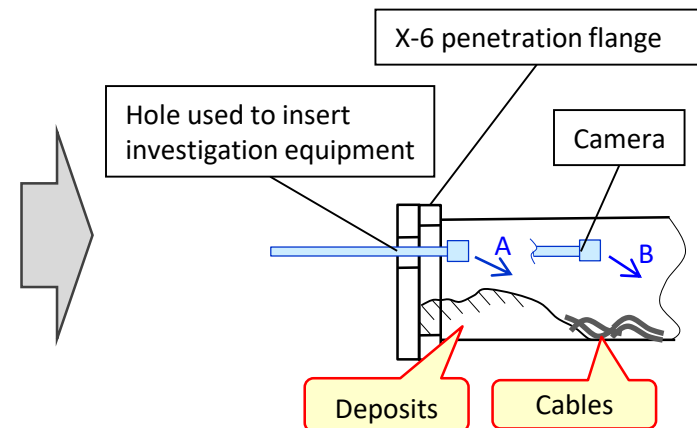
Diagram showing the assumed shape of deposits, etc.
