Causes and Countermeasures for Suspension of Unit 2 PCV Fuel Debris Trial Retrieval

September 5, 2024

Tokyo Electric Power Company Holdings, Inc.

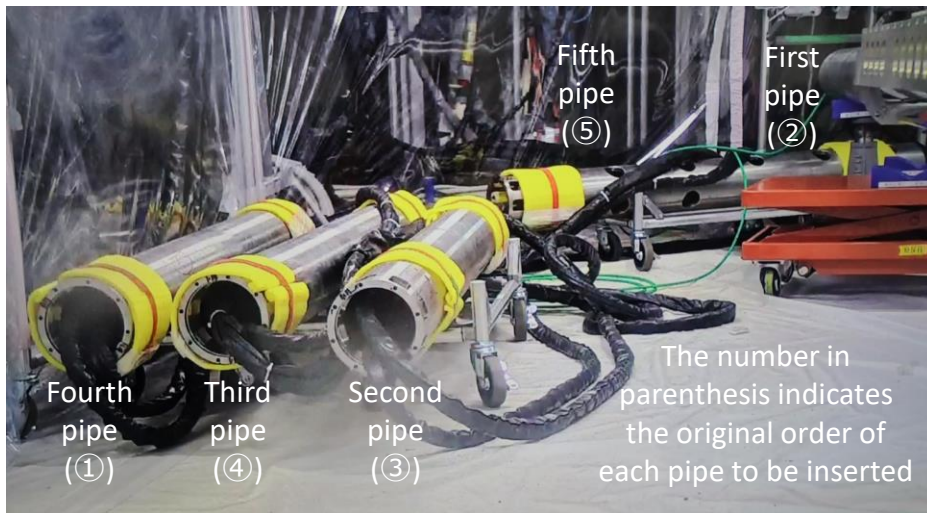
Installation status of push pipes

- At the site, it was confirmed the push pipe that should have been in the first position was in the fourth position. (The order was ②→③→④→①→⑤, whereas it should have been ①→②→③→④→⑤)

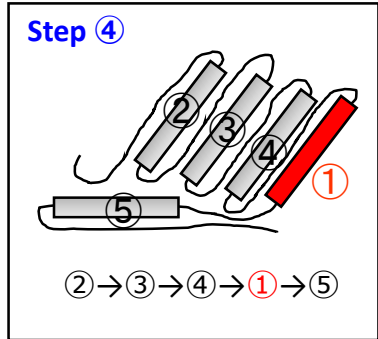
Step 1. (July 27)

- Transport and temporary store push pipes (five in total) (from large freight loading entrance to southwest area)

Step 2. (July 27)

- Transport four push pipes (from southwest area to west side passageway)
- *One push pipe was left in the southwest area due to exposure dose management considerations

Step 3. (July 28)

- Cable insertion begins while one of the push pipes is still in the southwest area

Step 4. (July 28, 29)

- The push pipe that was left in the southwest area (①) is unpacked at west side passageway and carried near the telescopic device. The pipe is positioned in front of push pipe (⑤) , and cable is inserted inside.

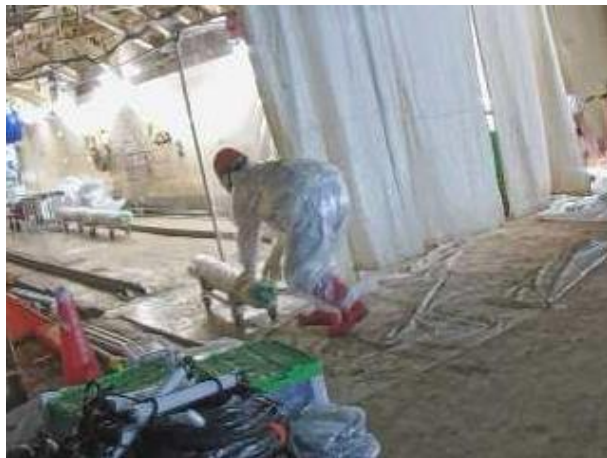
Transporting at the push pipes from the large freight loading entrance on the first floor of the reactor building to the west passageway

(July 27, 2024)

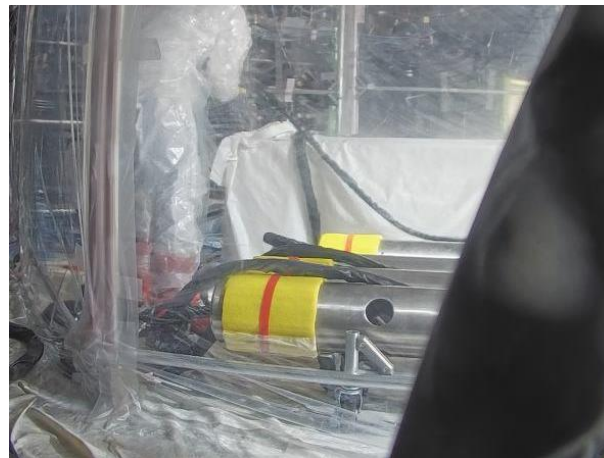
Inserting the cable into the push pipes

(July 28, 2024)

- e. On July 28, the primary contractor work manager checked cable insertion work in the field and found that the cable had been inserted into only four push pipes with one missing.

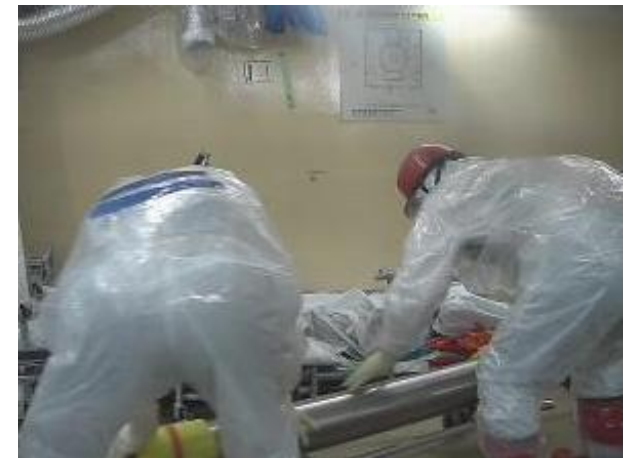
Transporting the push pipe from the west passageway on the first floor of the reactor building

to near the telescopic device

(July 29, 2024)

- f. The primary contractor work manager found the missing push pipe in the southwest area and carried it to the west side passageway, but did not directly check the identification number on the push pipe.

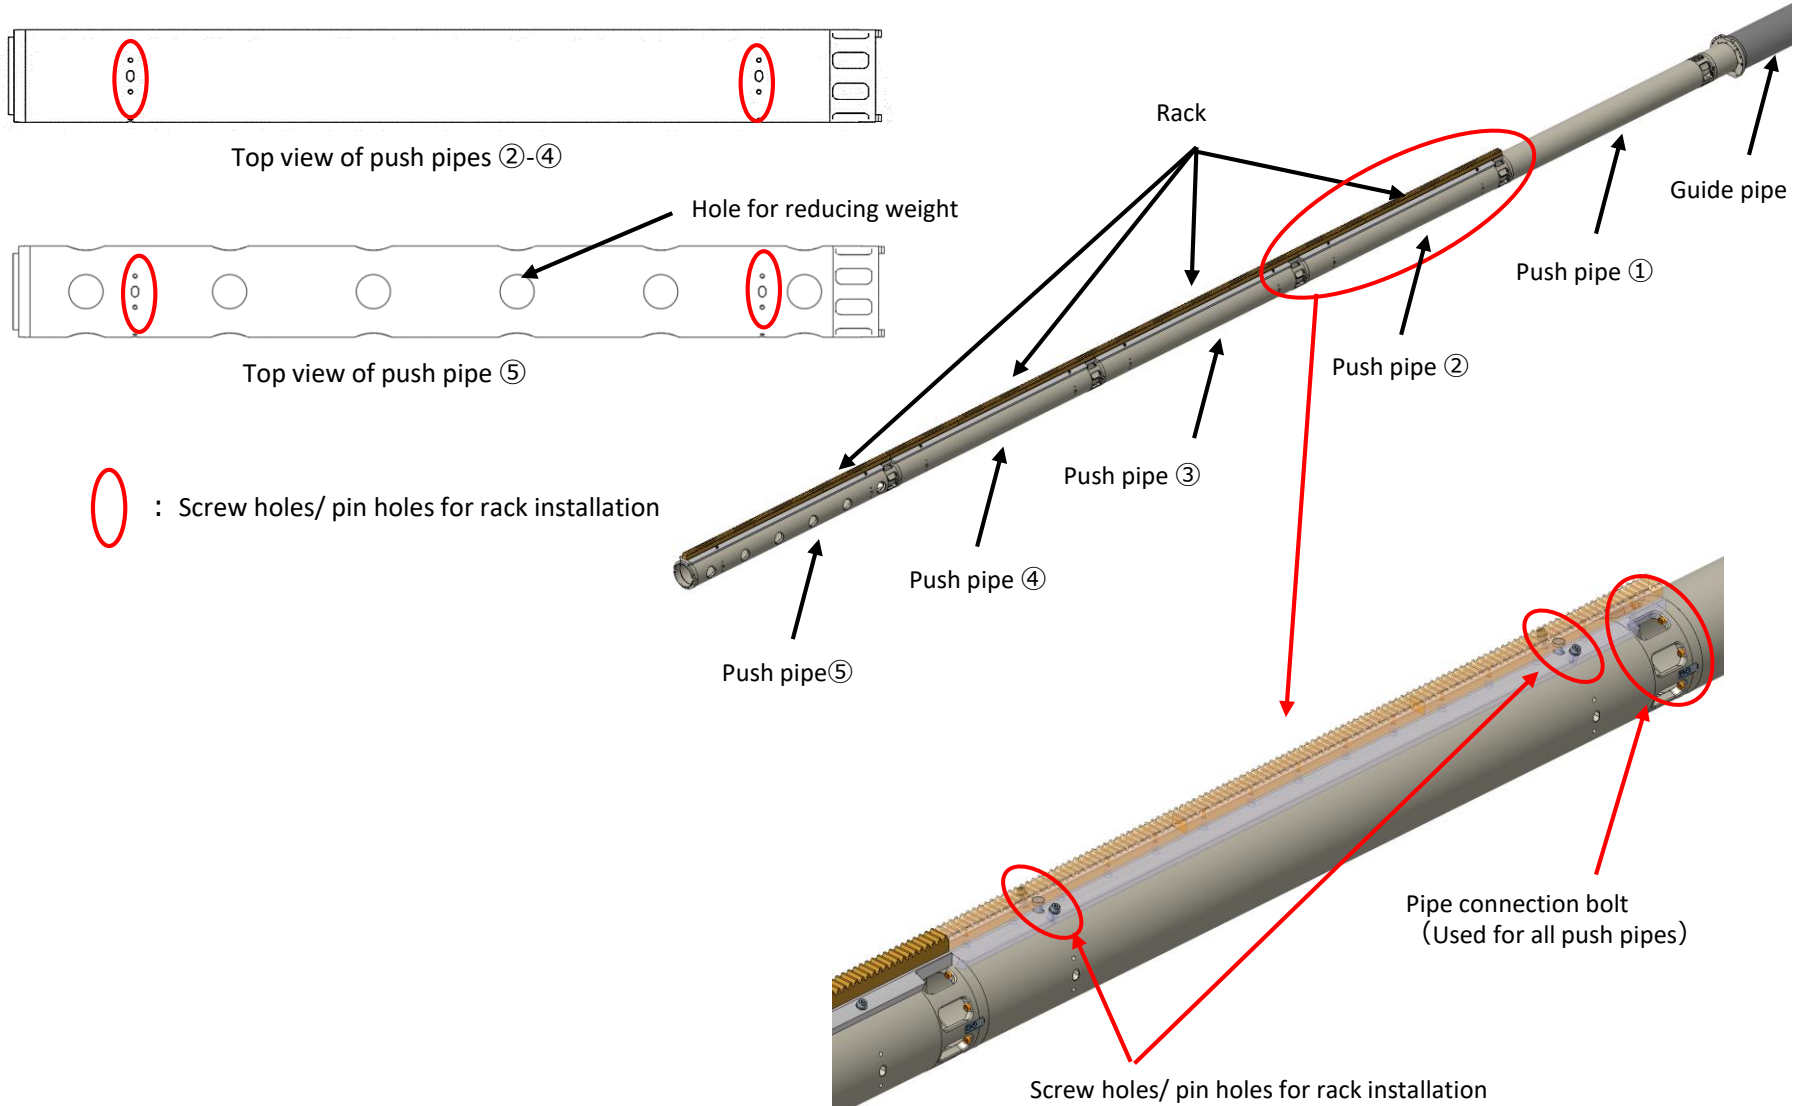
[Reference] Installation status of push pipes

Position of the push pipes during the training in simulated environment
(Correct position)
