Status of the Investigation into Camera Malfunctions during the Trial Retrieval of Fuel Debris at Unit 2

Results of camera signal intensity measurements taken with instruments

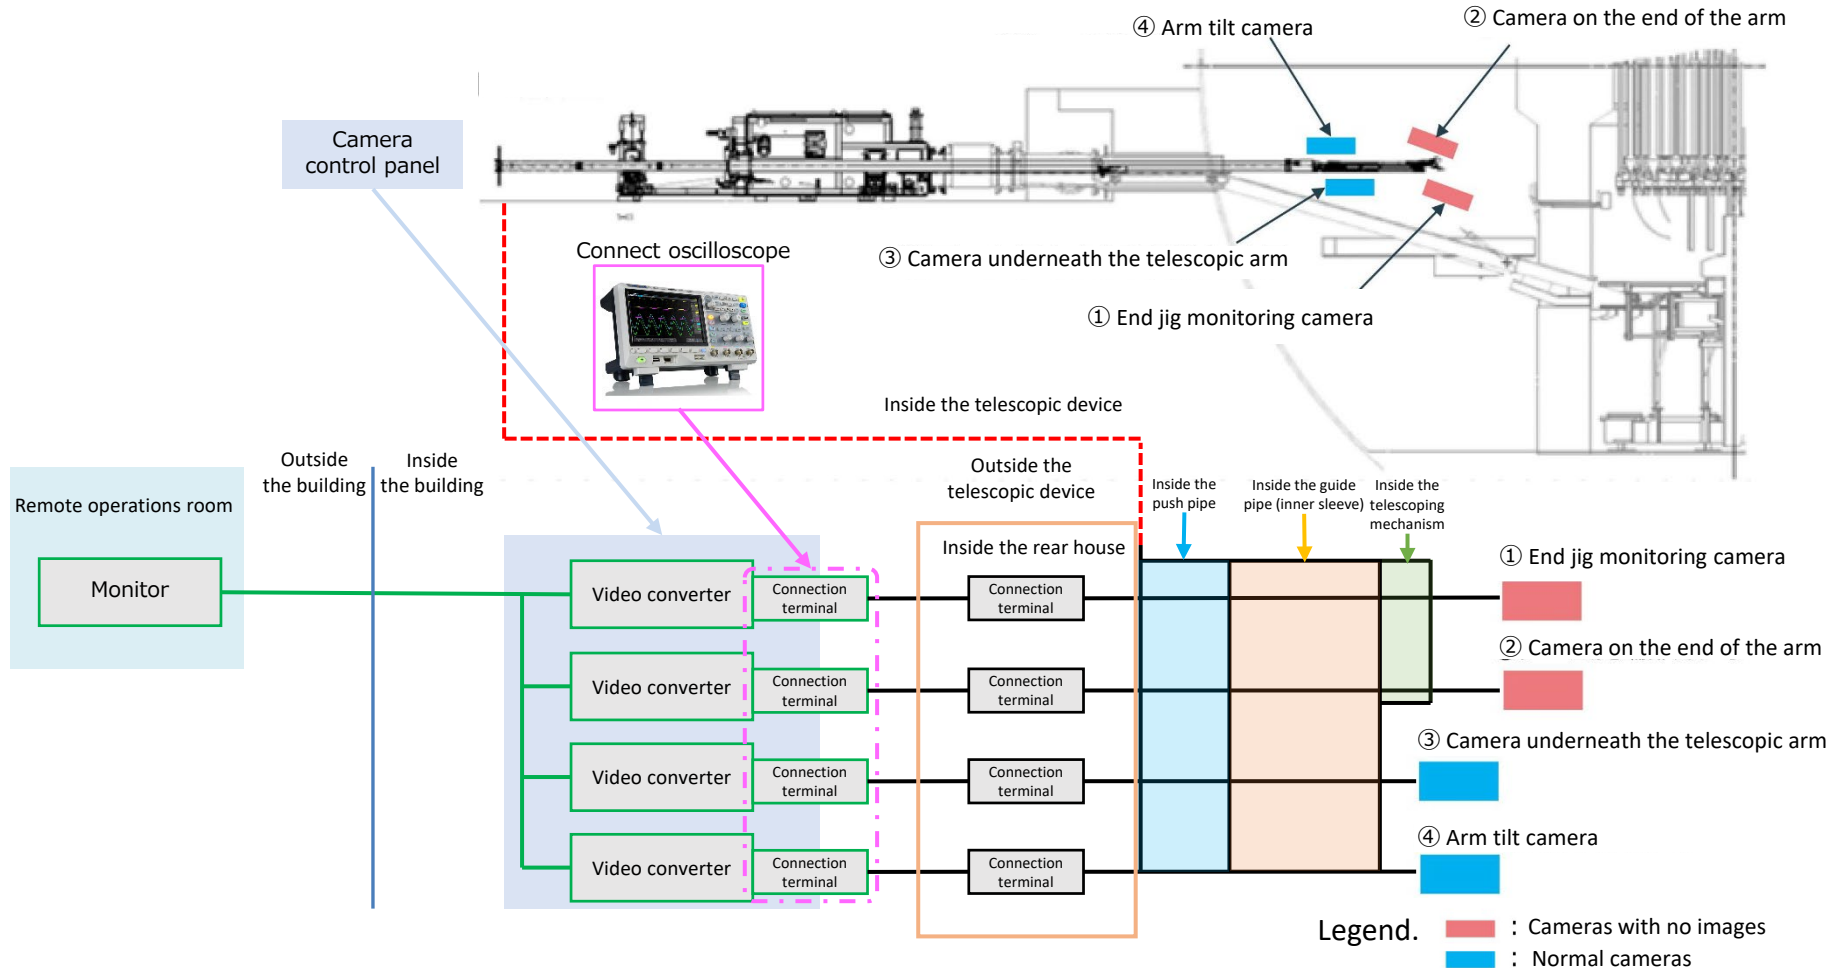
- Since it was detected that footage from the cameras on the end of the telescopic device (① End jig monitoring camera, ② Camera on the end of the arm) was not being sent properly to the monitors in the remote operations room during the trial retrieval of fuel debris from Unit 2, instruments were used to measure the intensity of the camera signal between September 20~21.
- The investigation into the cause is still underway. The current status of this investigation is as follows.

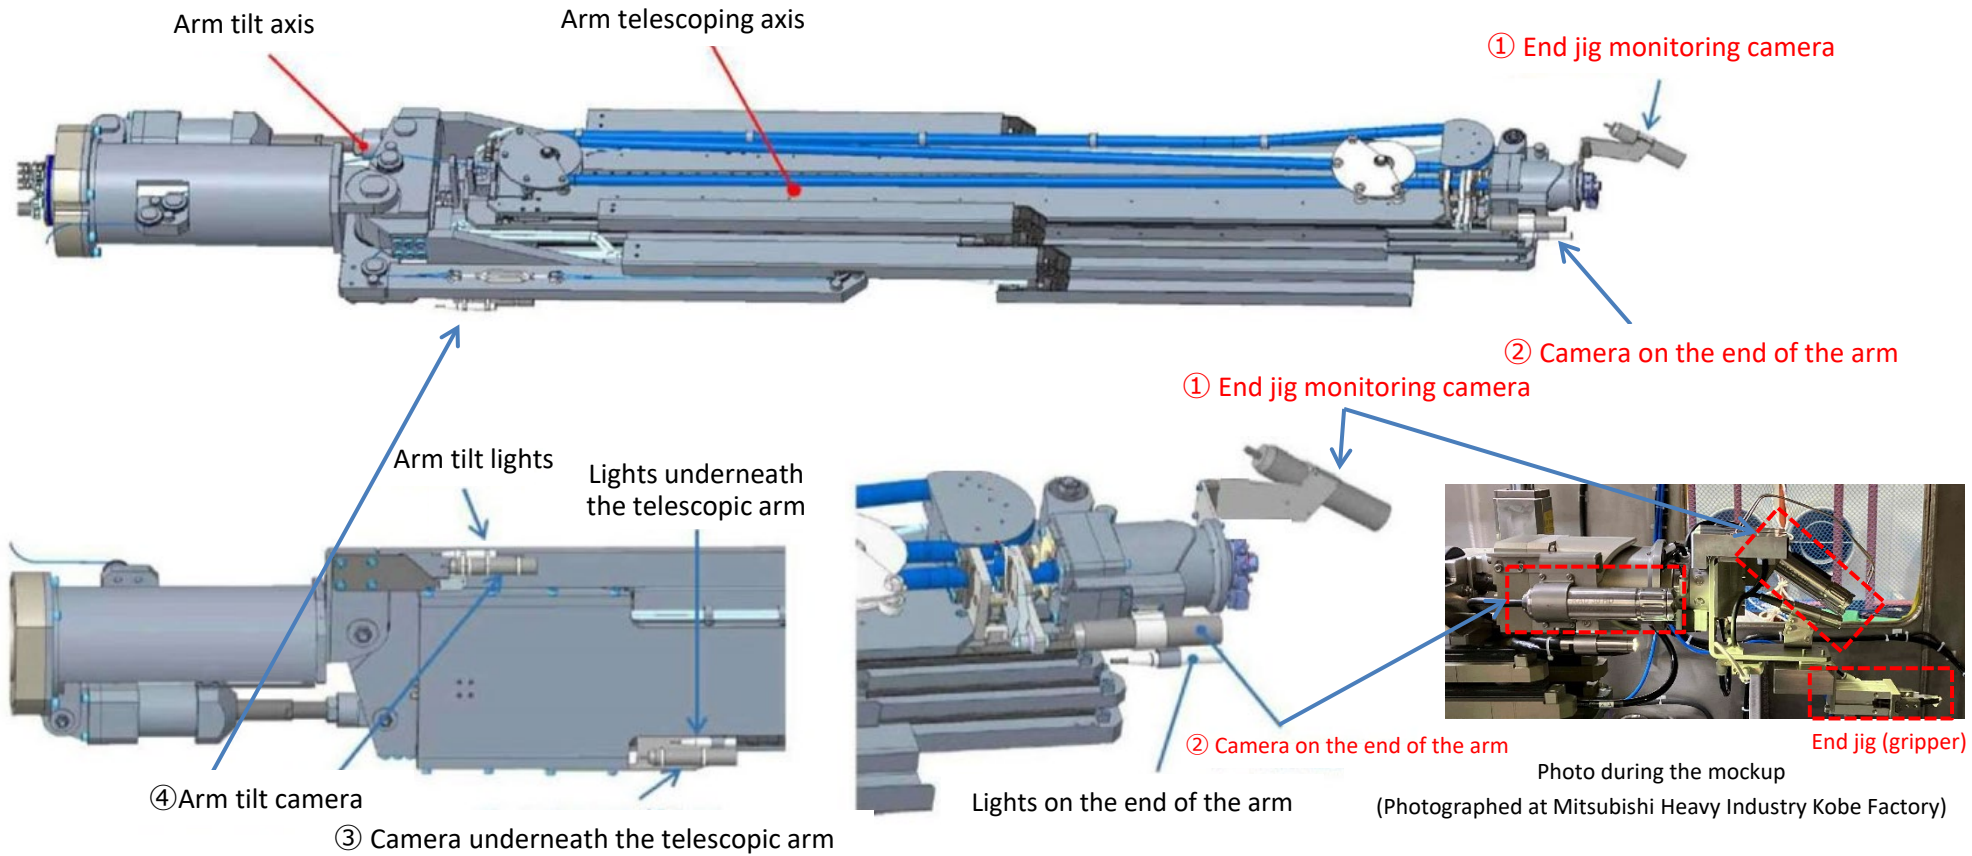
Reference: Cameras placement status of telescopic device

Cameras installed on the telescopic device
