Fukushima Daiichi Nuclear Power Station Unit 2 PCV Internal Investigation/ Preparation Status of Fuel Debris Trial Retrieval

September 26, 2024

International Research Institute for Nuclear Decommissioning
Tokyo Electric Power Company Holdings, Inc.

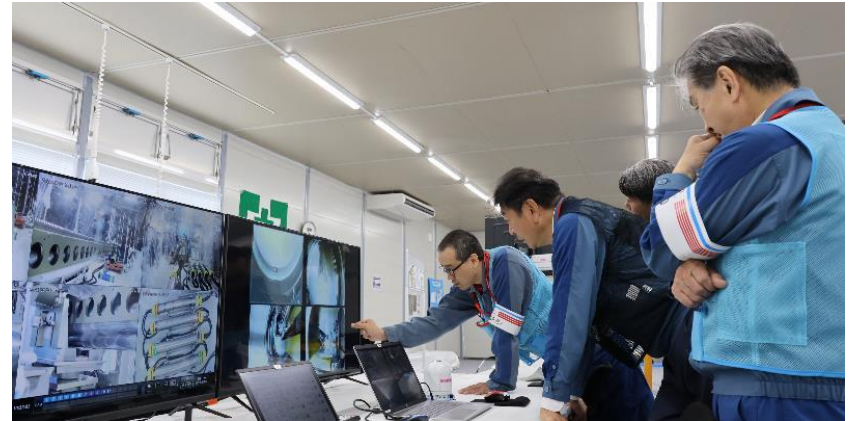
Checking in the remote operations room

- The identification numbers were written in an easily visible position so that it can be identified by wearing full protective equipment and remote cameras as well as by visual inspection.
- Different color tapes were attached to the protective sheet at the end of the push pipes.

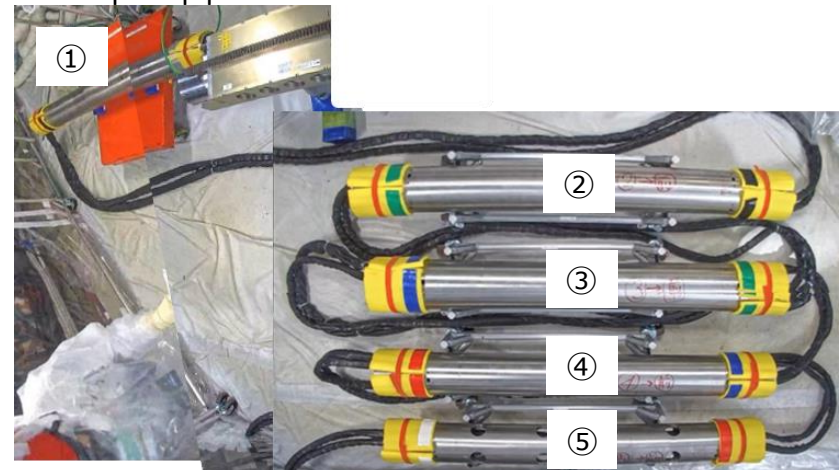
Completion of push pipes restoration work

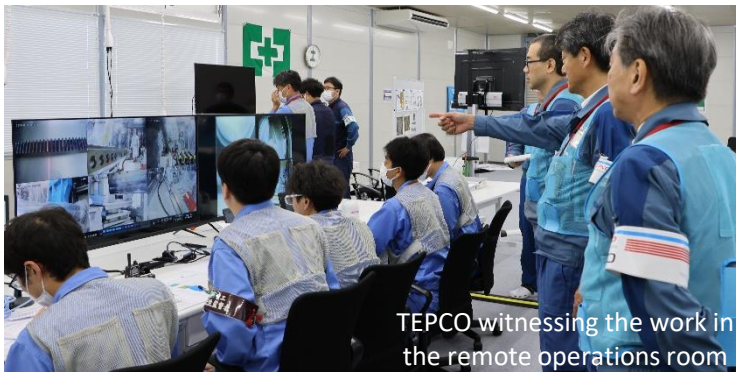
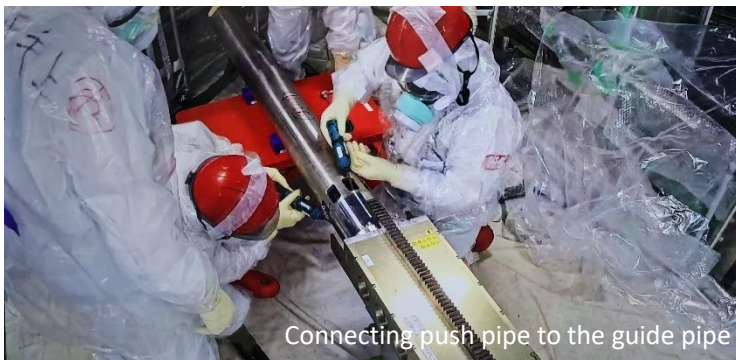
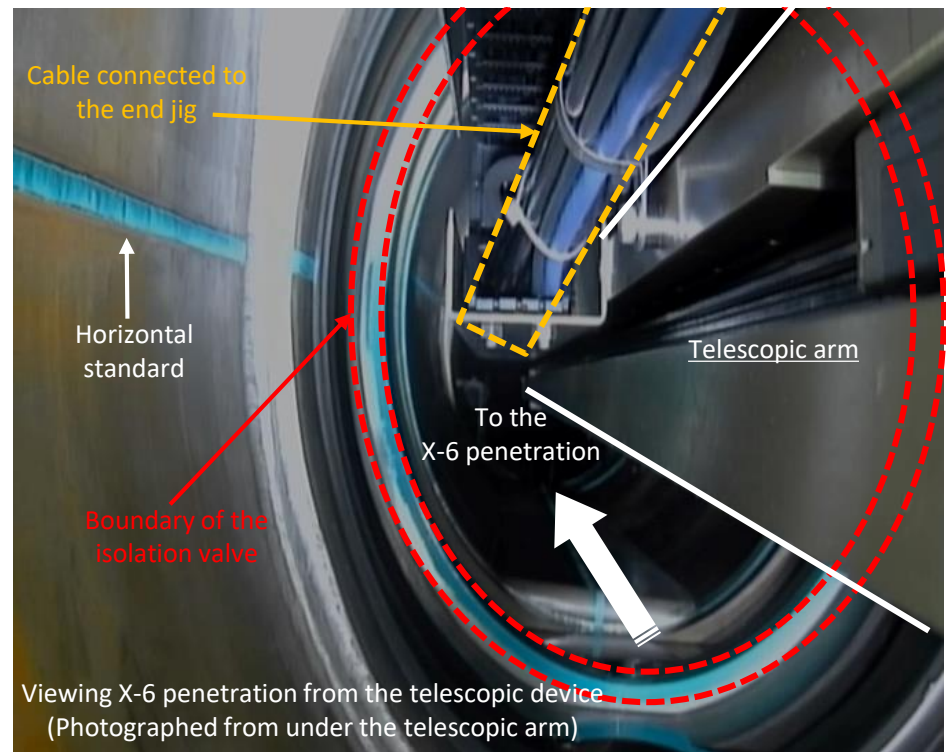
Trial retrieval work status (passing through the isolation valve)

- On September 10, trial retrieval work (inserting the guide pipe) was recommenced.
- Connection of push pipe① to the guide pipe (inner sleeve) and opening of the isolation valve were conducted. By inserting the guide pipe, the end jig of the telescopic device passed through the isolation valve.

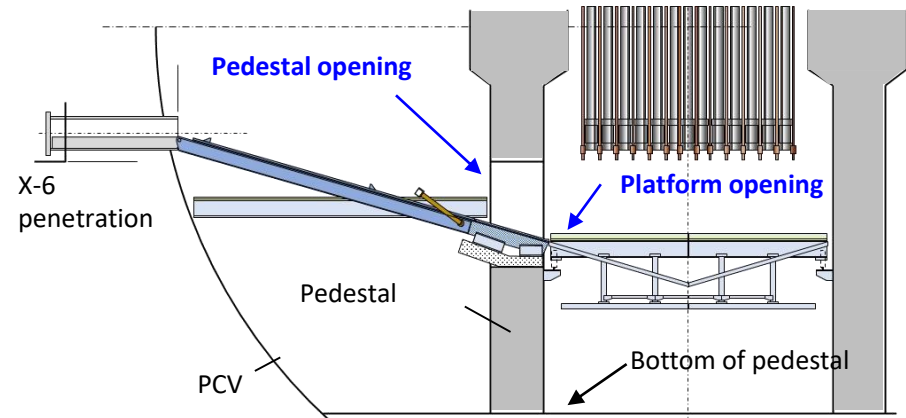
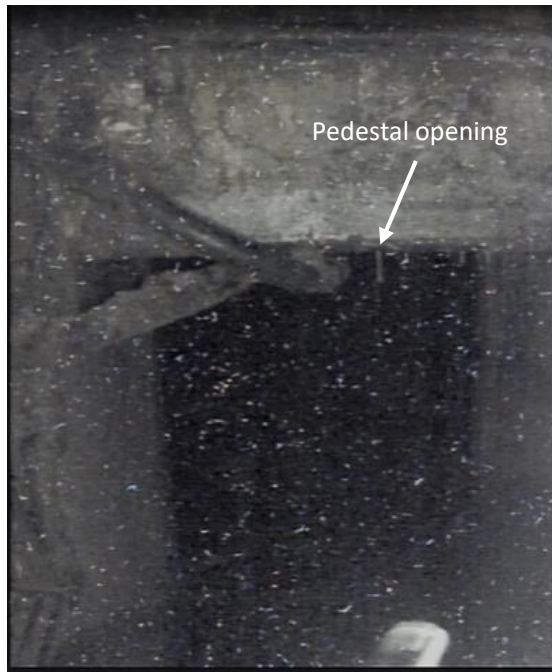
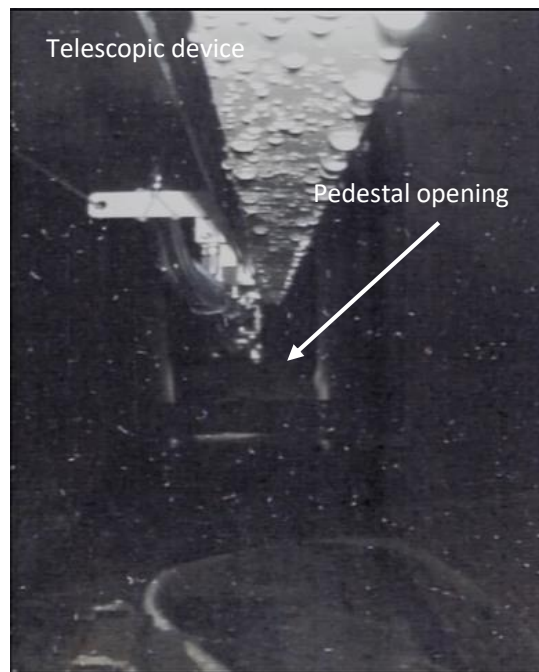
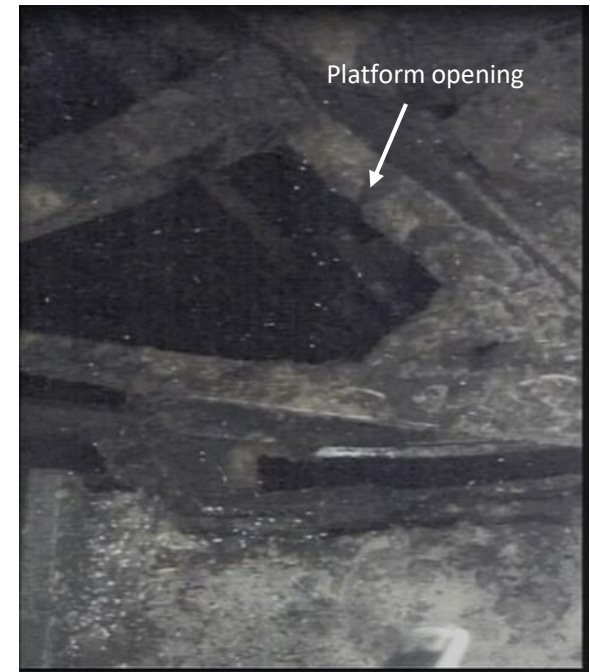
Footage from telescopic arm camera (Pedestal opening, platform opening conditions)

- On September 14, the telescopic device guide pipe was inserted into the PCV near the pedestal opening. Thereafter a telescopic arm function check (tilt mechanism, telescopic mechanism, end jig) was performed and conditions at the bottom of the pedestal were confirmed.

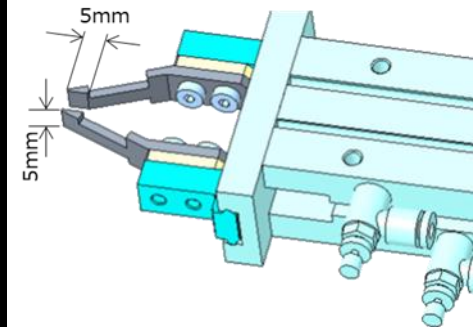
- On September 14, the telescopic device end jig was lowered to confirm conditions at the bottom of the pedestal. Fuel debris at the bottom of the pedestal could be seen via the end jig camera and the fuel debris was touched with the gripper tool.

Gripper claws will be used to determine the size (gripper tool)

Footage from the telescopic arm camera (conditions at the bottom of the pedestal)

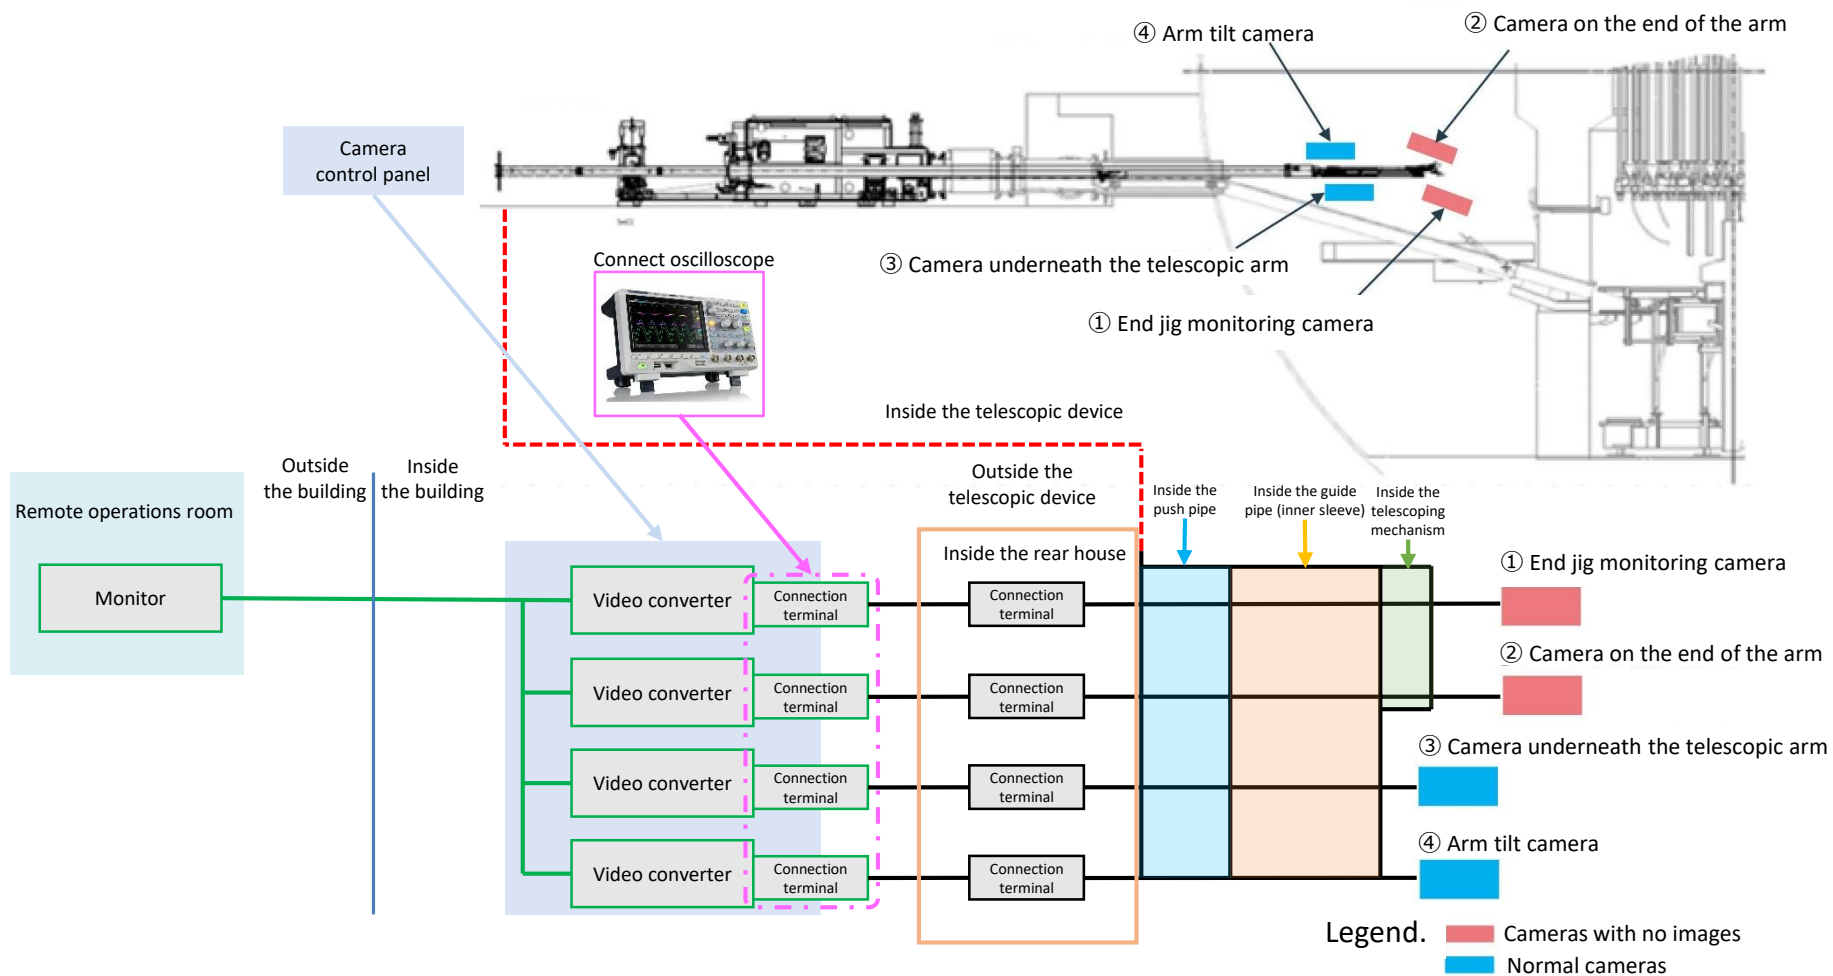
- In order to investigate the cause of this incident, we have been inspecting all camera cables, connection terminals, and the outside of the video converters by checking their exterior, signals and measuring insulation resistance.
- The oscilloscope was used to measure the intensity of the camera signal between September 20~21.

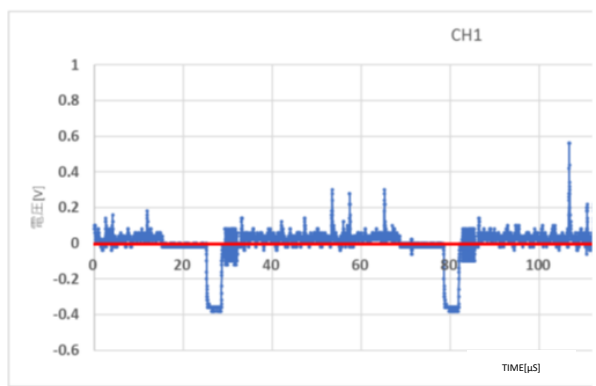
③Camera underneath the telescopic arm

- When measuring the intensity of the camera signals on the end of the telescopic device (① End jig monitoring camera, ② Camera on the end of the arm) and other cameras', we confirmed a difference in signal behavior between of the cameras on the end of the device and other cameras.
