Cameras installed on the telescopic device

Examinations regarding replacement of the cameras

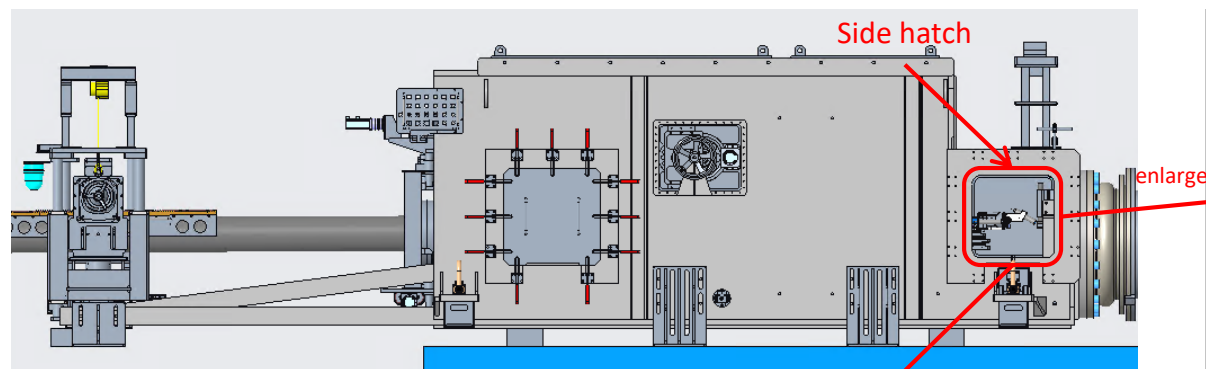
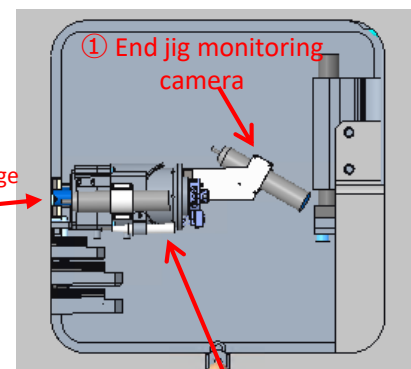
A mockup of the enclosure
(Mitsubishi Heavy Industry Kobe Factory)

- A mockup of the enclosure is being used to examine the accessibility and feasibility of camera replacement both within and outside the enclosure
- We are checking if the cameras can be replaced wearing the same personal protective equipment (PPE) that is needed in the field (cotton gloves and three layers of rubber gloves)

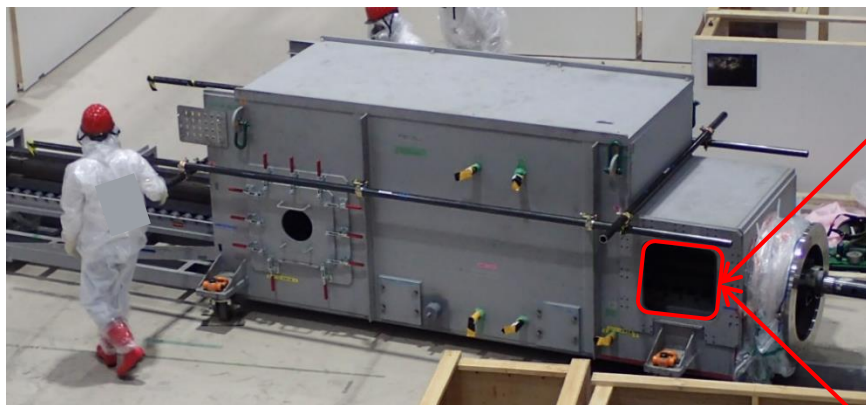
Side hatch
(same dimensions as on
the actual enclosure)

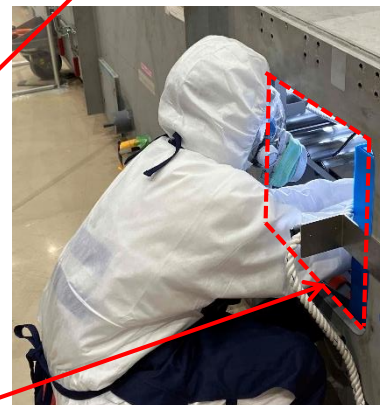
Reviewing accessibility
(Naraha Center for Remote Control
Technology Development)

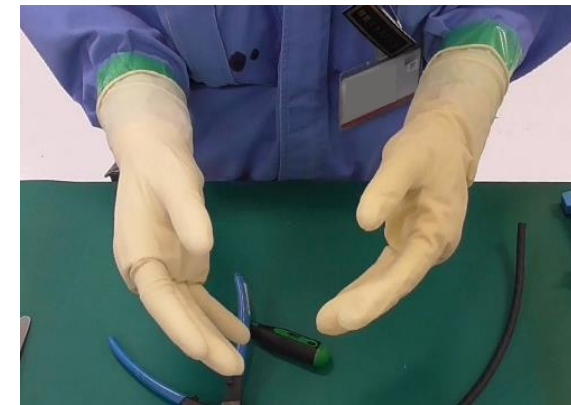
PPE worn during camera replacement
(cotton gloves and three layers of rubber gloves)
*Leather gloves are also used when connecting 2
cables.

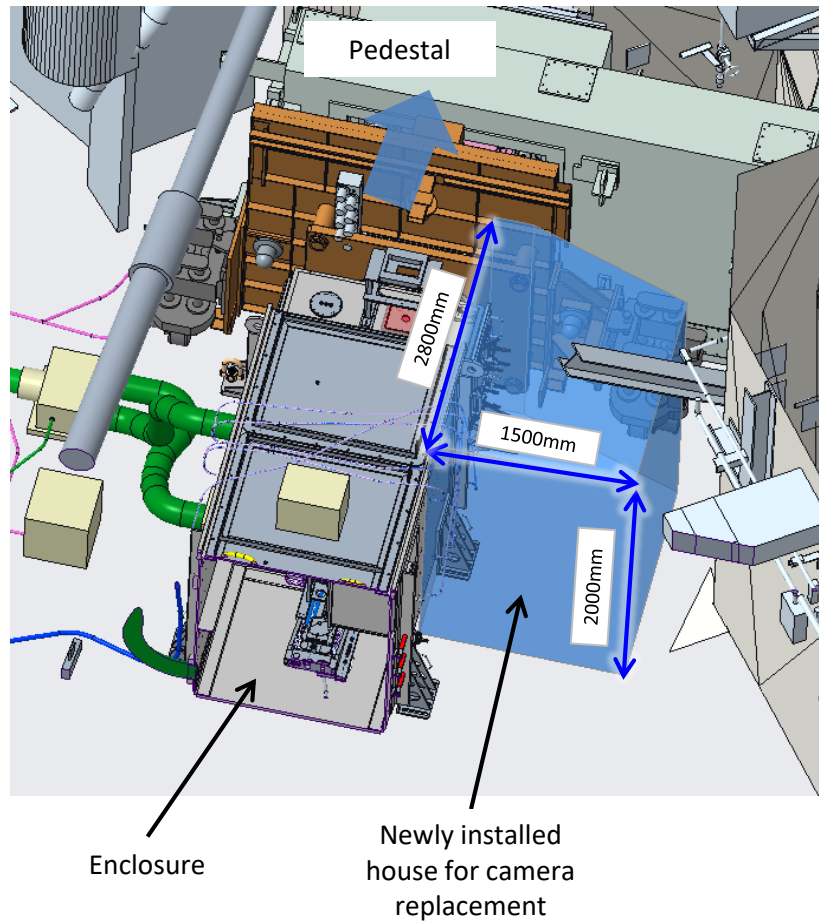
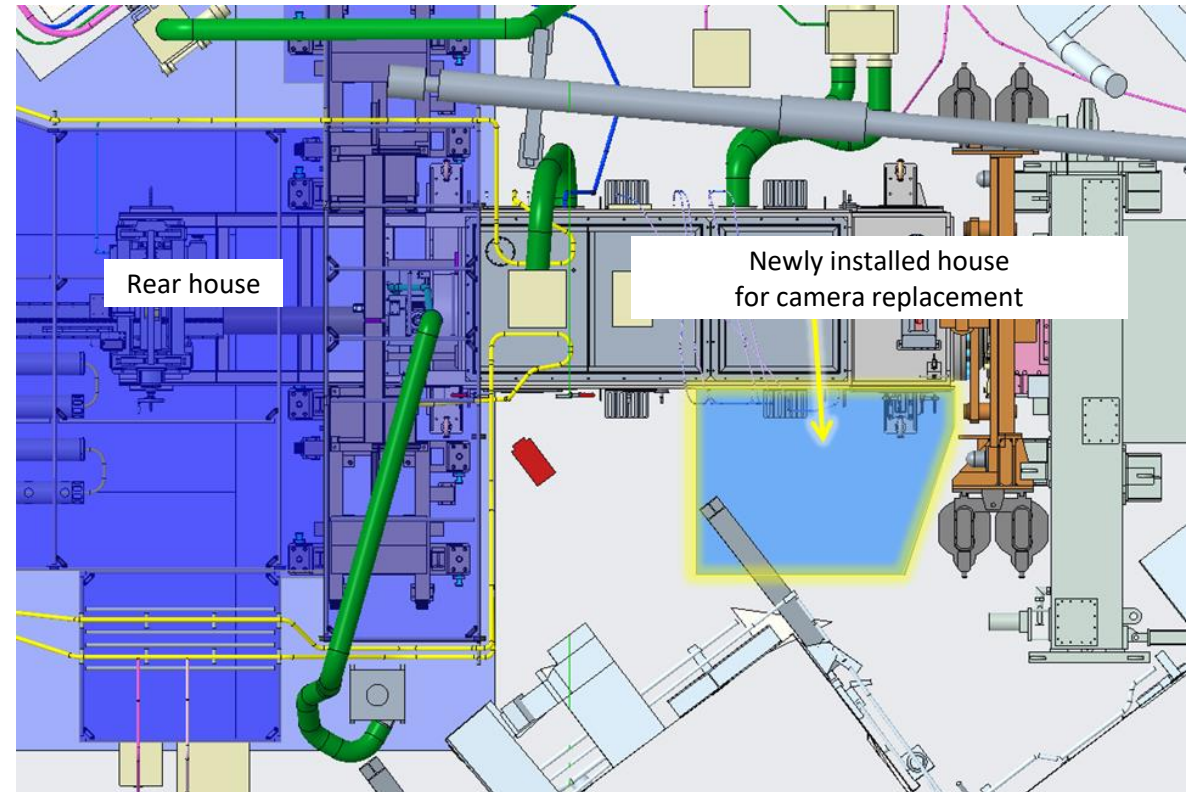
Installing a house on the side of the enclosure for camera replacement

- To prevent the spread of contamination, we are deliberately installing a house on the side of the enclosure for to be used during camera replacement
- Lights and work tables will be set up inside the house to improve the workability for workers when replacing the cameras
