Fukushima Daiichi Nuclear Power Station Unit 1

Pre-checks for an investigation of vicinity of the X-25 penetration

< Reference document >
November 18, 2024
Tokyo Electric Power Company Holdings, Inc.
Fukushima Daiichi Decontamination &
Decommissioning Engineering Company

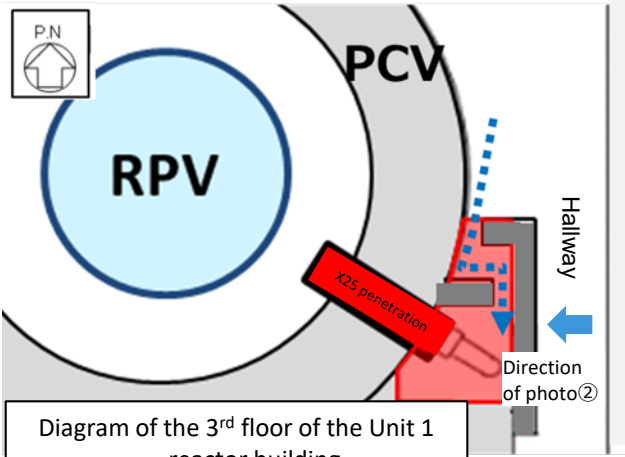
- Implementation date: Tuesday, November 19, 2024
- Implementation details: A crawler robot will be used to check accessibility inside the shielding blocks and measure air dose rates
 - ✓ STEP1 : Confirm that the robot can access narrow areas and run unimpeded on the floor
 - ✓ STEP2 : Look for drone obstacles such as pipes and other structures
 - ✓ STEP3 : Measure air dose rates
