K4 Area Tank Inspection Status

November 28, 2024

Tokyo Electric Power Company Holdings, Inc.

1. K4 area tank overview

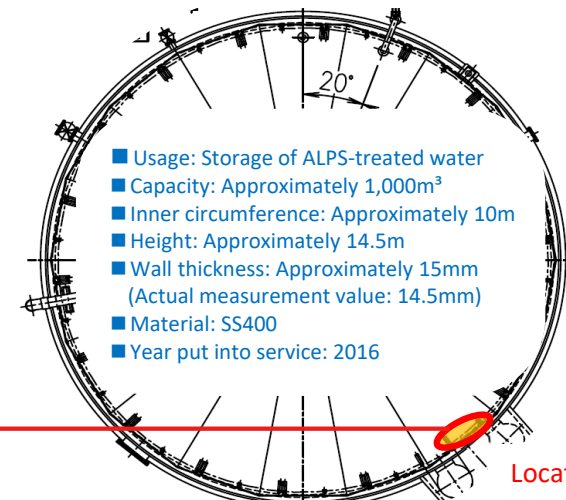
K4 area: Tank E1 plan view

- The transfer of ALPS-treated water being stored in the Group E tanks (E1~E5) to the measurement/confirmation facility was completed on November 21, 2023, and an internal inspection of the tanks was implemented between March and July 2024.
- Localized paint peeling and wall thinning due to corrosion was found in tanks E1, E2, and E5.
- A simulation was used to perform a stress assessment of the tanks (Reference 1) to ascertain the impact of the thinning, and it was confirmed that there has been no impact on the structural strength of the tanks.
- The locations of thinning in the group E tanks were repaired using overlay welding that was then repainted (Reference 2).

➤ A grinder was used to smooth out the entire area where thinning occurred and welding was overlaid after which the area was smoothed. (Photo: K4 area E1 tank)

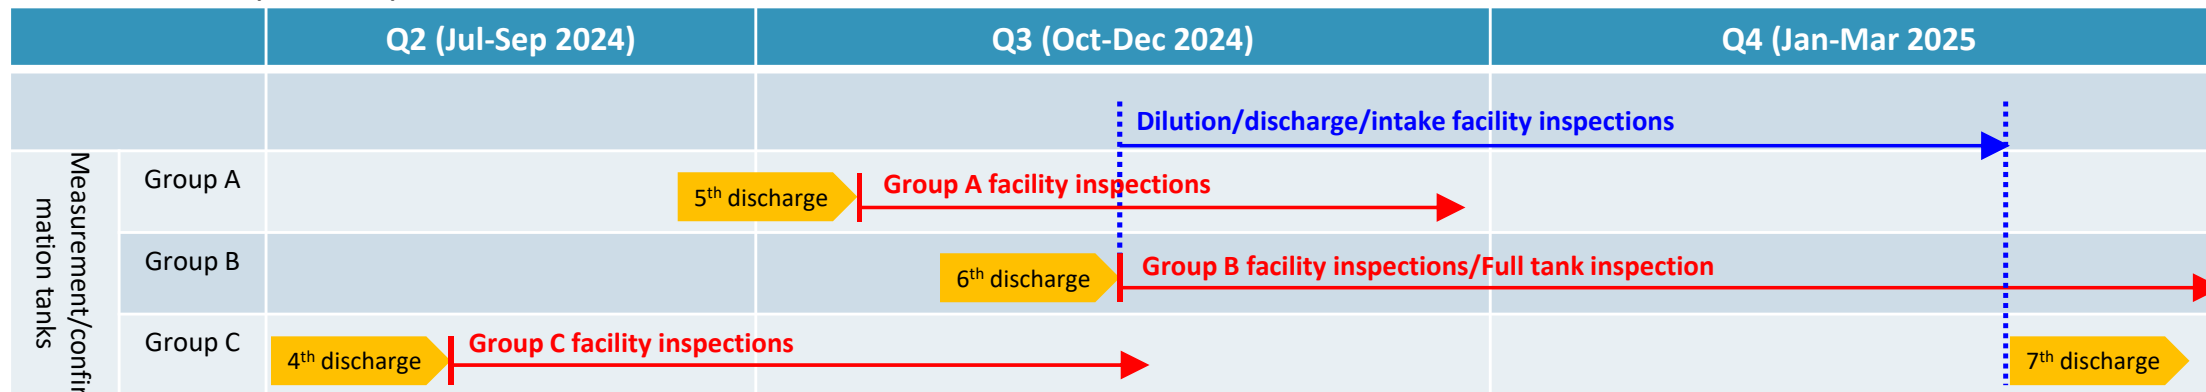
< FY2024 inspection plan >

- After completion of the 4th discharge of ALPS-treated water into the sea in FY2024, we began successively inspecting measurement/confirmation tanks in accordance with its long-term inspection plan. (Full inspections are underway for group B)
 - Since localized corrosion was found near the bottom of the group E tanks during the inspection, an internal inspection[※] was added to the annual inspections of group A and group C.
 - The long-term integrity of the measurement/confirmation tanks, etc., shall be maintained through regular inspections.
- ※ Visual inspection of areas near the bottom (including paint repairs)
