# Results of an In-House Investigation Performed in the Vicinity of the Unit 1 X-25 Penetration to Confirm Accessibility

November 28, 2024

Tokyo Electric Power Company Holdings, Inc.

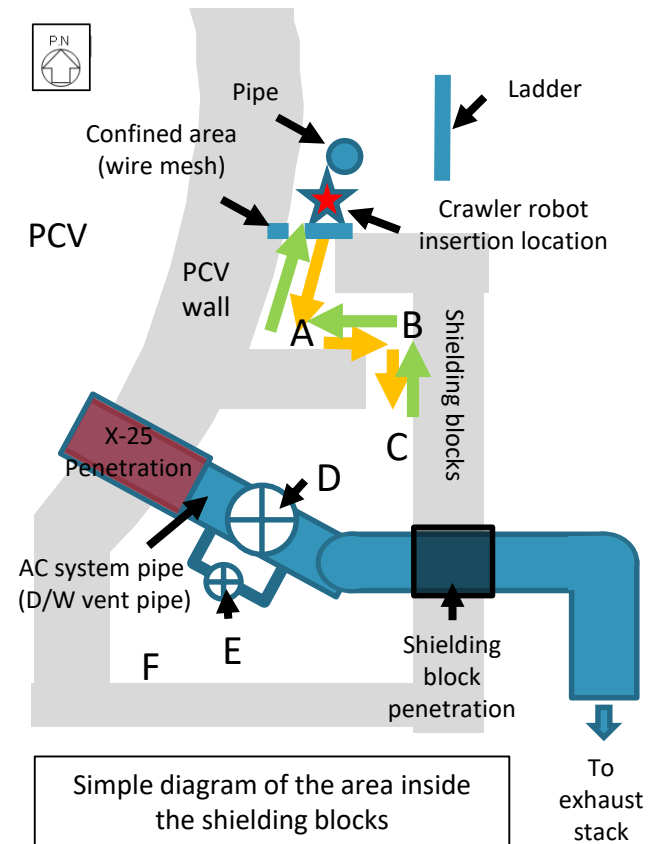
- It was confirmed that there are no large obstacles and the crawler robot can move.

Location D: Directly underneath D/W vent valve (large valve)  
 Location E: Directly underneath D/W vent valve (small valve)

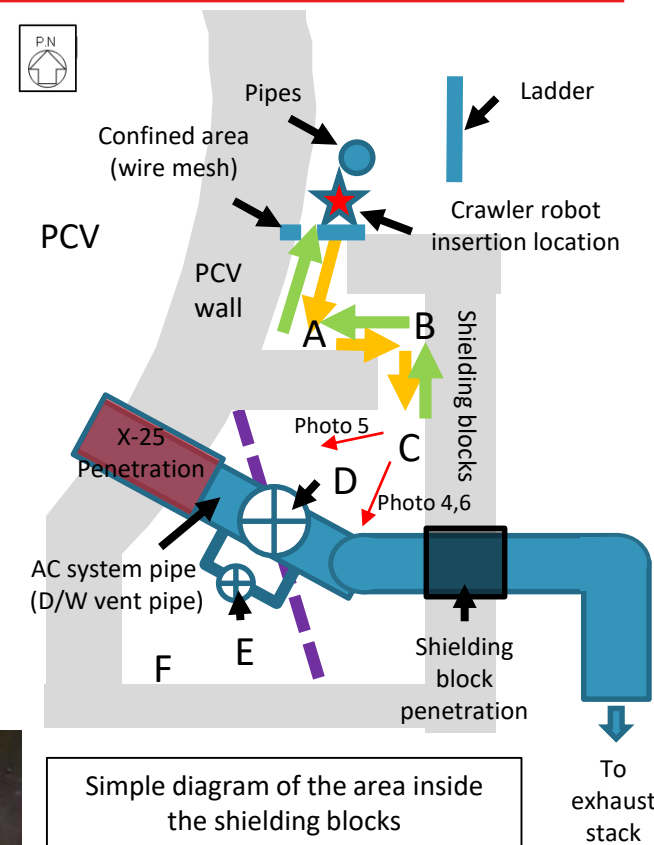
Simple diagram of the area inside the shielding blocks

- It was confirmed that there are no obstacles that would hinder drone flight
- A step ladder that would hinder crawler robot movement was found

Location D: Directly underneath D/W vent valve (large valve)  
 Location E: Directly underneath D/W vent valve (small valve)
