Causes and Countermeasures for the Decrease in Water Level of the Unit 2 SFP Skimmer Surge Tank and Going Forward Measures

November 28, 2024

Tokyo Electric Power Company Holdings, Inc.

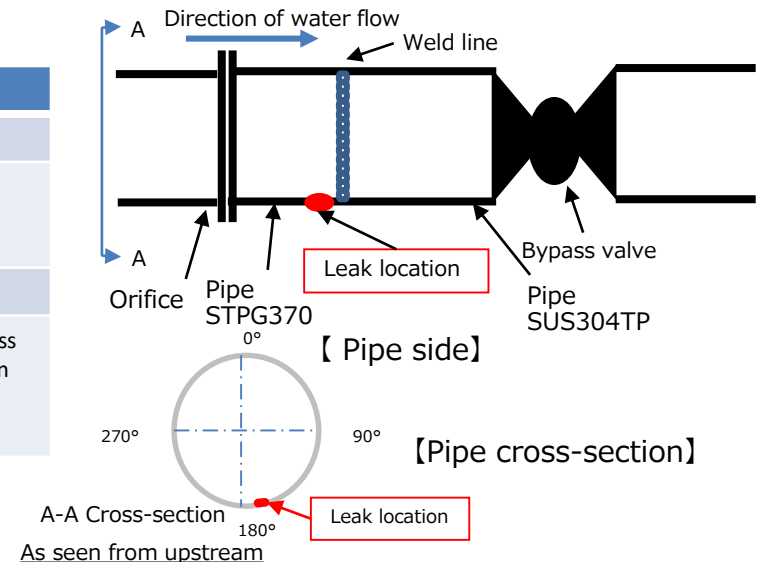
■ Details about the leak location

Leak location conditions
Dimensions of leak hole	Max: Approximately 13mm
Location of leak hole	Underneath the pipe (directly underneath and extending for a width of approximately 10mm in the circumferential direction) Stretches for approximately 18mm in the axial direction from the weld
Inside the pipe	Deposits found inside the pipes
Pipe configuration	<ul style="list-style-type: none"> The material used from the weld line to the motorized valve side is stainless steel for pipes (SUS304TP), and the dissimilar metal joint consists of carbon steel (STPG370) and stainless steel A flow adjustment orifice is installed on the heat exchanger side

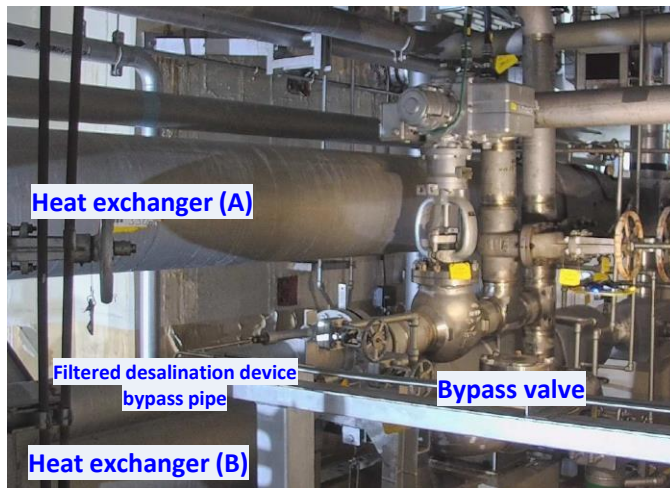
FPC Heat exchanger room

- ✓ The outside surface of the pipe was examined using drone cameras as well as via direct inspection by personnel.
- ✓ Discoloration thought to be rust was found around the hole causing the leak, but no significant corrosion was found on the outer surface of the pipe of the same line.

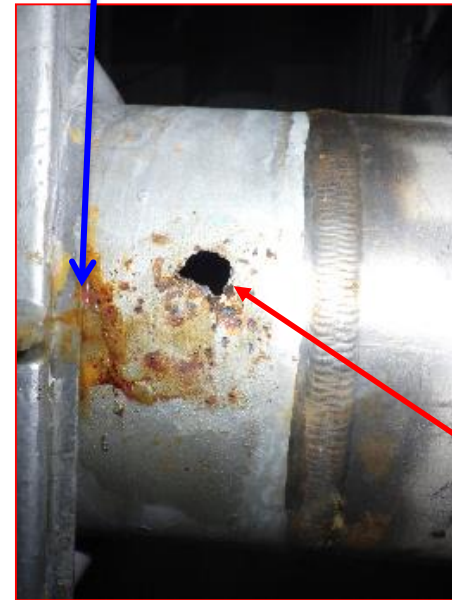
Leak location

- ✓ Adhesions on the outside of the pipe near the leak location were sampled and subjected to SEM – EDX analysis (elemental analysis).
- ✓ As a result of the elemental analysis, 0.6% chloride was detected.
- ✓ It is assumed that system water leaking from the leak location caused chloride to adhere to the outer surface of the pipe.

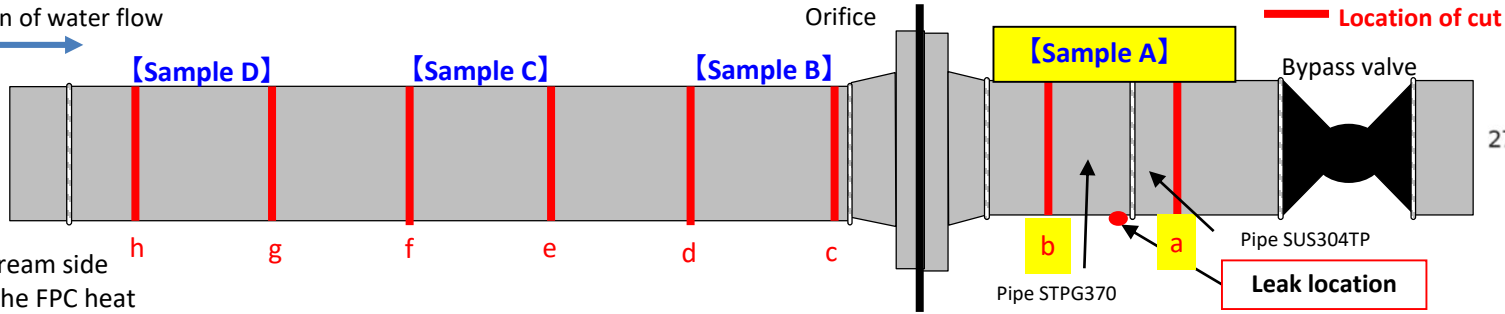
Reddish-brown adhesions were observed along the entire circumference of the inner surface of the carbon steel, and some clump-like adhesions were seen on the sky-side. There were bridge-like deposits on the ground-side, and the area below it was hollow. There were deposits on the ground-side on the stainless steel pipe side, and the area below it was hollow, but no deposits were found on the sky-side side.

○ : The green material above the deposits is iron powder generated during the cutting process (the same applies for the cut cross-sections)

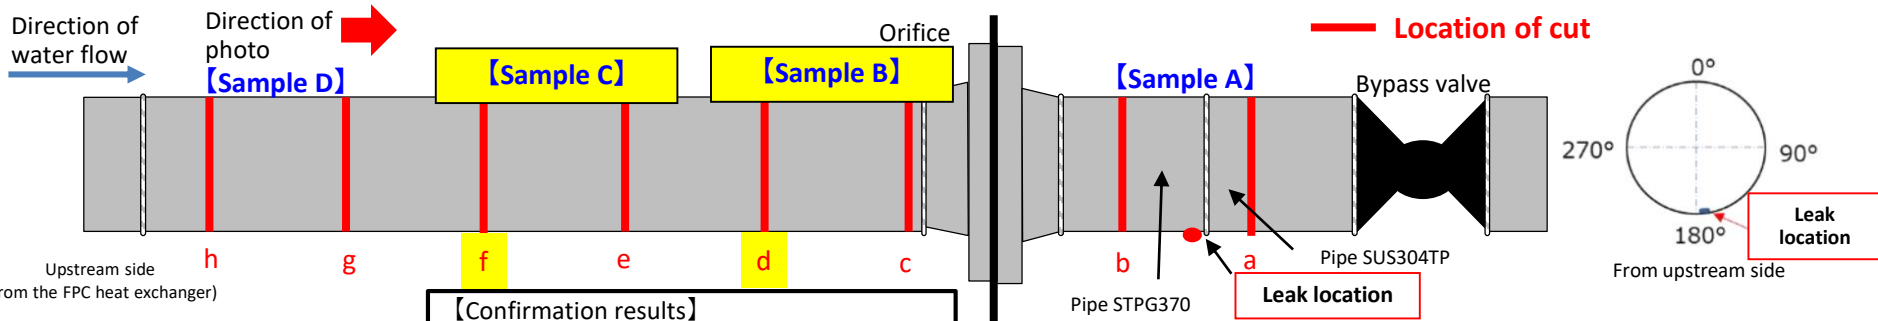
[Sample C f cross-section]

[Confirmation results]
 Reddish-brown adhesions were observed along the entire circumference of the inner surface, and some clump-like adhesions were seen on the sky-side. There were bridge-like deposits on the ground-side, and soil-like (gray) deposits were found below them. This area below was hollow.

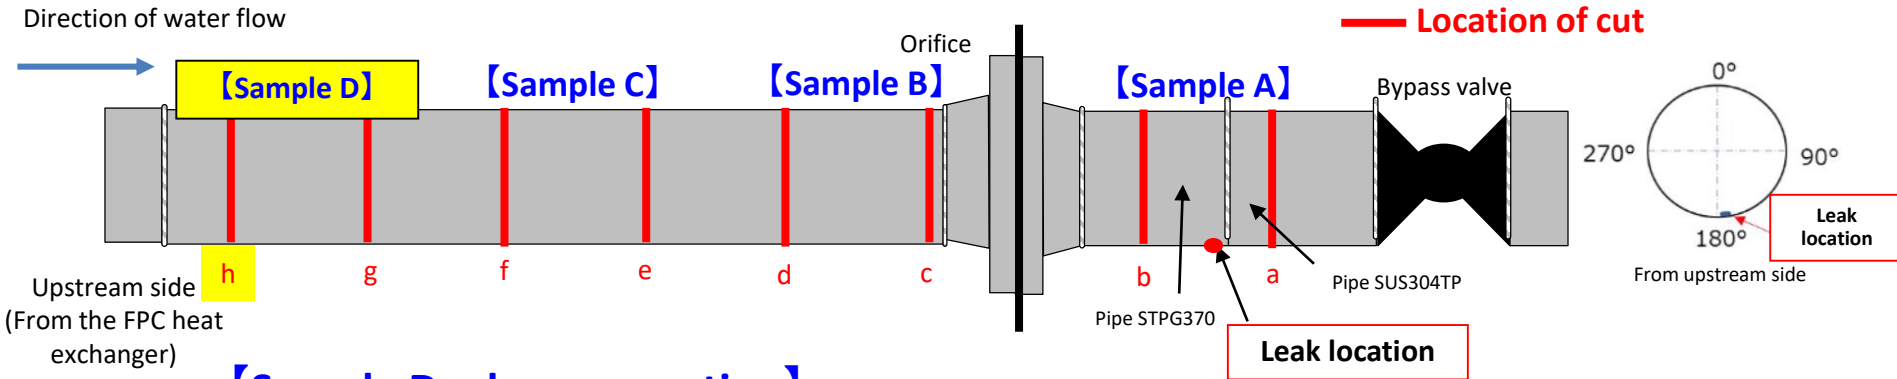
【Sample D h cross-section】

Reddish-brown adhesions were observed along the entire circumference of the inner surface, and some clump-like adhesions were seen on the sky-side. There were deposits on the ground-side (surface is reddish-brown, with gray deposits underneath)

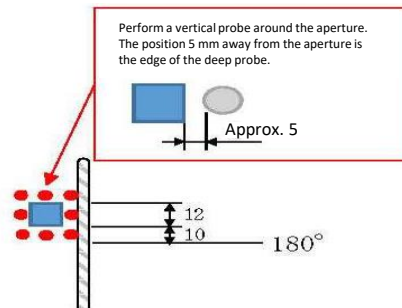
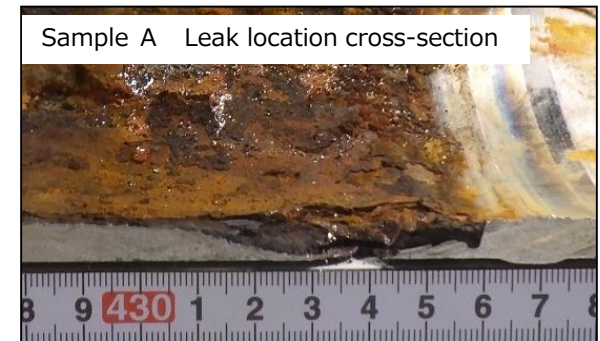
- ✓ Sample A : Thinning on the sky-side 0° and 90° was minimal, but other thinning was observed. The amount of thinning on the ground-side 180° was relatively large, and an abnormally large amount of thinning was found on the carbon steel side approximately 100mm from the weld line. No significant thinning of the stainless steel pipe was observed.
- ✓ Sample B : Thinning on the sky-side 0° was minimal, but other thinning was observed. The amount of thinning on the ground-side 180° was relatively large, and fairly uniform.
- ✓ Sample C : Thinning on the sky-side 0° was minimal, but other thinning was observed. The amount of thinning on the ground-side 180° was relatively large
- ✓ Sample D : Thinning was observed around the entire circumference, and there was little non-uniformity in each direction.

1.9	2.2	1.5
1.8	aperture	2.0
1.9	1.2	2.4

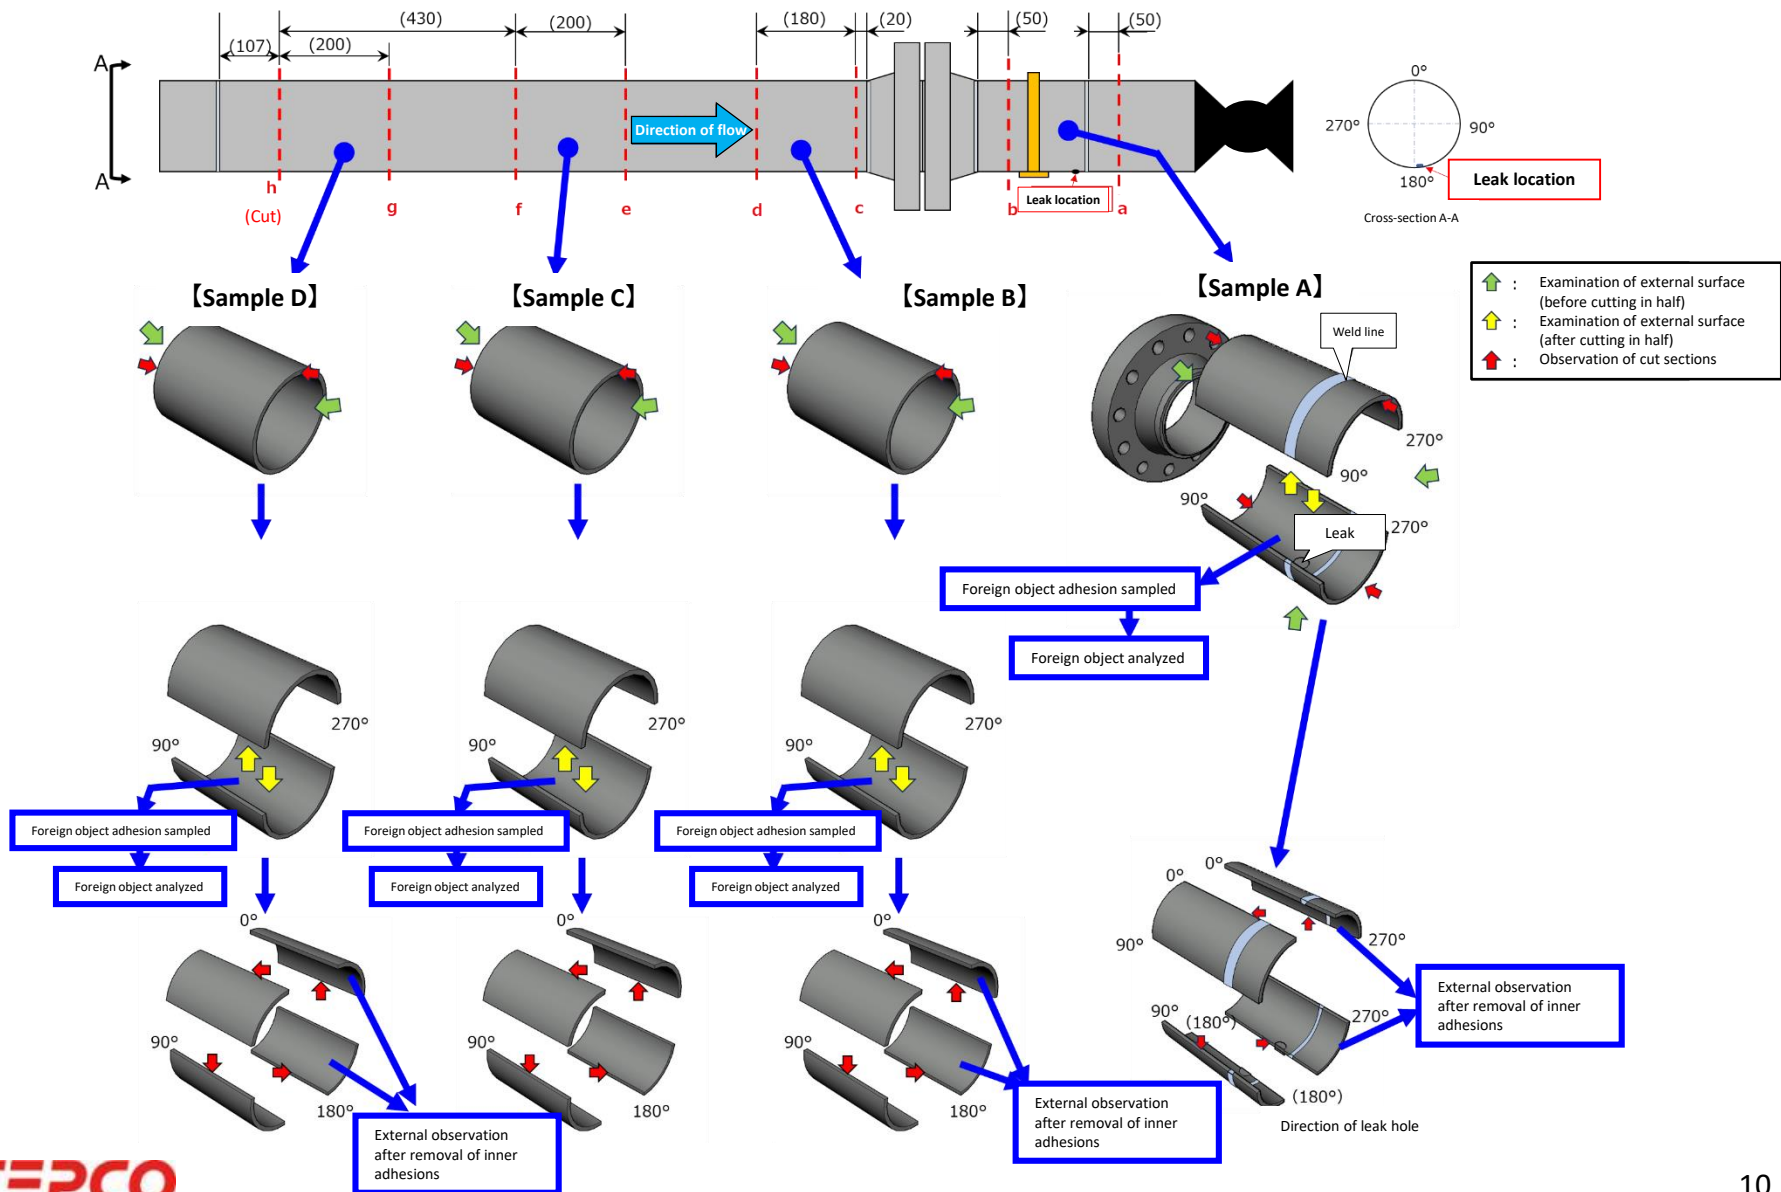
- ✓ In order to examine the inner surface of the pipes, Samples A~D were cut on the lines shown below after which they were split into four sections along the axis of the pipe.

- ✓ The internal surface of the pipe was observed after removing the deposits.
- ✓ The internal surface of pipe samples A, B, D confirmed corrosion throughout.
 - 【Sample A】 Abnormally large thinning was confirmed approximately 100mm from the weld line on the 180° side
 - 【Sample B】 Thinning on the 180° side was uniform with localized deeper thinning
 - 【Sample D】 Corrosion confirmed throughout

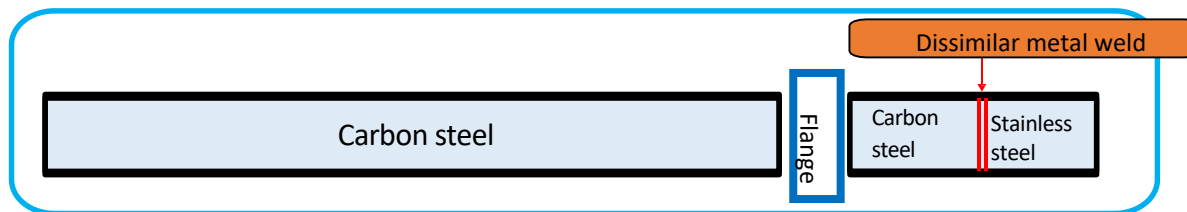
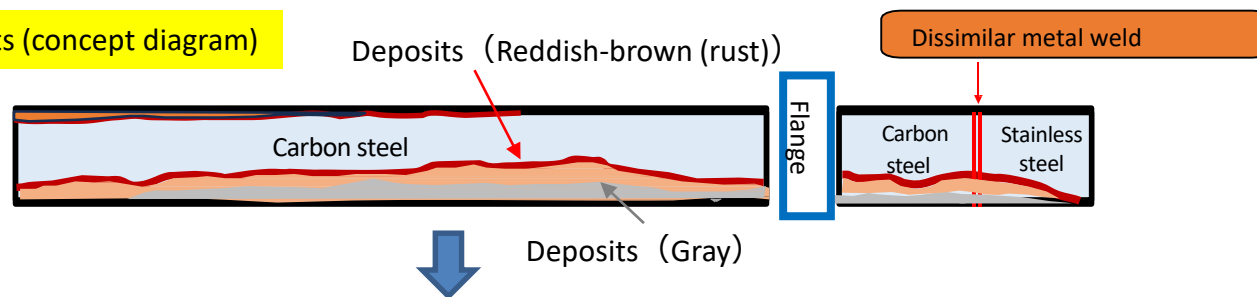
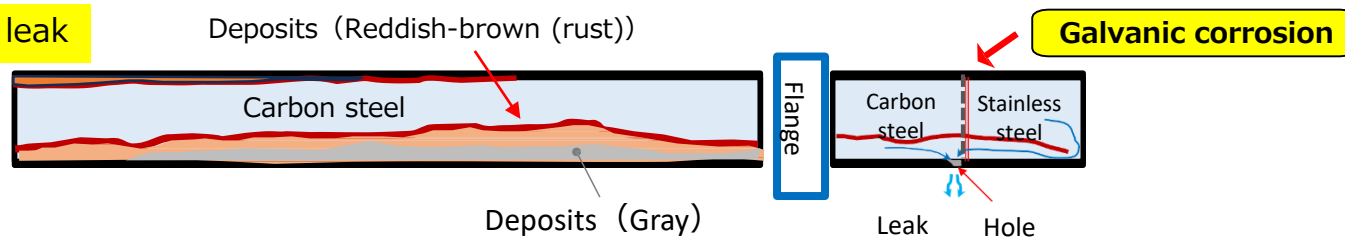
Increase in deposits (concept diagram)

- Corrosion, which is an electrochemical reaction, hardly occurred within pure water, which is an insulating environment, so rust and deposits did not form. Furthermore, galvanic corrosion also did not occur because the insulation prevented dissimilar metal welds from acting like a battery.

- Seawater is injected into the SFP as coolant. The seawater flows through the aforementioned pipe causing total corrosion (rust) along the surface of the carbon steel.
- In conjunction with this, galvanic corrosion occurs on the carbon steel side of the dissimilar metal welds between carbon steel and stainless steel.
- The aforementioned pipe branches off from the SFP circulated cooling system and the water in it is stagnant for the most part. Accordingly, rust, dirt and foreign objects in the water accumulated on the ground-side.
- SFP water was purified, but it will never be pure again, so corrosion continued along the entire surface of the carbon steel and rust continued to form thereby increasing the amount of deposits.

- Galvanic corrosion progresses on the downstream side of the flange and water starts to leak from the hole
- Relatively soft gray deposits on the ground-side gradually flow outside the system
- Part of the relatively hard and reddish-brown bridge-like deposits collapses causing the water leak to gradually grow and allowing almost all the great deposits to leak out
- Meanwhile, since of the reddish-brown (rust) deposits are hard, there remained in place resulting in hollowing of the area

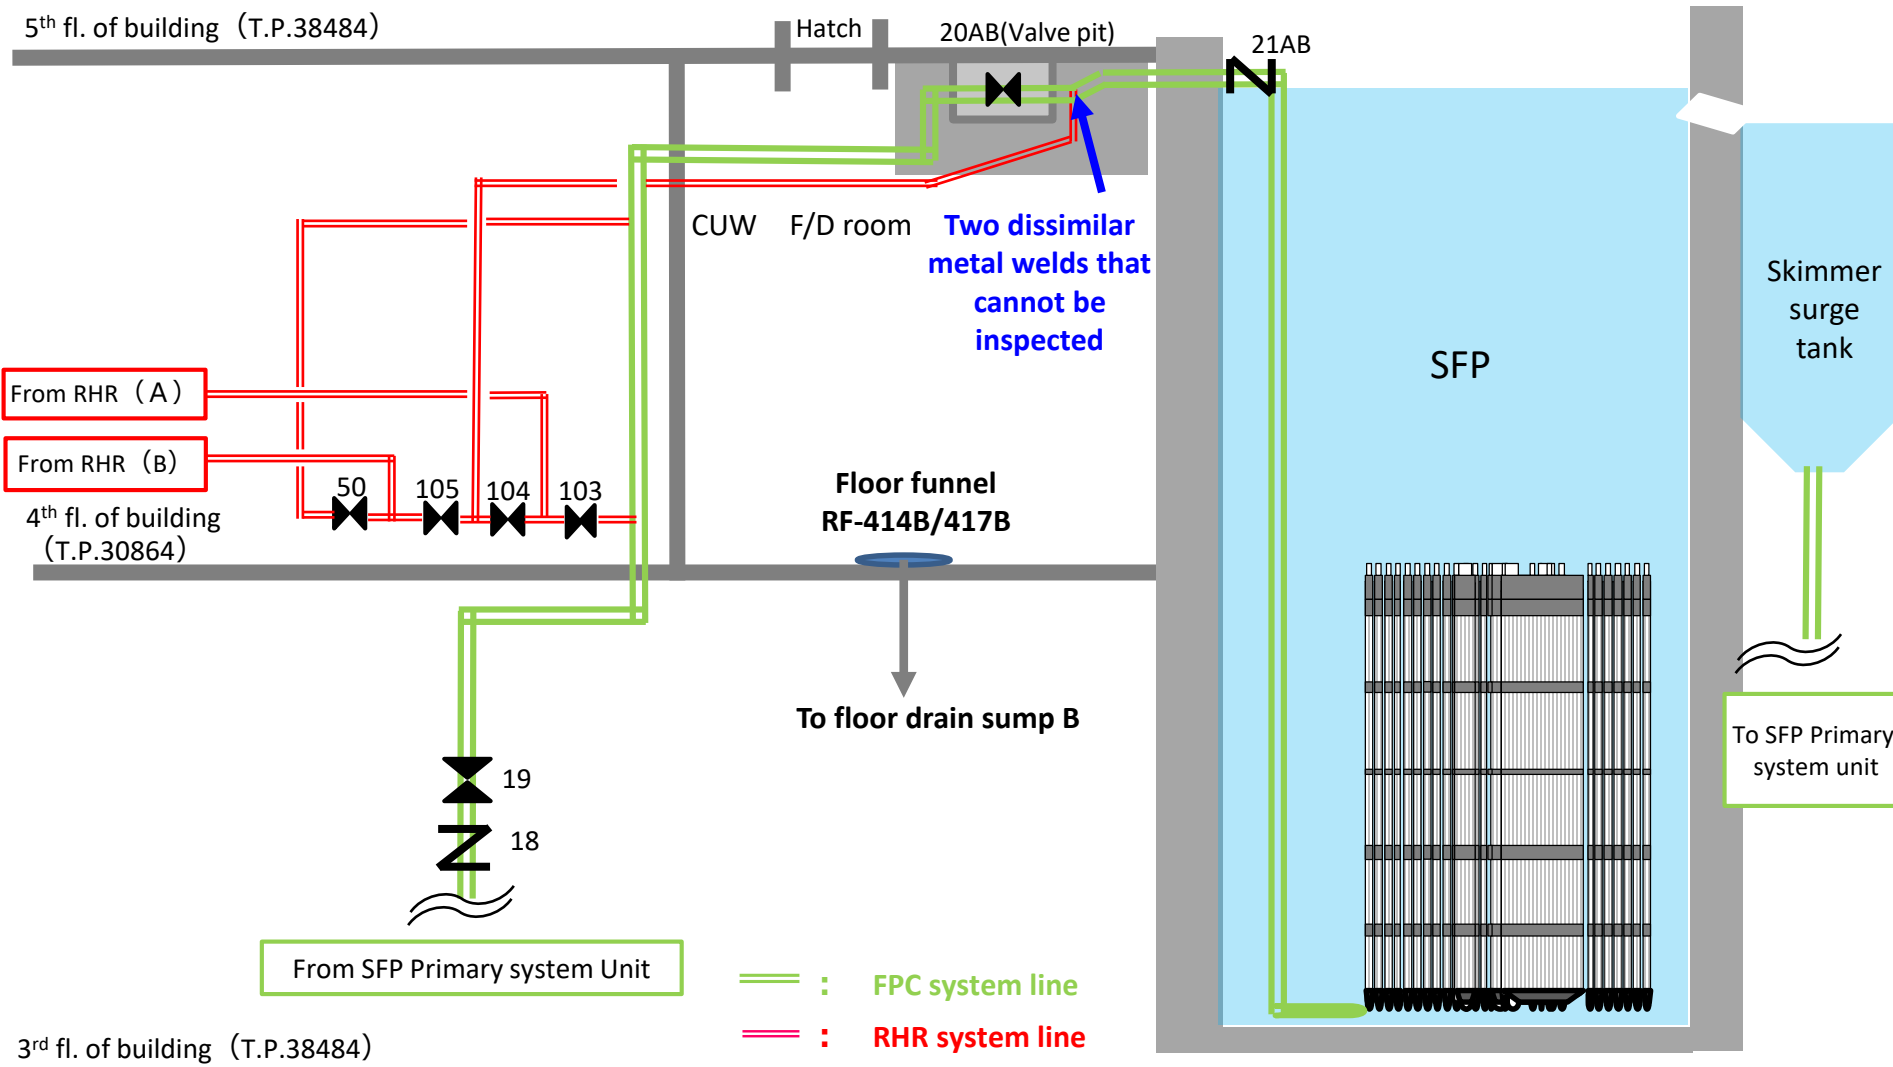
<Reference> SFP water level during siphoning

- Two of the similar dissimilar metal welds are buried in concrete and cannot be inspected. If there was a leak from either of these welds, the leaking water would flow down the gaps between the concrete and the pipe and flow into the CUWF/D room. The water would flow via the floor funnel into the stagnant water in the building. If siphoning were to occur, the leak would stop several centimeters below the NWL.
