ALPS Treated Water Discharge Status Update

January 30, 2025

Tokyo Electric Power Company Holdings, Inc.

2. Facility inspection status

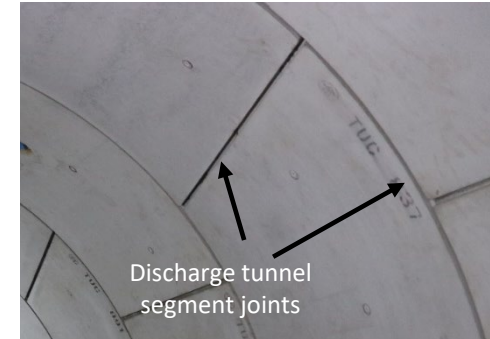
Location of photograph around approximate 350 m

| Inspection item | Results of this inspection (January 2025) | Results of previous inspection (June 2024) |
|---|---|---|
| Sediment conditions | Approximately 20cm on average on the bottom of the discharge outlet Sediments inside the discharge tunnel are sparse and <u>only several centimeters thick, there is sediment several centimeters thick at the vertical alignment change point.(no sediments more than 300 m from the exit)</u> | Approximately 20cm on average on the bottom of the discharge outlet Approximately several centimeters of sediment inside the discharge tunnel ^{※1} |
