# ALPS Treated Water Discharge Status Update

February 27, 2025

Tokyo Electric Power Company Holdings, Inc.

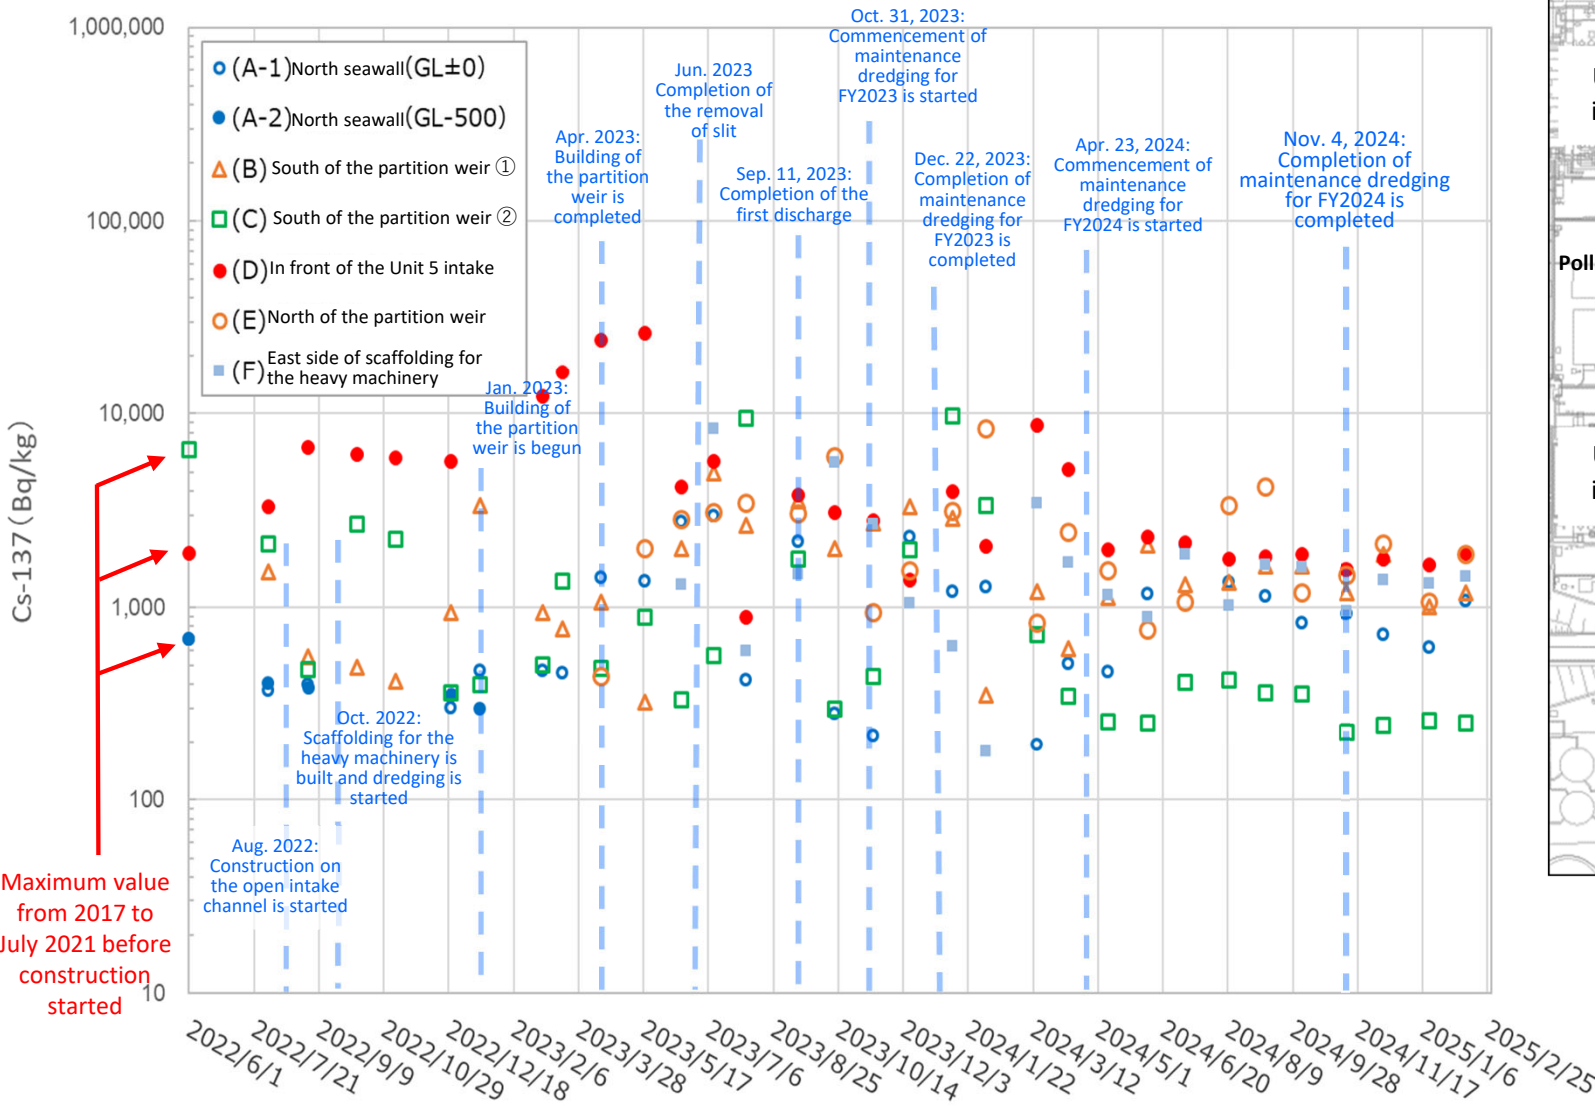
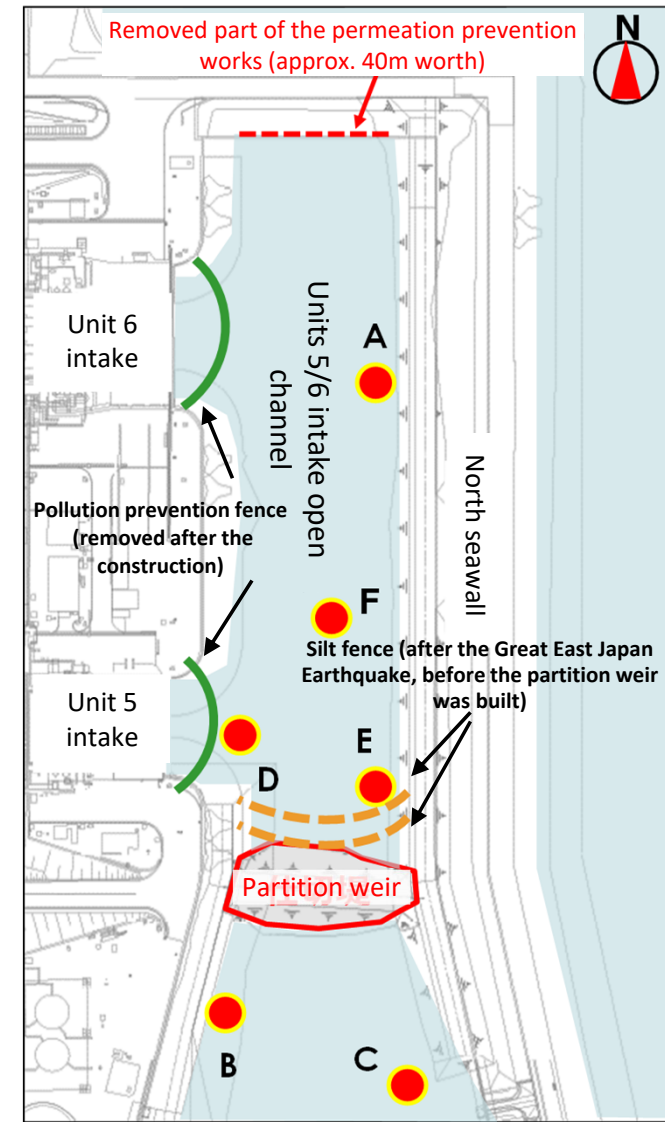
- Monitoring results for seabed soil in front of Unit 5 intake did not show significant fluctuations from the beginning of construction at the intake open channel until December 2022. While they showed higher readings after January 2023, we have confirmed that these readings decreased after the completion of silt removal.
- We will continue to monitor the seabed soil.

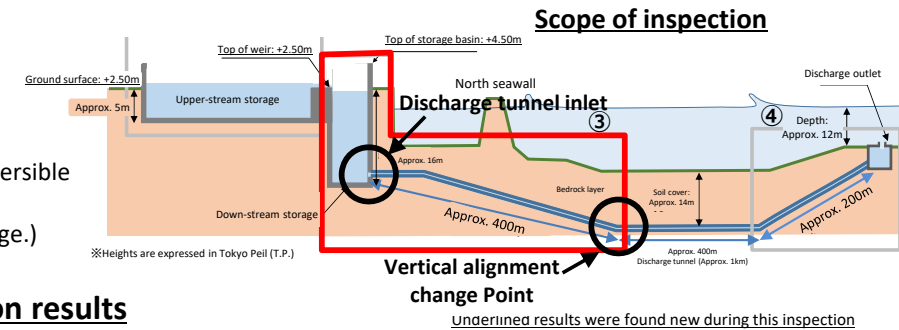
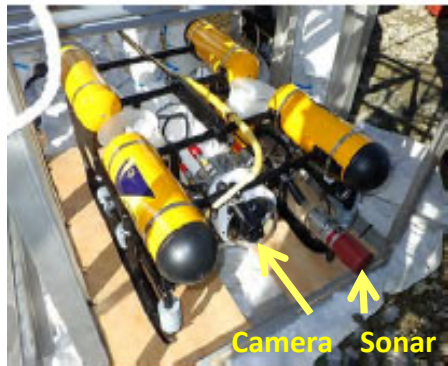
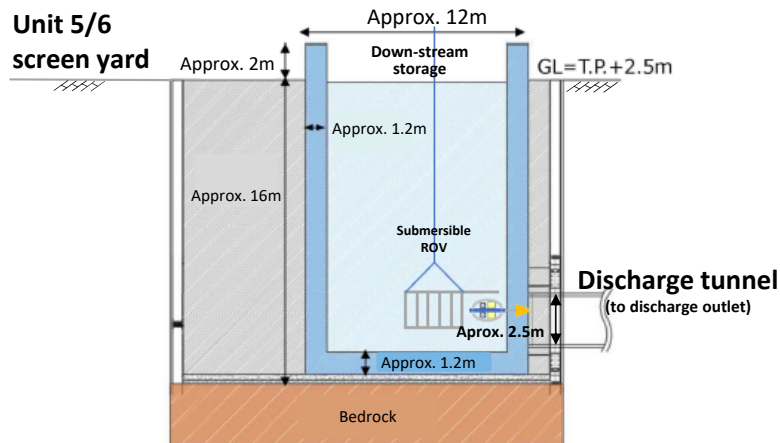
**Discharge tunnel/down-stream storage**  
Diagram of submersible ROV inspection

■ An internal inspection of the discharge tunnel and down-stream storage were conducted and no abnormalities were confirmed.

- A submersible ROV was put into the down-stream storage on-site and checked the conditions of approximate 400m down the discharge tunnel from the inlet.

Inspection item	Results of this inspection (February 2025)	Results of previous inspection (February 2024※)
Marine organism adhesion	Inside the discharge tunnel: Some adhesion of marine life (barnacles) have adhered themselves Inside the down-stream storage: <u>A small amount of marine life has adhered itself to the wall</u>	Barnacles (few)
Sediment conditions	Inside the discharge tunnel: <u>Approximately 1~2cm of sediment exists until about 50m into the tunnel</u> Inside the down-stream storage: <u>Approximately 10cm of sediment exists at the bottom</u>	Almost none (some floating mud)
Issues that may impact discharge, such as cross-sectional closure (foreign objects, etc.)	None	None

(We are deliberating increasing the distance back into the tunnel that the inspection is conducted, but since submersible ROV propulsion may be affected as the submersible ROV cable rubs against sediment and marine organism that has affixed itself to the inside of the tunnel, the distance from the exit will be gradually increased as we obtain knowledge.)
