Fukushima Daiichi Nuclear Power Station Unit 3 PCV Internal Investigation (non-submerged area) using Micro-drones

December 25, 2025

Tokyo Electric Power Company Holdings, Inc.

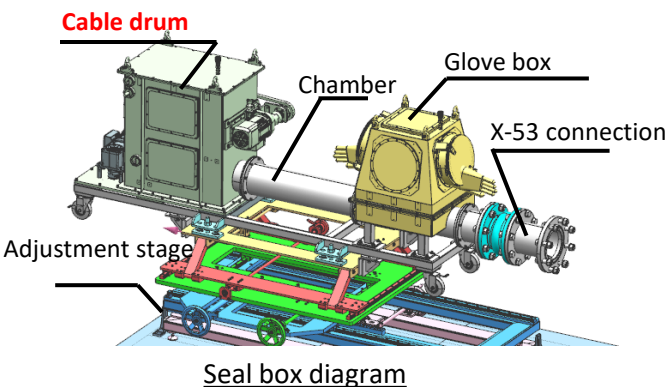
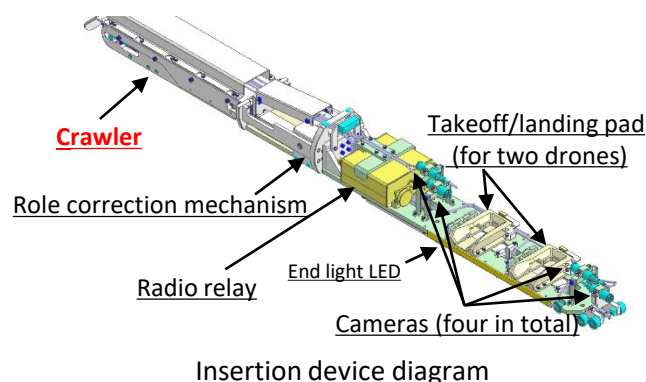
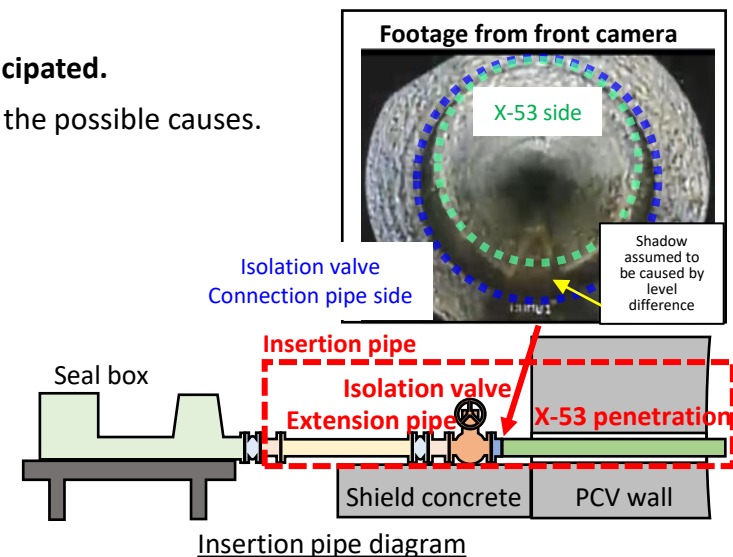
- In order to identify the cause of this event conditions on-site were inspected and the causes were analyzed from the perspectives of the “**investigation**” device and the “**on-site environment**”.
- As a result, **we now assume that the conditions inside the insertion pipe differ from those anticipated.**
- A detailed inspection of the inside of the insertion pipe was conducted in order to narrow down the possible causes.

Cause 1	Cause 2	Assumed cause	Confirmed on-site conditions or assumed conditions	Possible
Investigation devices	Cable drum	Drum malfunction	【On-site condition check】 Camera footage from the cable drum and the fact that the torque abnormality interlock has not tripped suggests they are working correctly even in the face of this problem.	×
		Caught cable	【On-site condition check】 An external examination found no evidence of the cable being caught on anything. And camera footage of the cable behavior shows that it is working correctly even in the face of this problem.	×
	Insertion device	Crawler track malfunction	【On-site condition check】 An external examination found no deformation or derailment. Function checks showed that the device can be repeatedly moved back and forward with no problem.	×
		Crawler drive system malfunction	【Field condition check】 Function checks showed that the device can be repeatedly moved back and forward with no problem.	×

On-site environment	Insertion pipe	Part of the insertion route is smaller in diameter due to a level difference	【Assumed conditions】 We cannot deny that a level difference at the pipe coupling may have caused the access pathway to become narrower and the insertion device to get caught. 【Field condition check】 A shadow that is assumed to be caused by a level difference between the isolation valve connection pipe and the X-53 penetration was found.	○
		The current crawler cannot move forward any further due to the level difference	【Assumed conditions】 If there is a level difference that exceeds the crawler's capabilities or prevents it from fully performing, we cannot deny the possibility that the device may not be able to pass this point.	○

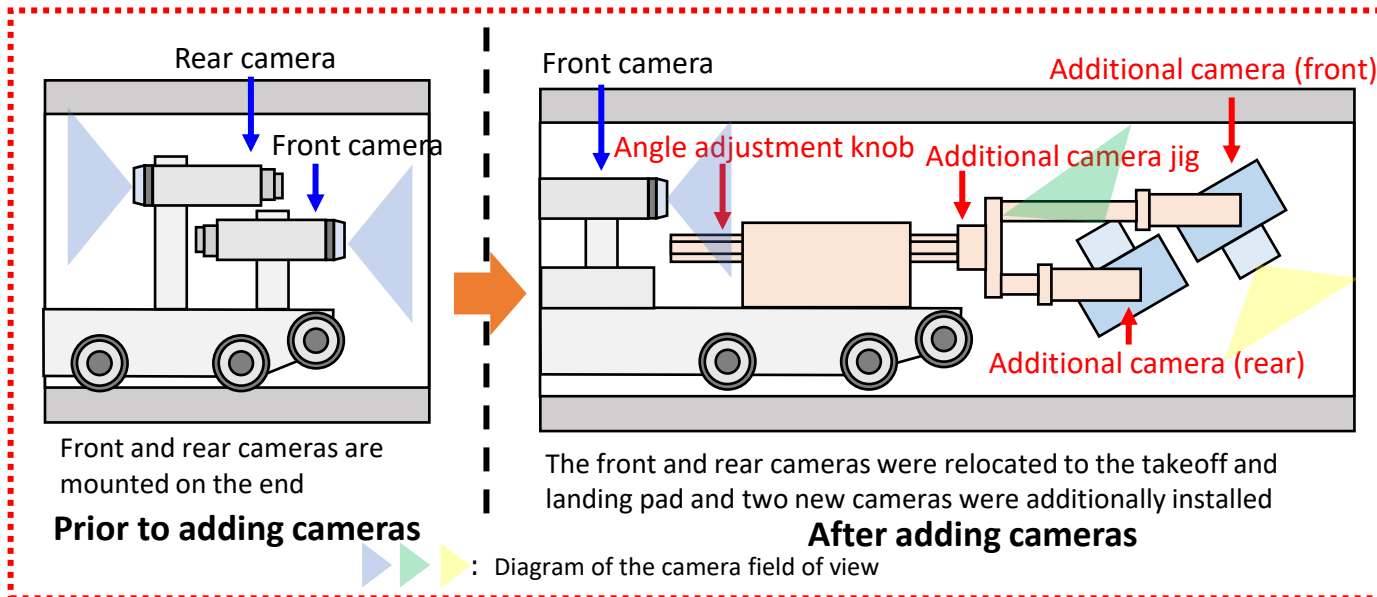
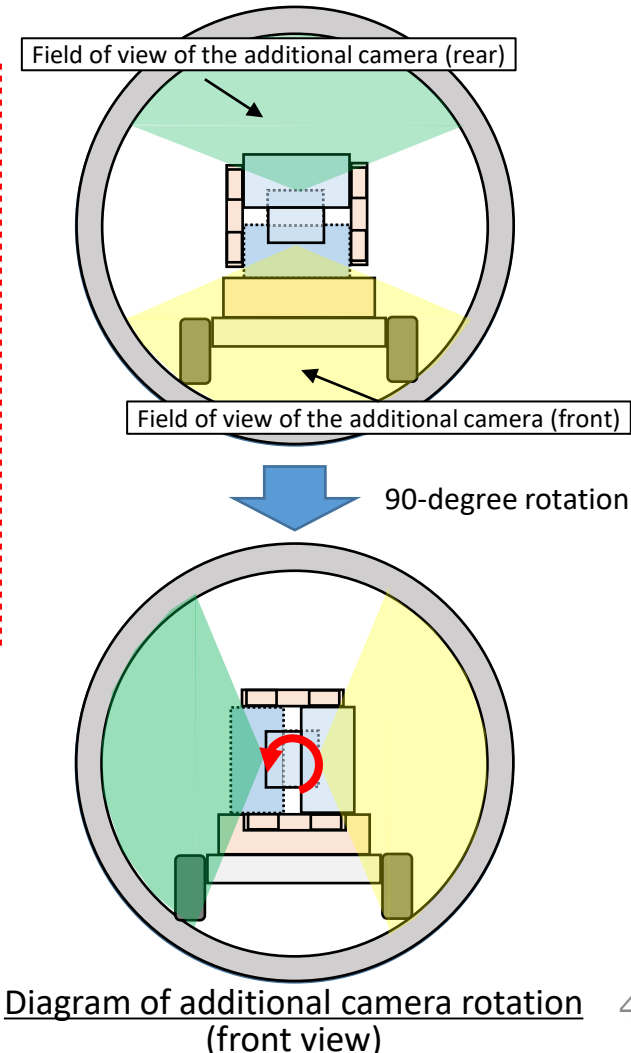
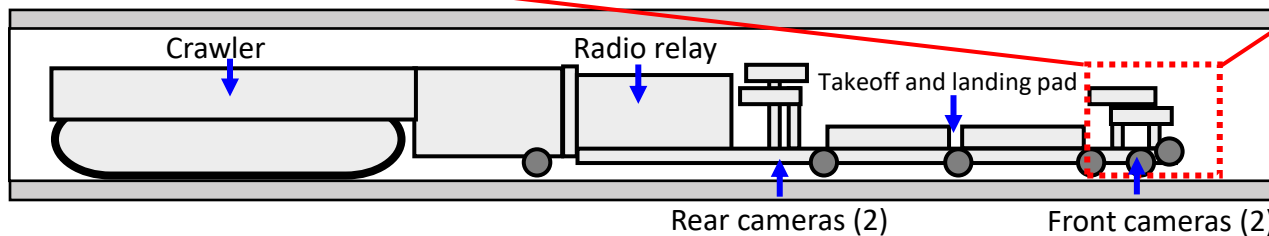
Diagram showing the insertion device (side view)

- **Two cameras were added to the end of the insertion device** in order to perform a detailed inspection of the inside of the insertion pipe.
- Both cameras are angled slightly forward and to the rear to take photos of the **level difference inside the pipe and the shape of the inner walls of the pipe.**
- The cameras can also rotate along the axis of the pipe, so **turning each of them 90-degrees enables us to acquire footage of the entire inner circumference of the pipe.**

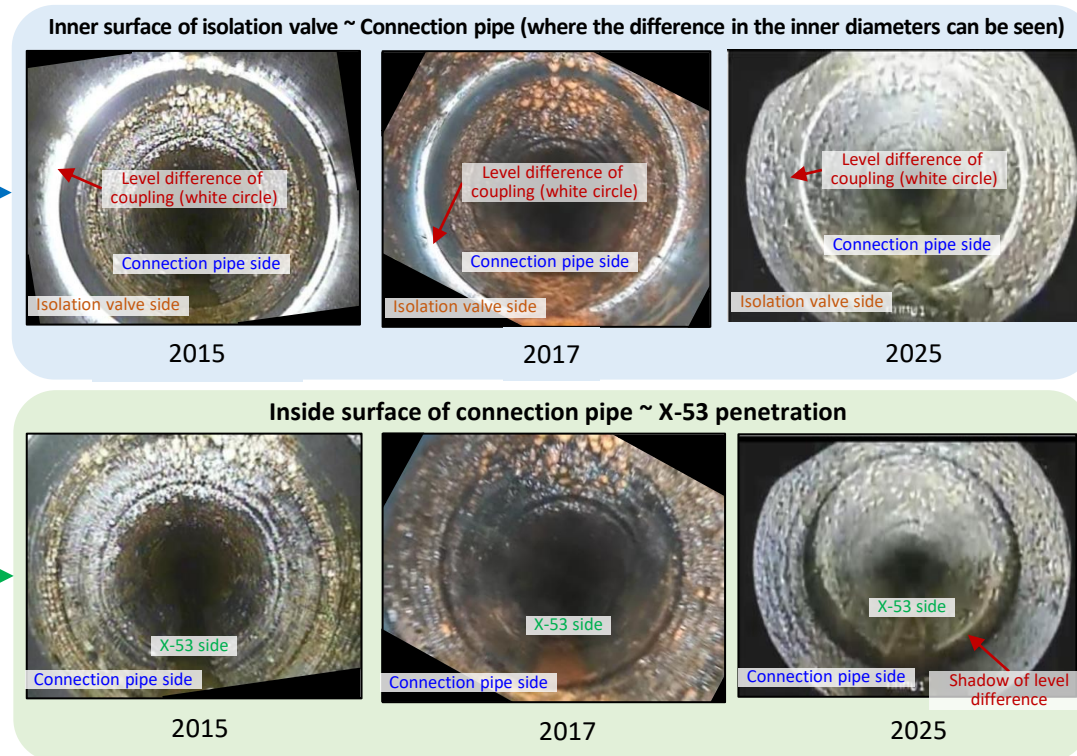
- The X-53 penetration was used to access the inside of Unit 3 during the PCV internal investigation conducted in 2015, and an isolation valve was manually installed using a glove box.
- At the time, the area around X-53 penetration still showed the impact of the accident and field dose rates were high, so the cut end of the X53 penetration was secured to the isolation valve connection pipe using a straub coupling that did not require a lot of time to be installed.
- The straub coupling can be affixed even if the joint is slightly misaligned, so footage from recent PCV internal investigation (2017) were checked to see if we could see a level difference. However, we could not discern such things from the footage. ※1

※1: In how the level difference appears due to the difference in lighting and the direction of the cameras in the footage from past investigations and this investigation.
