Fukushima Daiichi Nuclear Power Station Unit 3 PCV Internal Investigation (non-submerged area) using Micro-drones

March 26, 2026

Tokyo Electric Power Company Holdings, Inc.

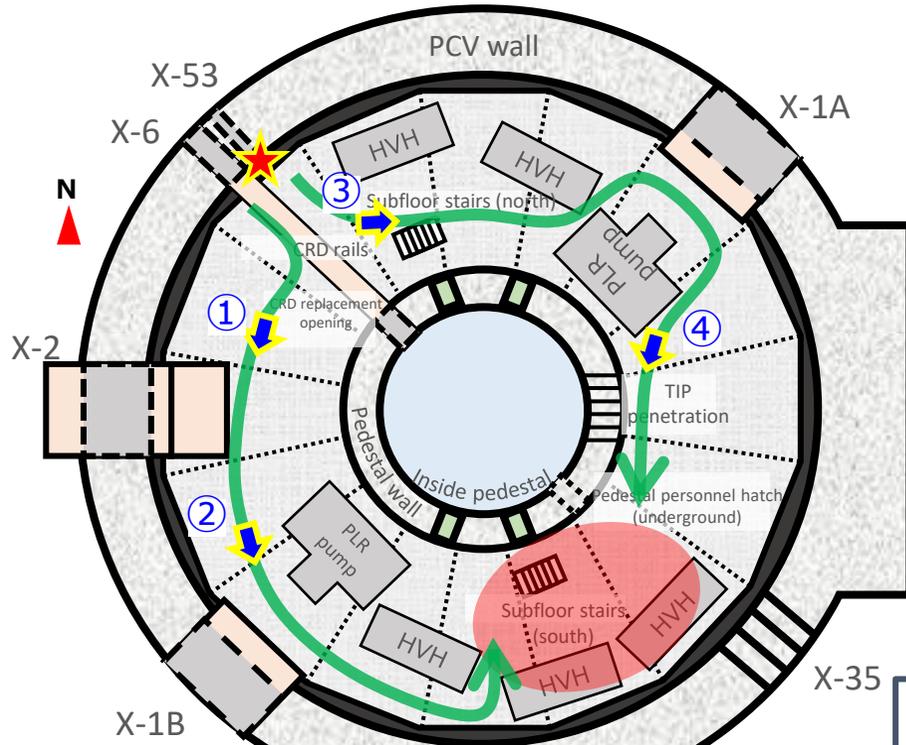
Plainview diagram of proposed flight route on the first floor of the Unit 3 D/W

- **Fog conditions:** As with Unit 1, fog was seen **outside the Unit 3 pedestal** (visibility was approx. 3m).
- **Ease of radio communication :** It was confirmed that **communications are poor** in the southeast area across from the X-53 penetration where the radio was.

- **Component damage/Obstructions check:** No significant damage or obstructions were seen. (rust and fallen insulation were seen)
- **Flight history:** Excluding the southeast area where comms was poor, flights were implemented clockwise and counterclockwise around the D/W1FL area.

- **Dose rate: Dose rates in the vicinity of the X-53 penetration were approx. 0.6Gy/h (γ-rays).** The dose rates outside the entire pedestal will be estimated using radiation noise on the recorded footage.

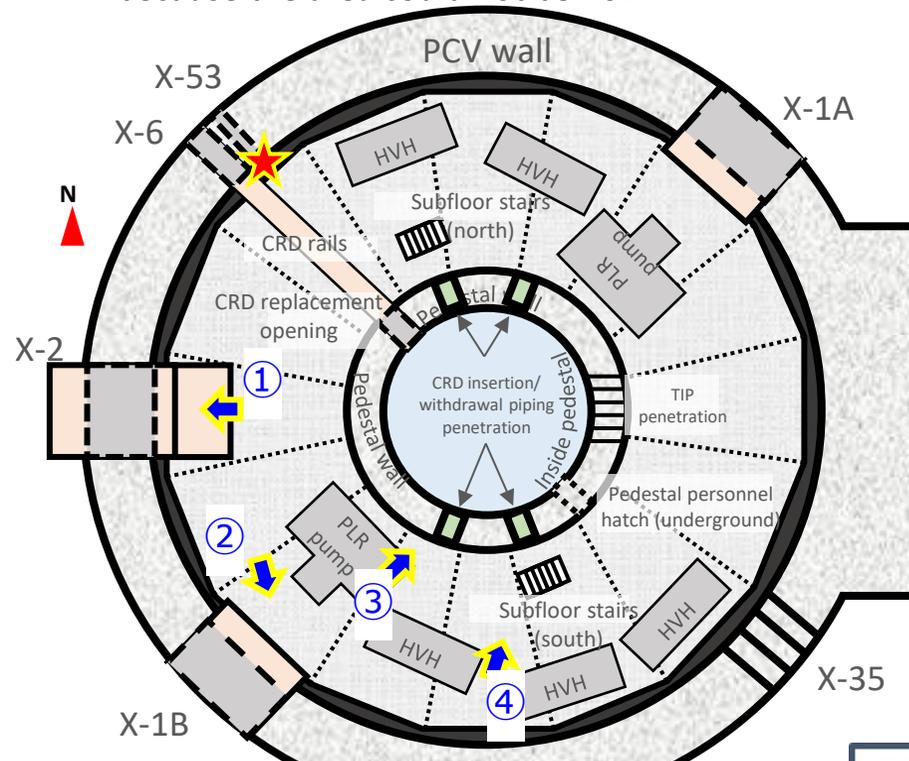
Plainview diagram of proposed flight route
on the first floor of the Unit 3 D/W

- **X-2 penetration、 X-1B penetration:** No obstructions nor damage or deformation of the penetration were found.
- **CRD insertion/withdrawal pipes (south):** No damage or deformation of the pipes on the southwest side were found. Communications were poor in the aforementioned area on the southeast side so no confirmation was possible because the area could not be flown.
- **Subfloor stairs (south):** No obstructions nor damage or deformation of the stairs were found.
- **X-35 penetration:** Communications in the southeast area outside the pedestal were poor, so no confirmation was possible because the area could not be flown.

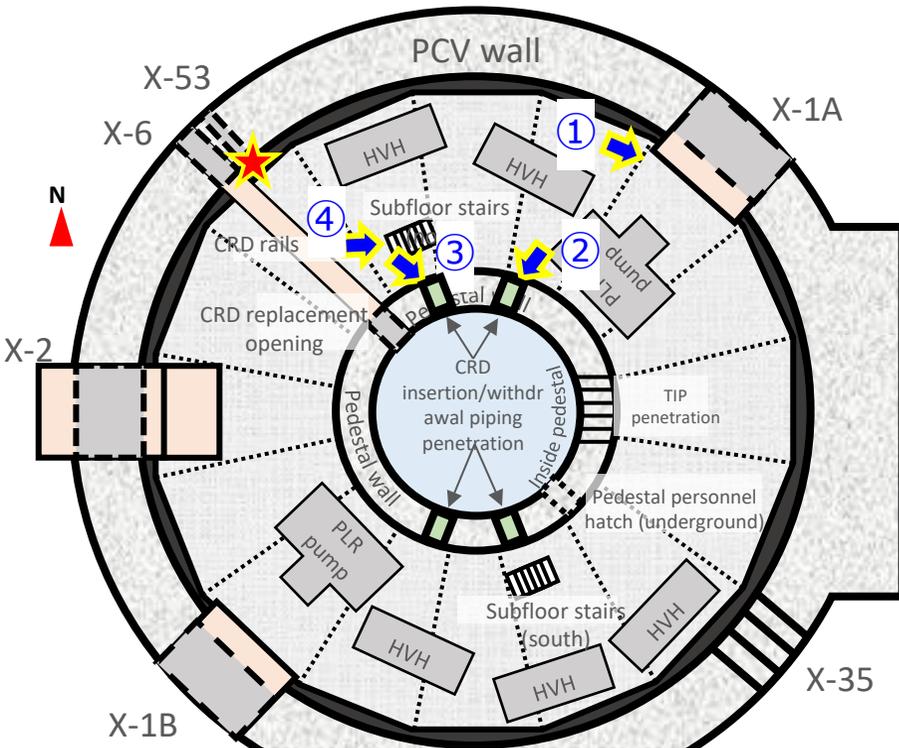
Plainview diagram of proposed flight route
on the first floor of the Unit 3 D/W

- **X-1A penetration: No obstructions nor damage or deformation of the penetration were found.**
- **CRD insertion/withdrawal pipes (North): No damage or deformation was found to the pipes in the northwest and northeast.**
- **Subfloor stairs (North): No obstructions nor damage or deformation of the stairs were found.**

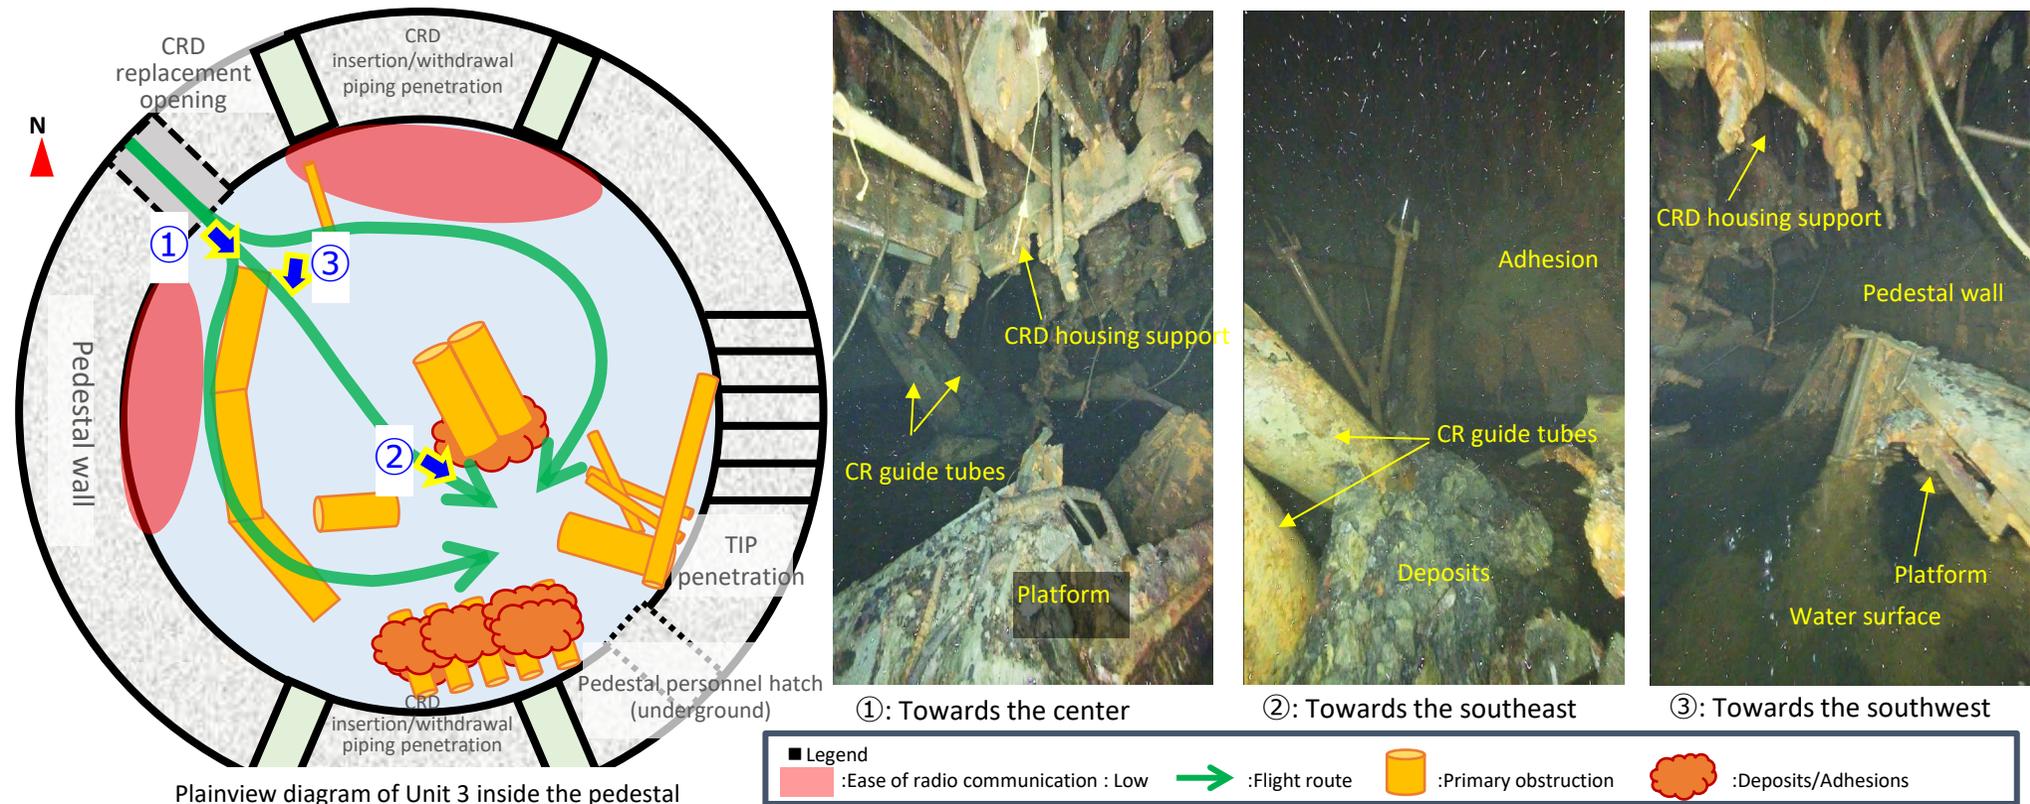
- **Fog conditions:** As with Unit 1, fog was seen **inside the Unit 3 pedestal** (visibility was approx. 3m)
- **Ease of radio communication:** Communications near the **CRD replacement opening**, which shadows the radio, **were poor**.
- **Component damage/Obstructions check :** We confirmed that the CRD housing and CR guide tubes have fallen (drone flight is possible).
- **Flight history:** Excluding the area near the CRD replacement opening where communications were poor, **flights were implemented in clockwise, counterclockwise, and inward (toward the center) directions**.
- **Point cloud footage:** The horizontal and vertical cameras were used to take footage for point cloud. Point cloud footage will be implemented going forward.
- **Dose rate:** The dose rates outside the entire pedestal will be estimated using radiation noise on the recorded footage.

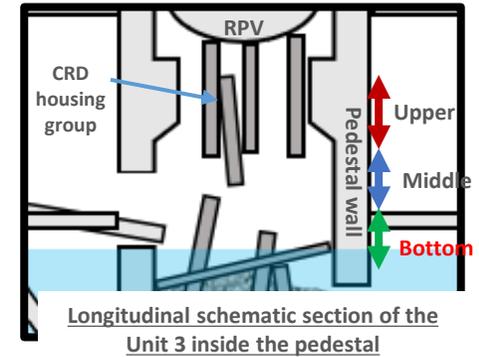
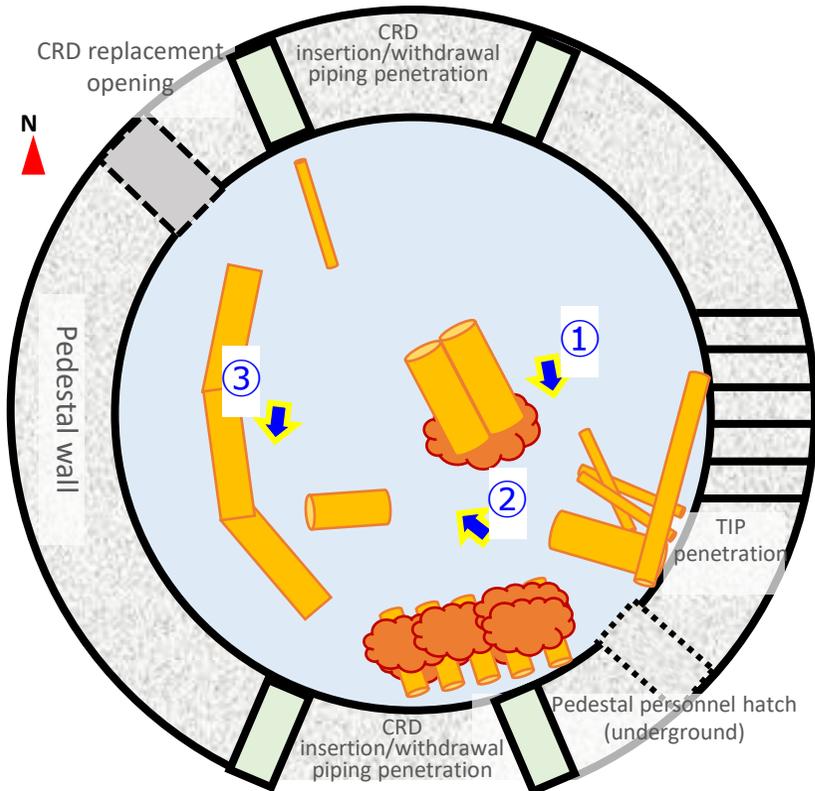
- Deposits:** Deposits were found at the base of the CR guide tubes in the middle. It is assumed that there are CR guide tubes in the water as well.
- Fallen structures:** CR guide tubes, which are structures in the RPV, were found
- CRD replacement machine related equipment:** Deformation of the platform was found. The presence of other equipment is currently being reviewed through detailed analysis of the footage.
- Water in the PCV:** By comparing the height of the water surface with the surrounding structures, it was confirmed that the water level inside the PCV is consistent with the value converted from the S/C pressure gauge (and the level outside the pedestal is approximately the same).

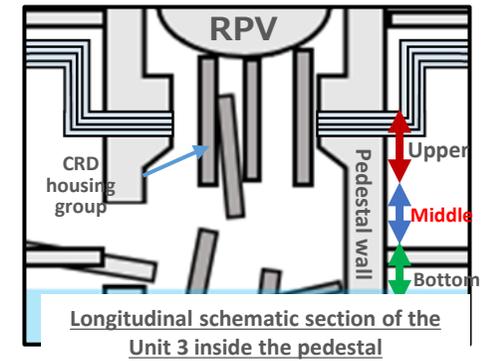
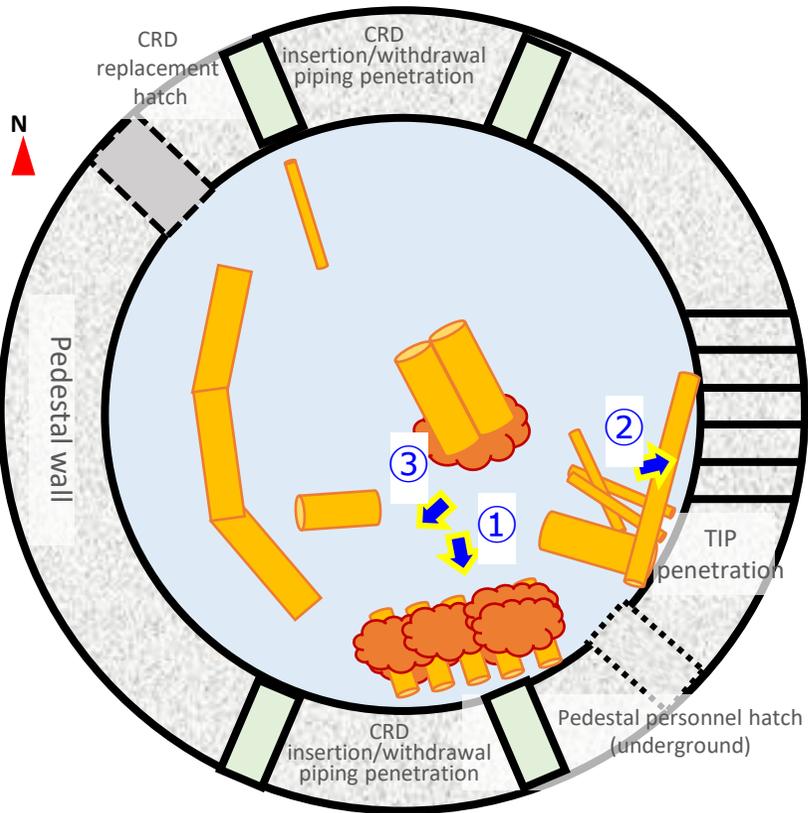
- **Adhesions:** The CRD housing group on the south side was found to have clump-like adhesions.
- **Pedestal wall surface:** No significant damage was seen within the scope of photography
- **TIP penetration:** The index tube was confirmed to be damaged
- **Fallen structures:** The CRD housing group, which is a RPV bottom structure, was found to be tilted

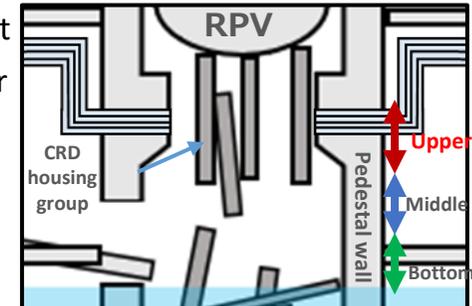
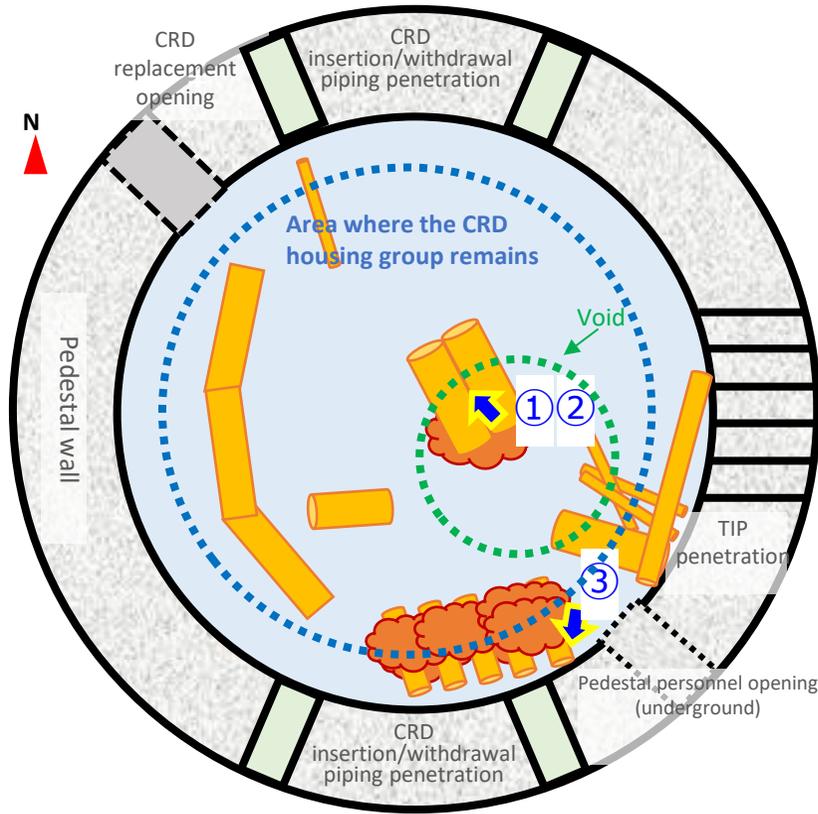
Longitudinal schematic section of the Unit 3 inside the pedestal

- Adhesions:** Clump-like adhesions found on the CRD housing group located the middle to the southeast
- CRD housing group:** Although tilting and deformation are observed, most of the structures remain near their original positions. **Voids** were found in the upwards direction from the middle to the southeast.
- CRD insertion/withdrawal pipes:** Only the southeast portions could be photographed, and **pipe damage** was found.
