Fukushima Daiichi Nuclear Power Station Unit 3 Drone Investigation Results of the inside of the reactor building

April 23, 2026

Tokyo Electric Power Company Holdings, Inc.

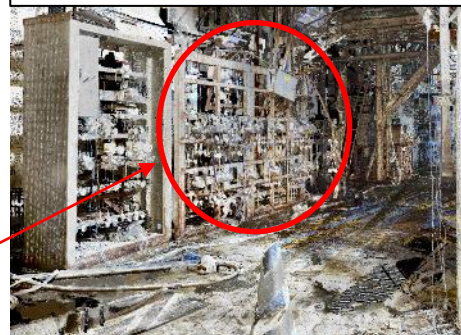
High pressure coolant injection system instrument rack
(west area, 1st floor, reactor building)

The PCV boundary must be considered when removing racks, making operation of the primary valve necessary.

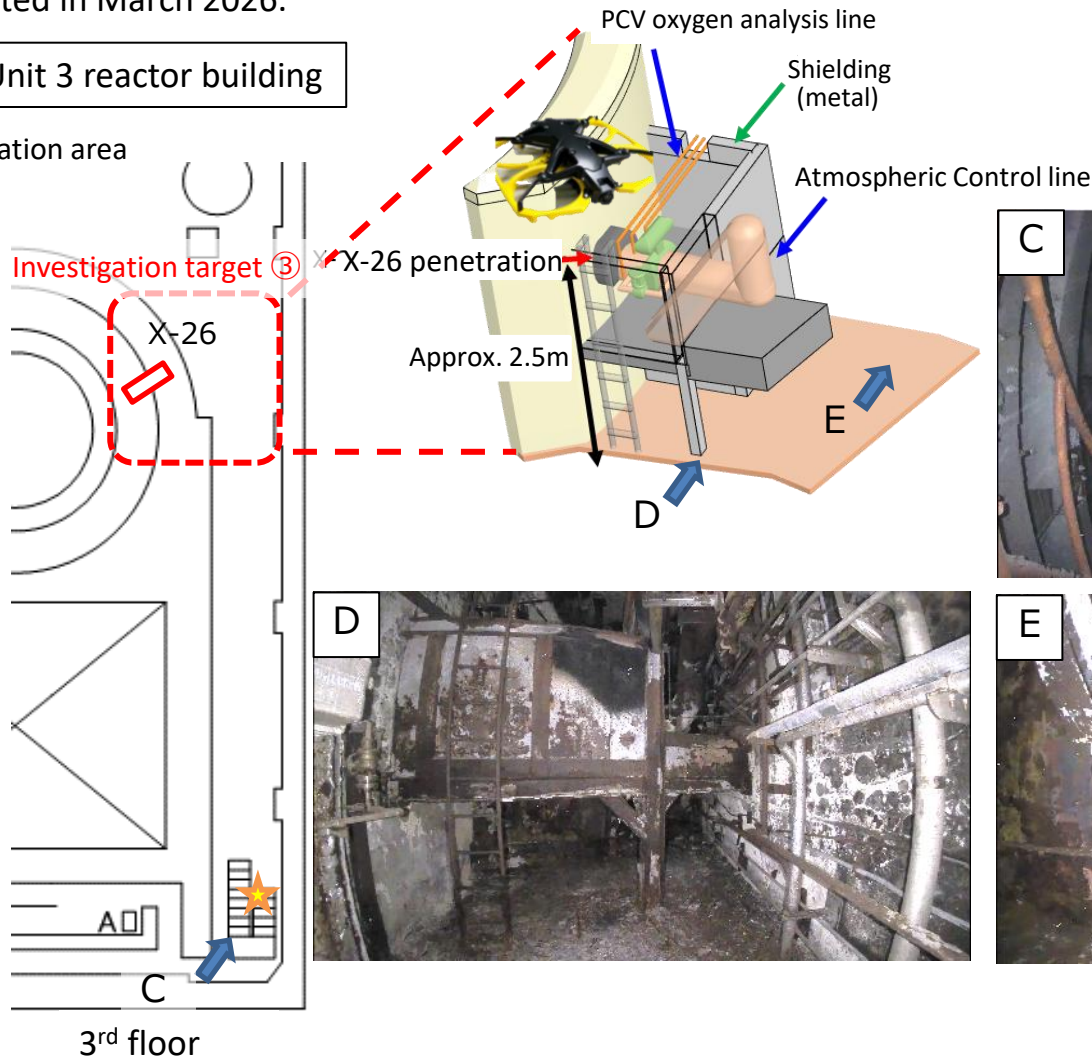
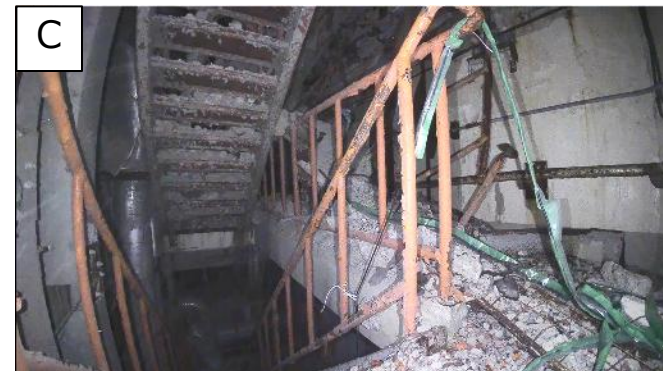
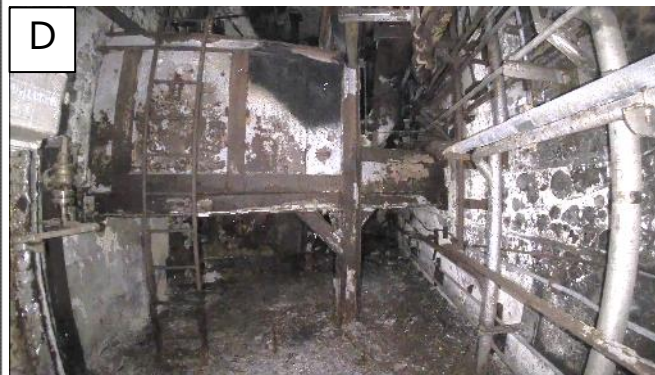
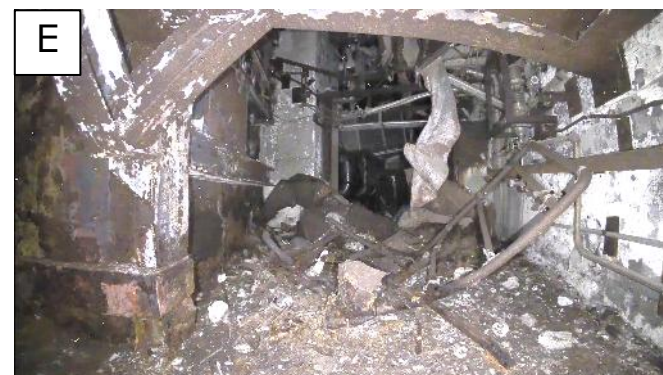
- The objective of the investigation was to confirm the condition of the instrument line.
- In February 2026, a micro-drone and relay were placed in the northeast area of the second floor of the reactor building and an investigation was implemented, but the signal didn't reach. Therefore, the relay deployment location was changed to the southeast area of the third floor of the reactor building and another investigation was implemented in March 2026.

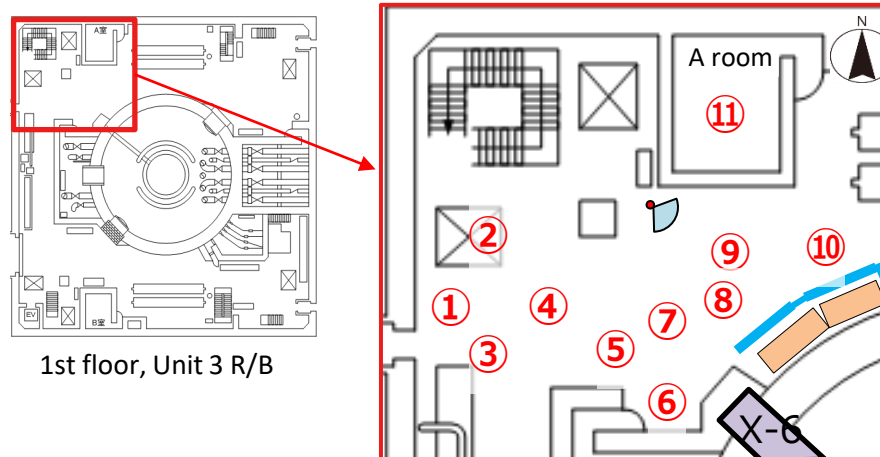
1st floor, Unit 3 R/B

- The HCU (north side) is greatly affected by doses from the jet pump instrument rack, and it is not clear whether there are any other radiation sources.
- The HCU and jet pump instrument rack, which are the main radiation sources, have been shielded, and the air dose rate around the X-6 penetration is between 3~5mSv/h, thereby prohibiting workers from remaining in the area for a long period of time.

- Dose reduction measures for the jet pump instrument rack closest to the X-6 penetration are being deliberated.
- Due to the difficulty of work implementation, it is expected that much time will be needed to reduce doses in the HCU.
