Initiatives Aimed at Improving the Overall Quality of Work at Power Stations in Light of the Incidents Involving the Unauthorized Access of a Power Station Building and the Partial Incompletion of Safety Measures at Unit 7 at the Kashiwazaki-Kariwa Nuclear Power Station

February 15, 2021
Tokyo Electric Power Company Holdings, Inc.

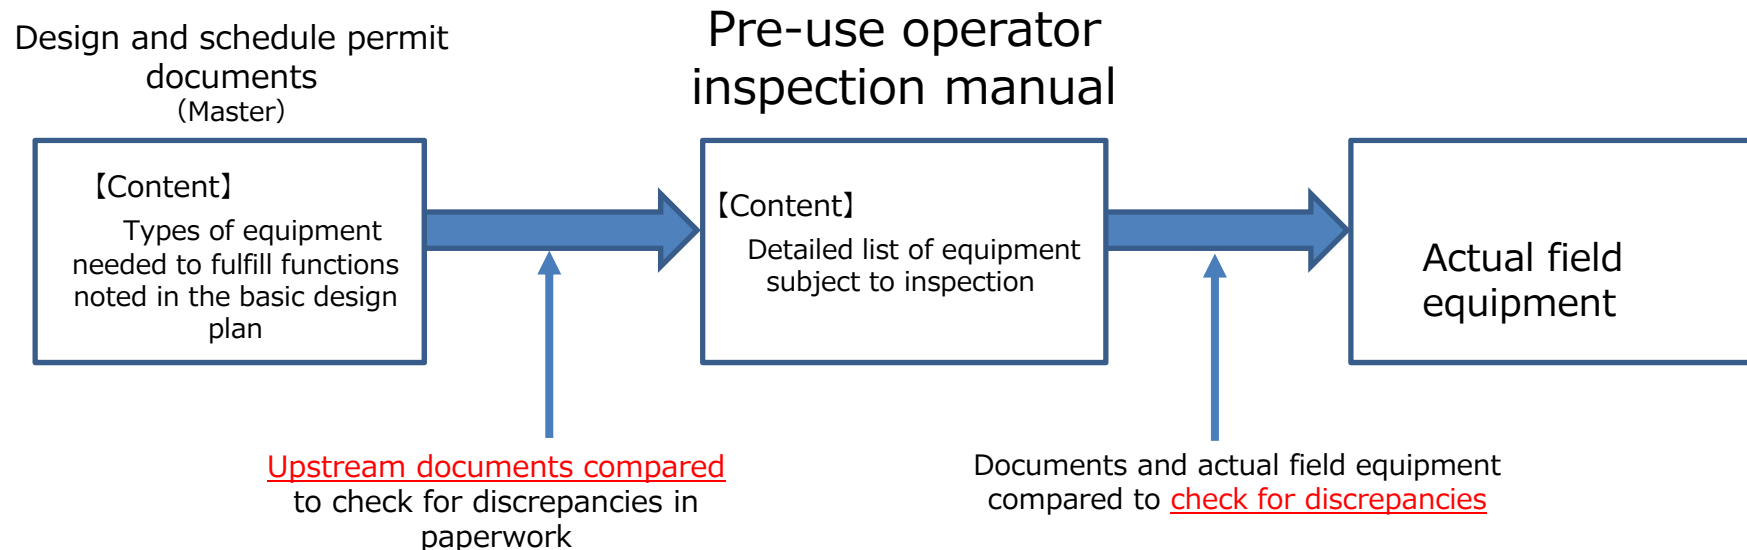
Comparison of design and schedule permit application with actual field conditions

Even after the general inspection, equipment integrity and functionality shall be checked during the pre-use operator inspections currently underway, and appropriate measures will be taken if any nonconformances are discovered.
