# Results of Investigation of the Lower Part of Unit 2 Vent Pipe at Fukushima Daiichi Nuclear Power Station

March 5, 2013

Tokyo Electric Power Company

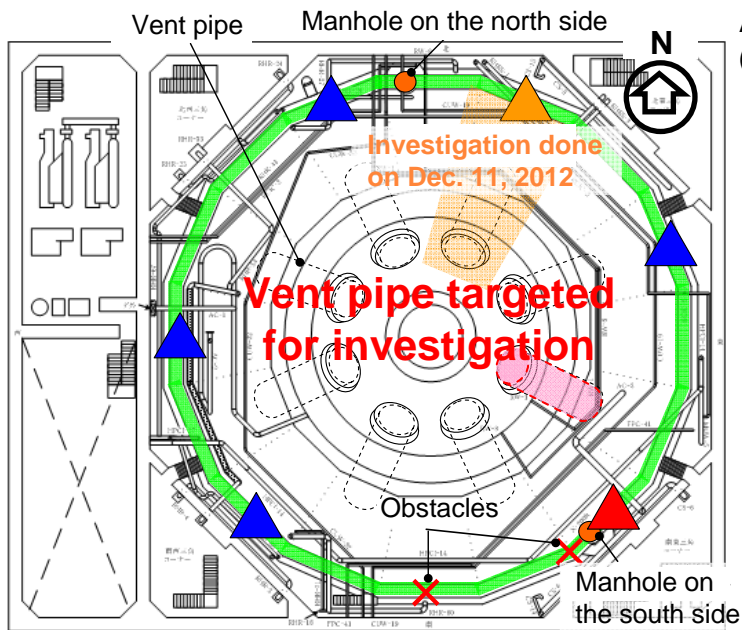
Torus room (Plan view)

Area where the quadrupedal walking robot reached (Vent pipe investigation area)

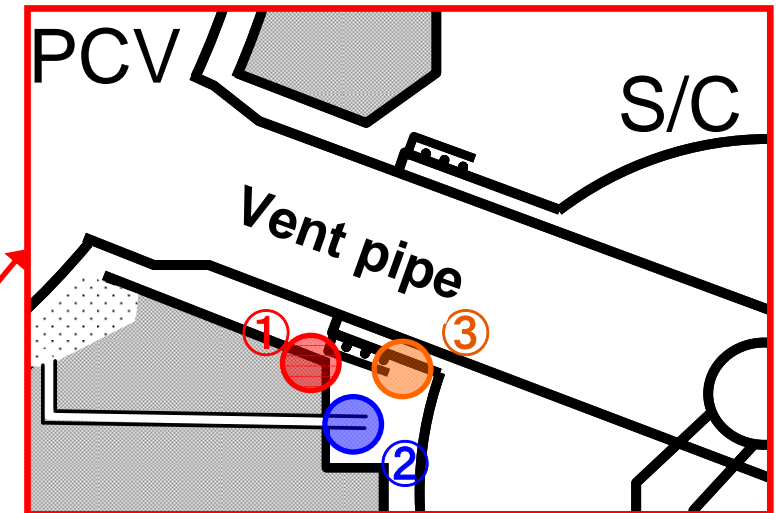
Lower part of the vent pipe (Enlarged)

③ Lower part of the vent pipe bellows cover: No water leakage found

No water leakage (water flowing) was found on the concrete stage \* on the lower part though the condition was not directly checked.

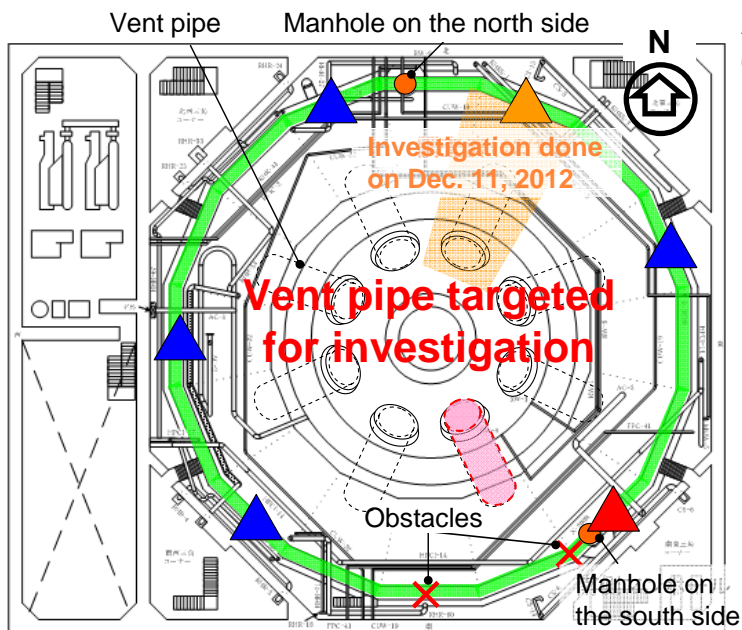
Torus room (Plan view)

Area where the quadrupedal walking robot reached (Vent pipe investigation area)

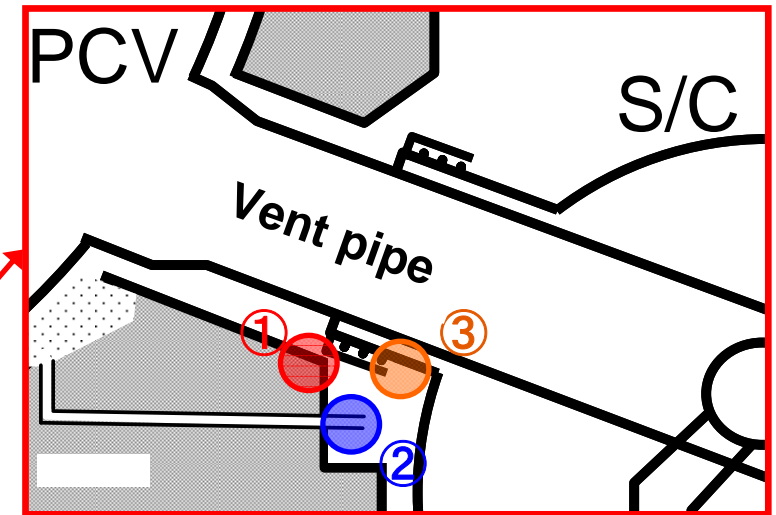
Lower part of the vent pipe (Enlarged)

- ③ Lower part of the vent pipe bellows cover: No water leakage found

No water leakage (water flowing) was found on the concrete stage \* on the lower part though the condition was not directly checked.
