Results of Investigation of the Lower Part of Unit 2 Vent Pipe at Fukushima Daiichi Nuclear Power Station

March 6, 2013

Tokyo Electric Power Company

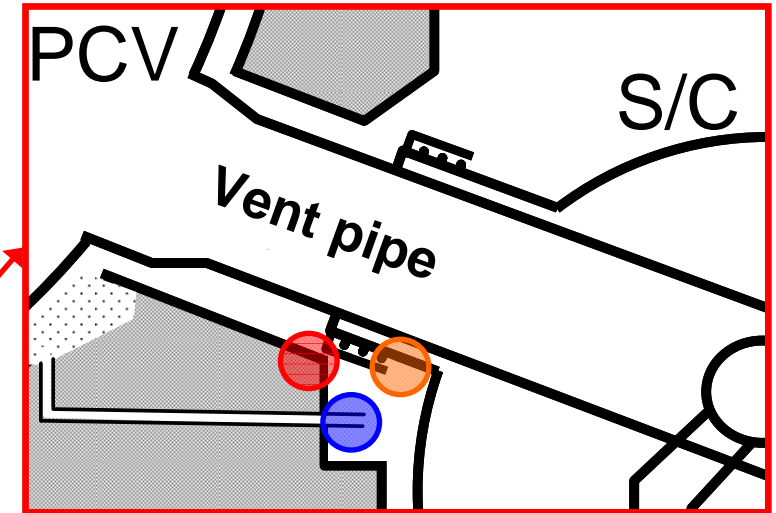
Lower part of the vent pipe (Enlarged)

1. No water leakage was found at the edge of the vent pipe sleeve.
2. No water leakage was found at the edge of the sand cushion drain pipe.
3. No water leakage was found at the lower part of the vent pipe bellows cover.
