Results of Investigation of the Inside of Unit 2 PCV

March 19, 2013
Tokyo Electric Power Company

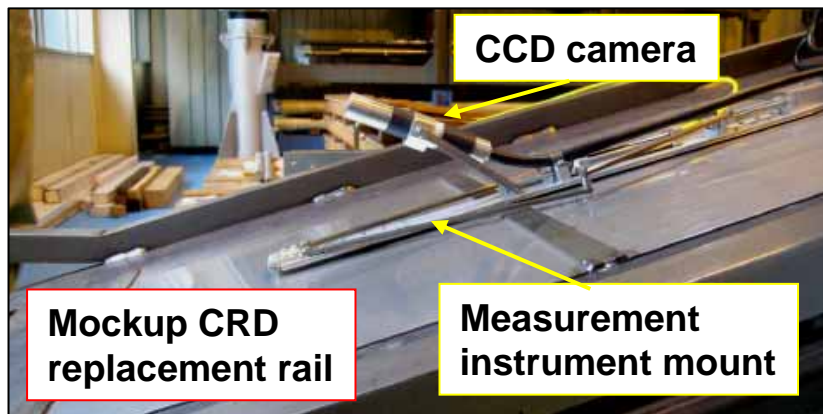
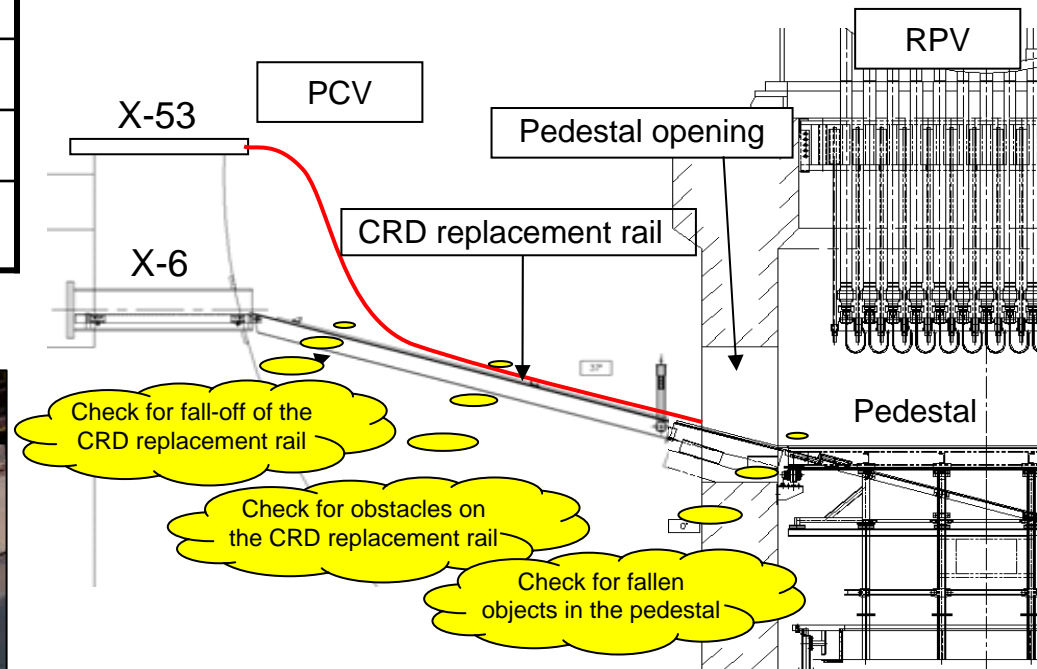
Scope of investigation of the inside of the PCV through X-53 penetration

Since the CRD replacement rail could not be found, the investigation of the rail and the area near the pedestal could not be performed. The camera was able to reach the upper part of the grating on the first floor.
