Power Supply Facilities Failure (Units 3-4 Temporary M/C (A), etc.)

March 22, 2013

Tokyo Electric Power Company

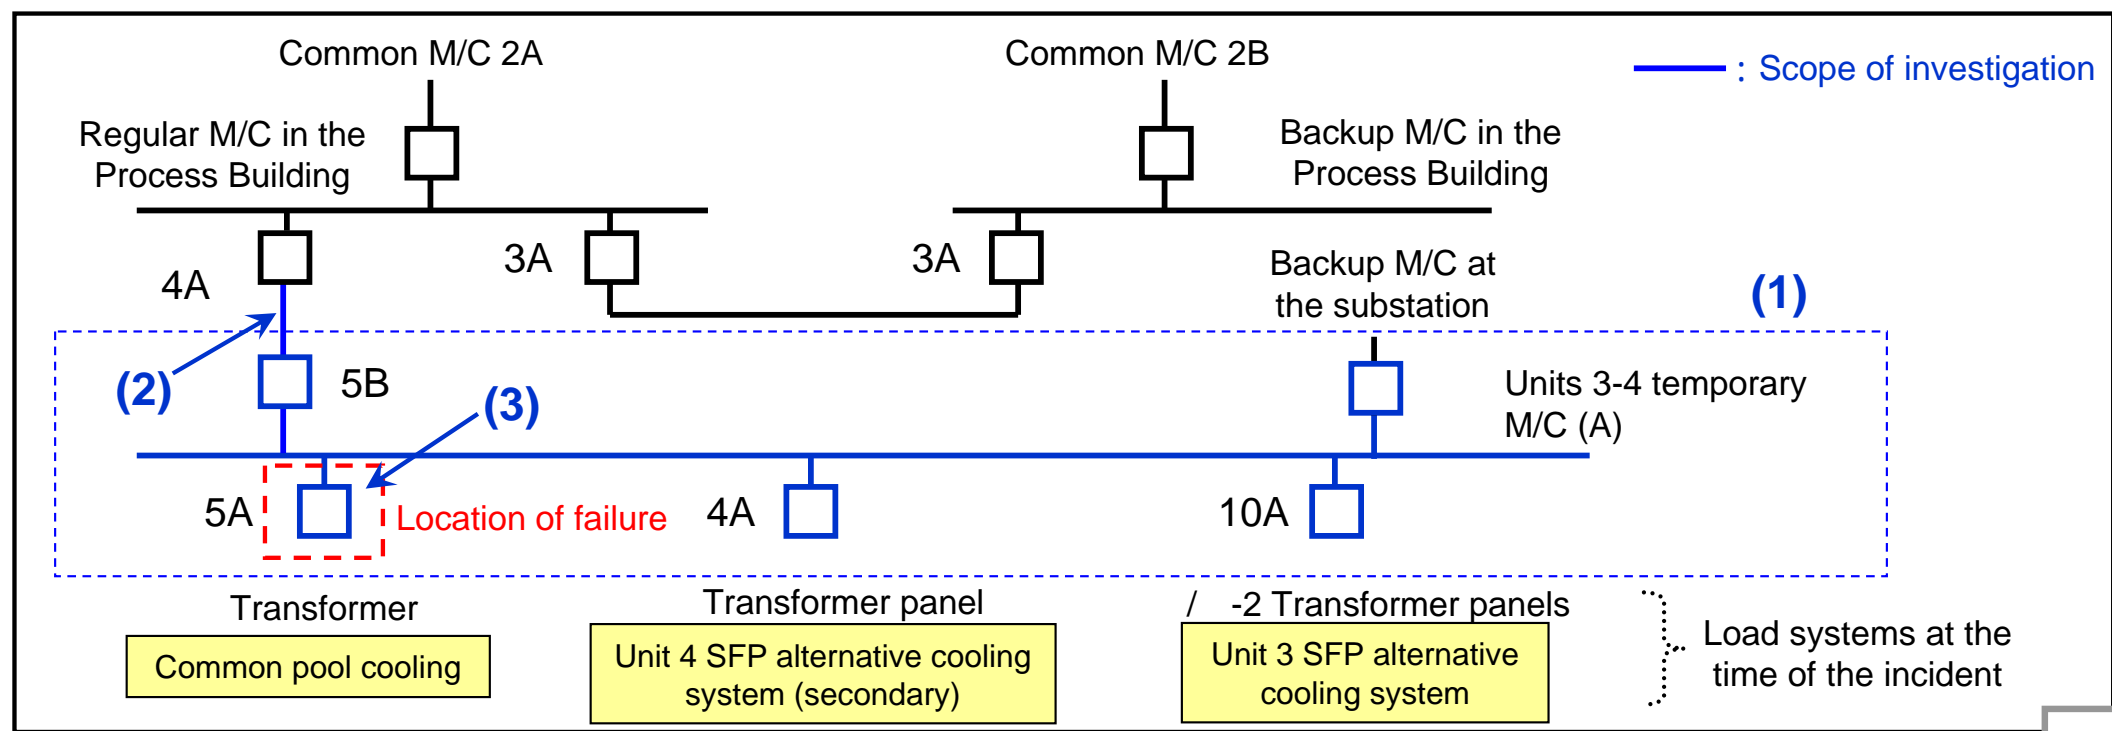
Investigation of Units 3-4 Temporary M/C (A) Unit (5A)

A trace of short circuit was found on the primary conductor (R, S, T phases) of the current transformer in the back of 5A unit of Units 3-4 temporary M/C (A). Also, a small animal was found dead on the floor of the same unit.
