# **Power Supply Facilities Failure at Units 1-4 of Fukushima Daiichi Nuclear Power Station**

**March 28, 2013  
Tokyo Electric Power Company**

# Investigation Result (1) Appearance Inspection: Trace of a short circuit found inside Units 3-4 Temporary M/C (A)

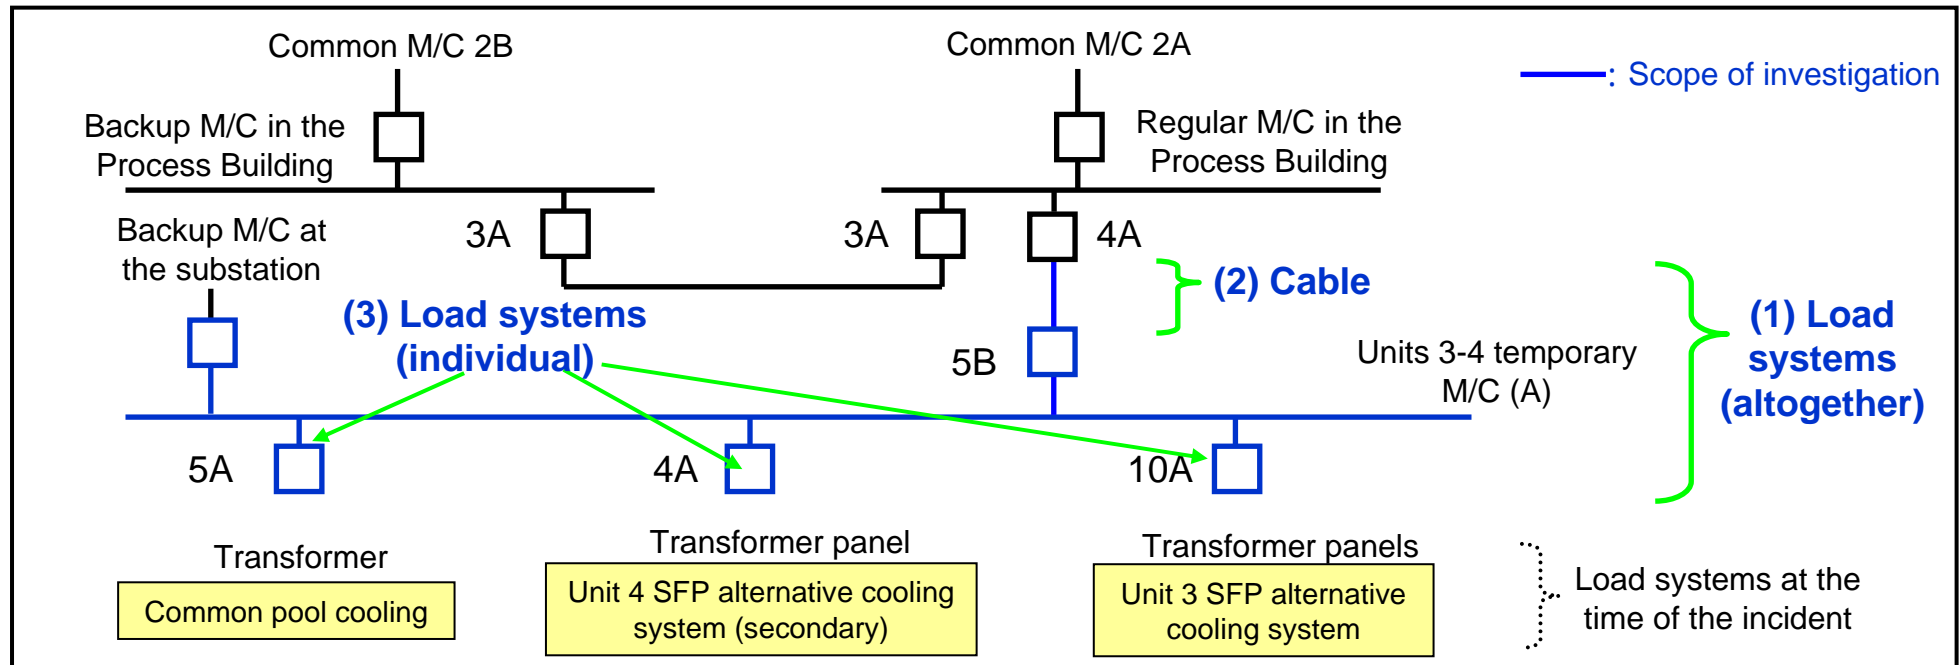
(1) Load systems from the regular M/C in the Process Building to Units 3-4 temporary M/C (A) (altogether): No abnormality found

(2) Cable from the regular M/C in the Process Building to Units 3-4 temporary M/C (A): No abnormality found

(3) Load systems from the regular M/C in the Process Building to Units 3-4 temporary M/C (A) (individual): No abnormality found

The location of failure could not be identified by the investigation.

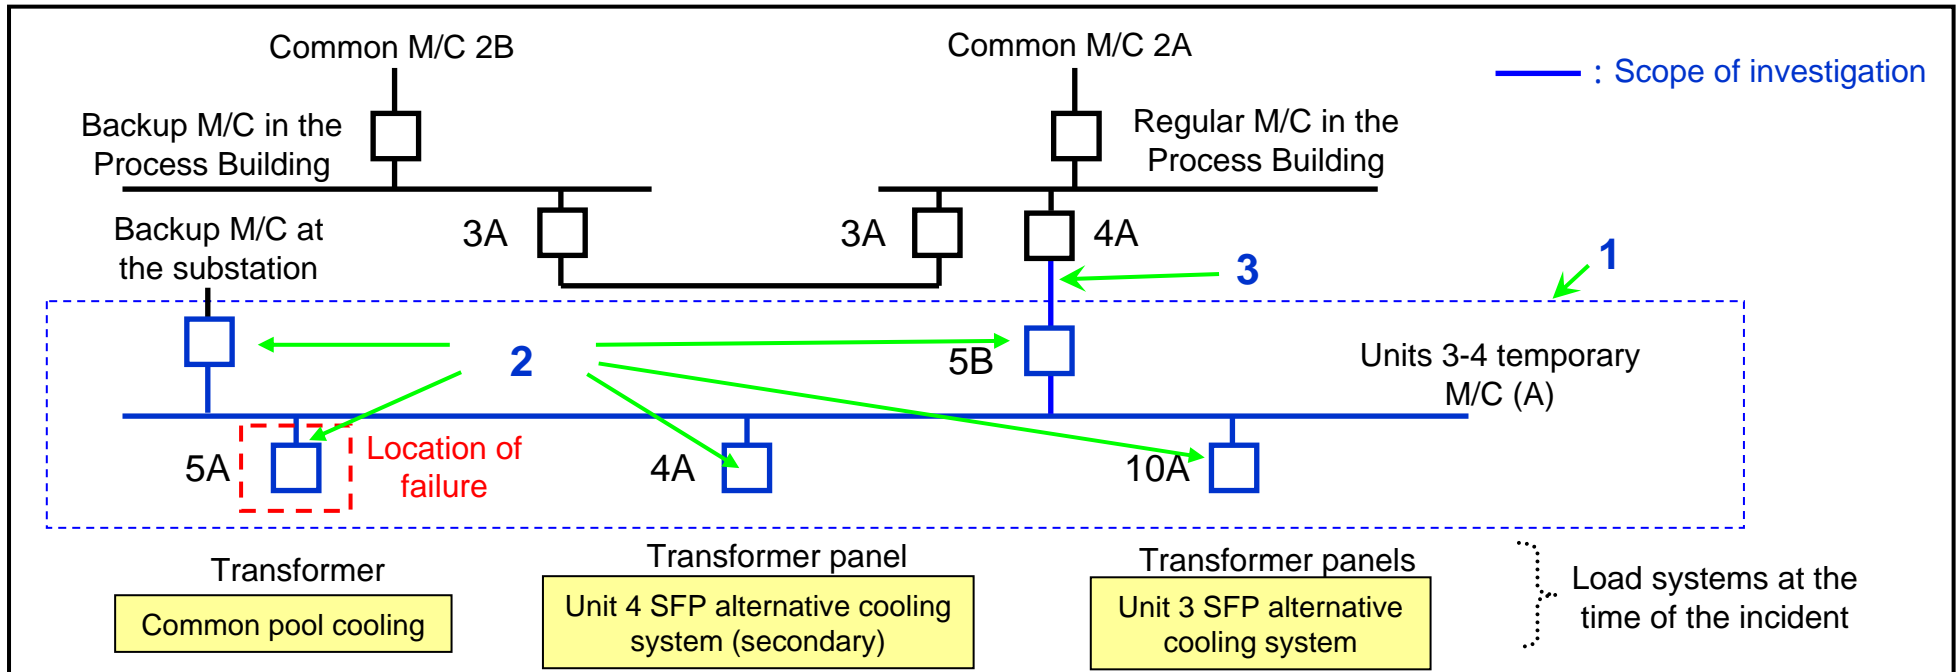
# Overview of Investigation (Performed on March 20)

**Results: Traces of a short circuit and an arc were found in Unit 5A of Units 3-4 temporary M/C (A) (Investigation results (1), (2) and (3)). A mouse was found dead on the floor of the same unit (Investigation results (1) and (4)).**

**Results: Discoloration was found on the circuit breakers (Investigation result (5)).**

**Results: No abnormality was found.**

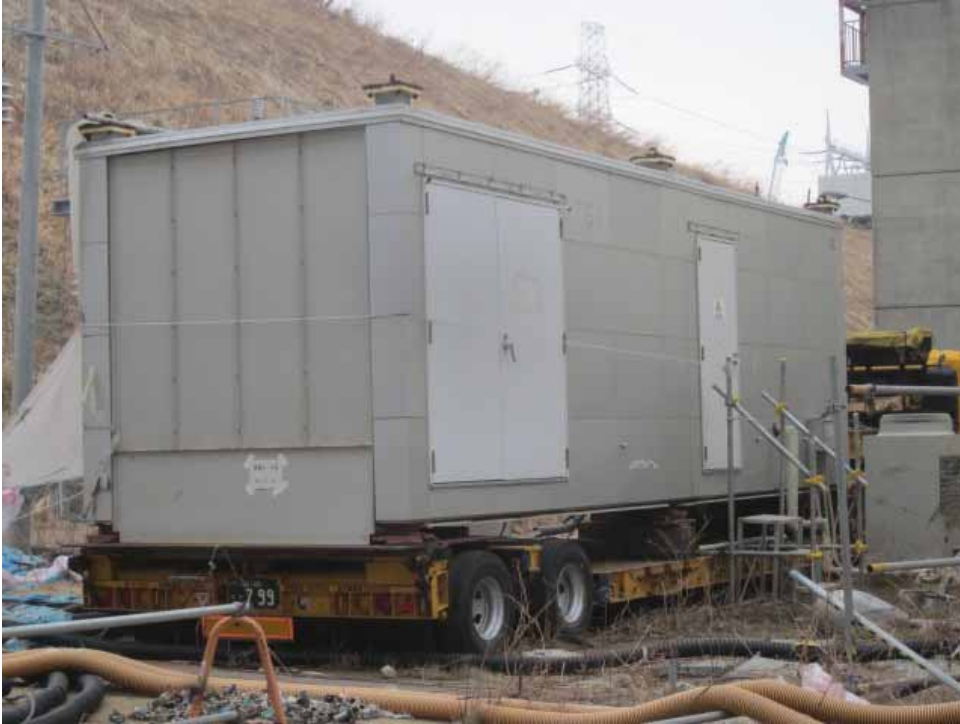
Side surface of the container, entrance of Units 3-4 temporary M/C

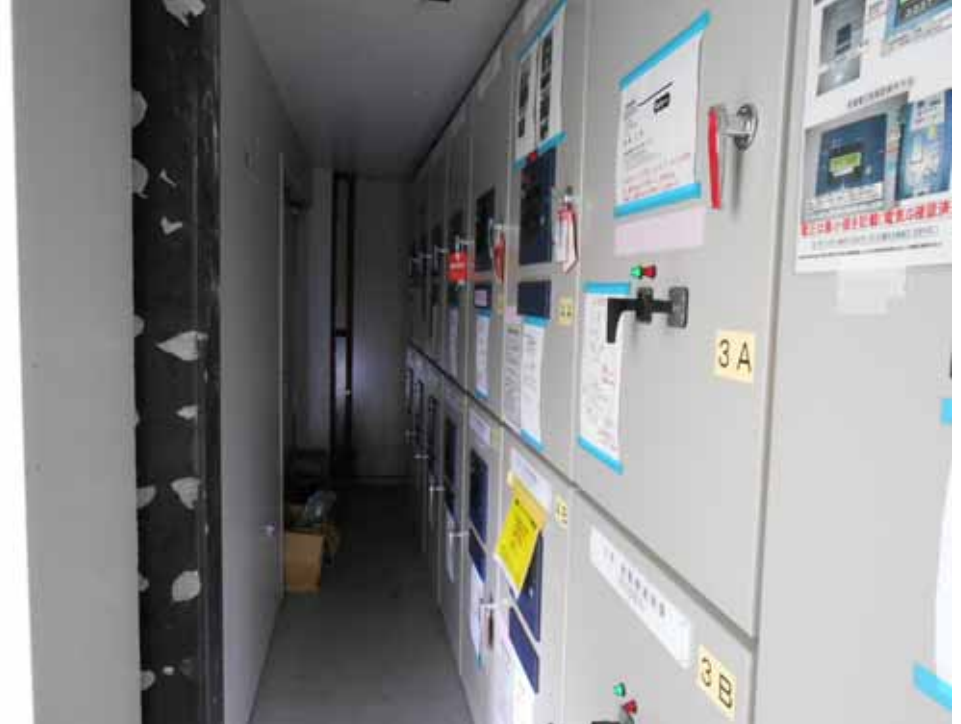
Front of Units 3-4 temporary M/C (inside the container)

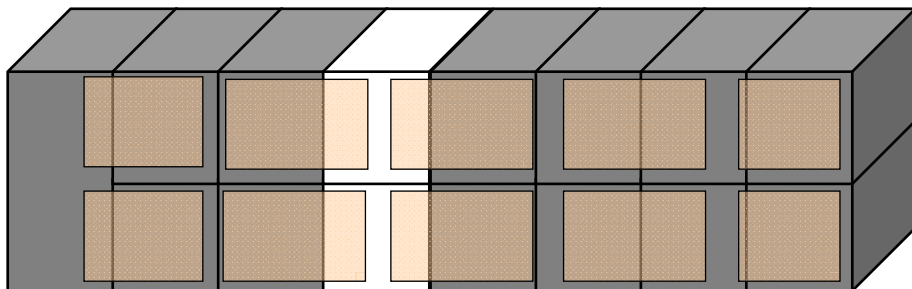
Back side of Units 3-4 temporary M/C (A) and its doors

- Traces of short circuit were found on the conductor in the back of Units 3-4 temporary M/C (A) (5A). Also, a dead mouse (with an electric mark) was found on the floor of the same unit.
- No trace of short circuit or foreign substance was found in other units in Units 3-4 temporary M/C (A) and the main line.

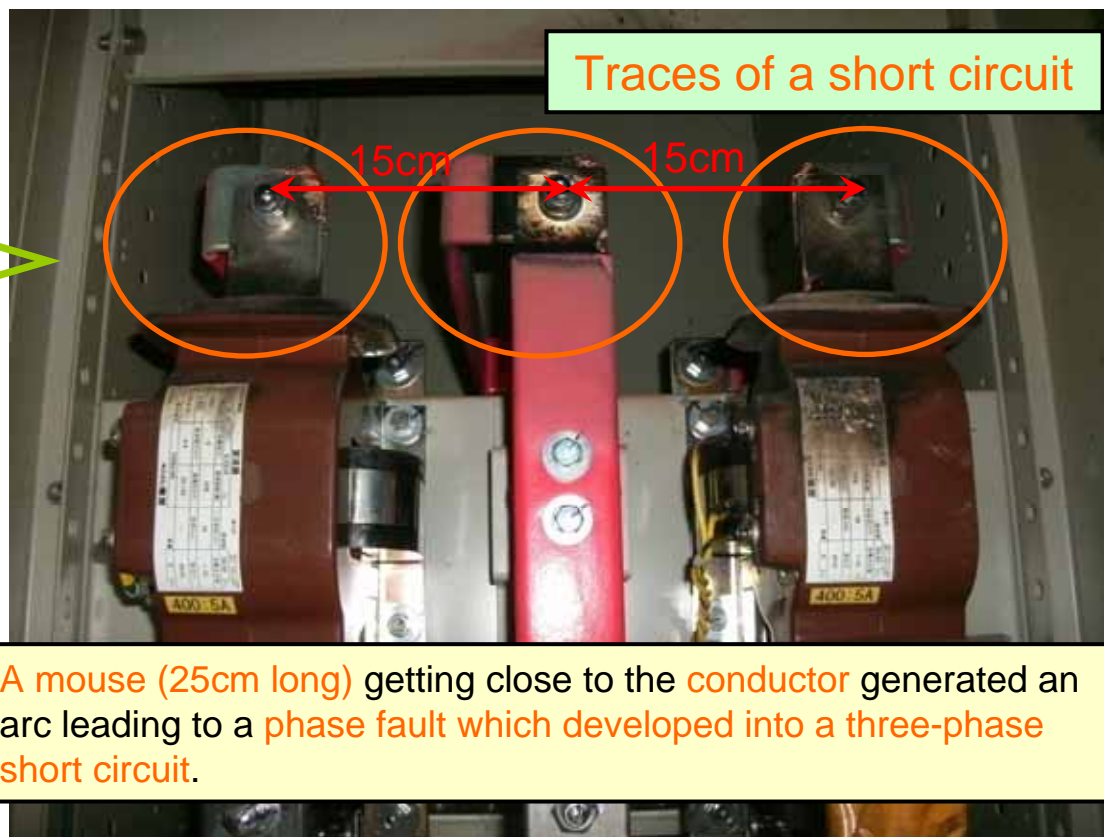
Traces of a short circuit

A mouse (25cm long) getting close to the conductor generated an arc leading to a phase fault which developed into a three-phase short circuit.

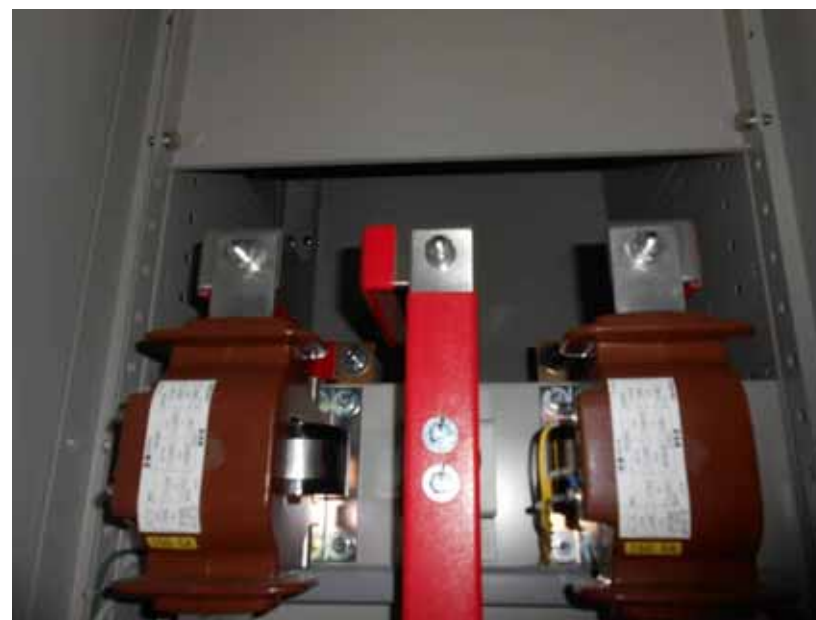
No problem was found with units other than 5A where short circuit occurred.

Sound condition of power panel (6A)

Photo 2: Sound condition of power panel

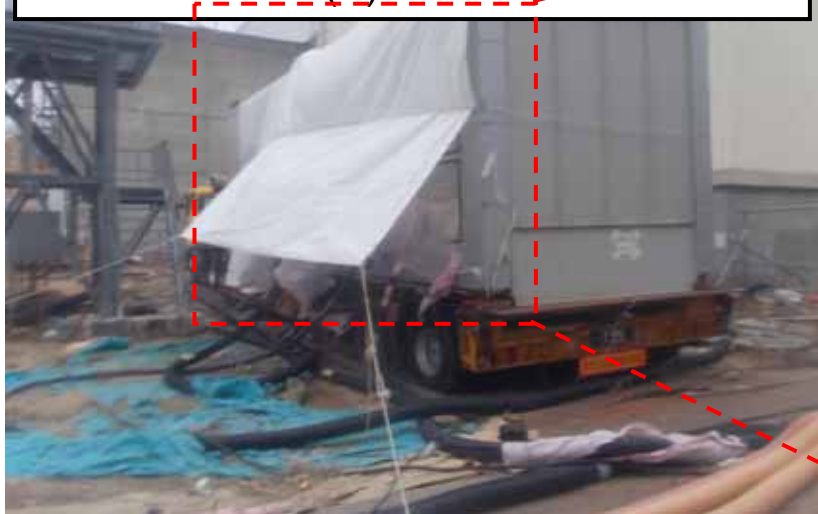
Container where Units 3-4 temporary M/C (A) is installed

- A mouse may have gotten into the unit from the opening generated by sheet partially coming off.
- Since the sheet was removed for investigation, trace of mouse, etc. could not be confirmed.
- No abnormality was found with the appearance of the sheet, etc. at the time of inspection performed in the morning of March 18.

In addition to the countermeasures for small animals currently being implemented, the openings such as cable penetration areas will be closed for high voltage power panels which can be significantly affected by power supply failure.
