**Current Handling of  
the No. 3 Underground Reservoir  
( As of 6:00pm, April 7, 2013 )**

April 7, 2013

Tokyo Electric Power Company

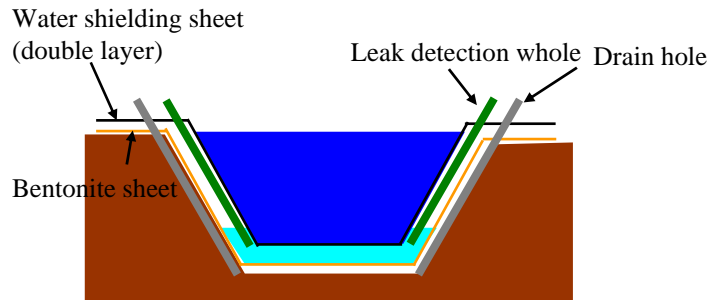
# Event organization based on location of leak

Water level changes in the storage tank and section holes have been slow. Water concentrations in the detection hole and drain hole on the northeast side show rises in saline and all beta radiation thereby suggesting a leak from the top.

There have been no changes in the water levels of the storage tank and the detection holes, rather only an increase in the concentration of water in the detection hole thereby suggesting a leak from the top.

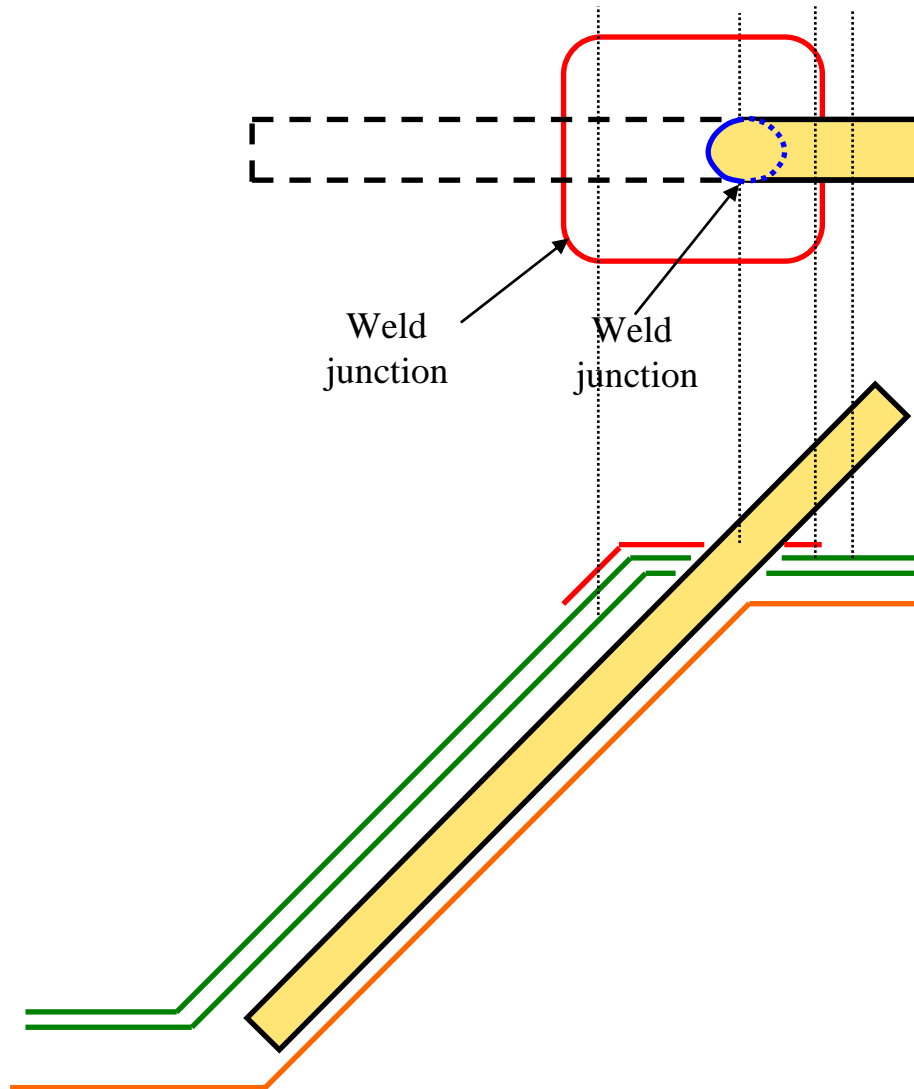
# Parts with the potential to leak

- The underground reservoir has manual welds and is subject to large tensile forces, so areas penetrated by different types of materials (leak detection hole penetration) are difficult to construct and may have lost durability.

Leak detection hole welds
