# **Response to the Comments Received at the Eighth Meeting of the Committee for Monitoring and Evaluating the Specified Nuclear Facilities**

- Water Treatment Operation Plan Excluding the Use of the Underground Reservoirs**
- Usage of the Filtrate Water Tank in Response to the Disuse of the Underground Reservoirs**

April 19, 2013

Tokyo Electric Power Company

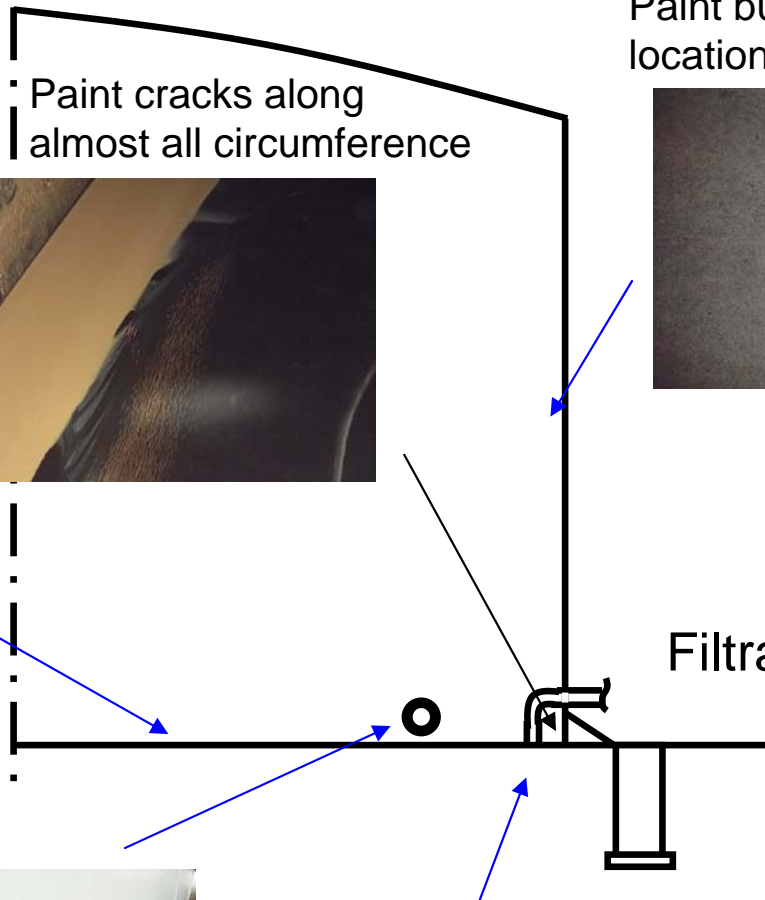
Filtrate water tank No.1

# Filtrate Water Tank No.1 Inspection Results

Since paint peeling and deformation were found inside the filtrate water tank as a result of inspection, the following measures will be implemented before the water transfer from the underground reservoirs and during water storage.

- For the areas with paint damages, the paint will be removed and repaired.
- For the corroded flanges, the flange surface will be cleaned and leakage prevention measure using repairing materials will be implemented.
- Detailed visual inspection and soundness evaluation will be performed on the areas with deformation.
