# The Activity Status of the “Emergency Response Headquarters for Reliability Improvement at Fukushima Daiichi Nuclear Power Station”

May 16, 2013

Tokyo Electric Power Company

# **Transfer of Retained Water from the Underground Reservoirs No.3 and No.6 to G6 Tank**

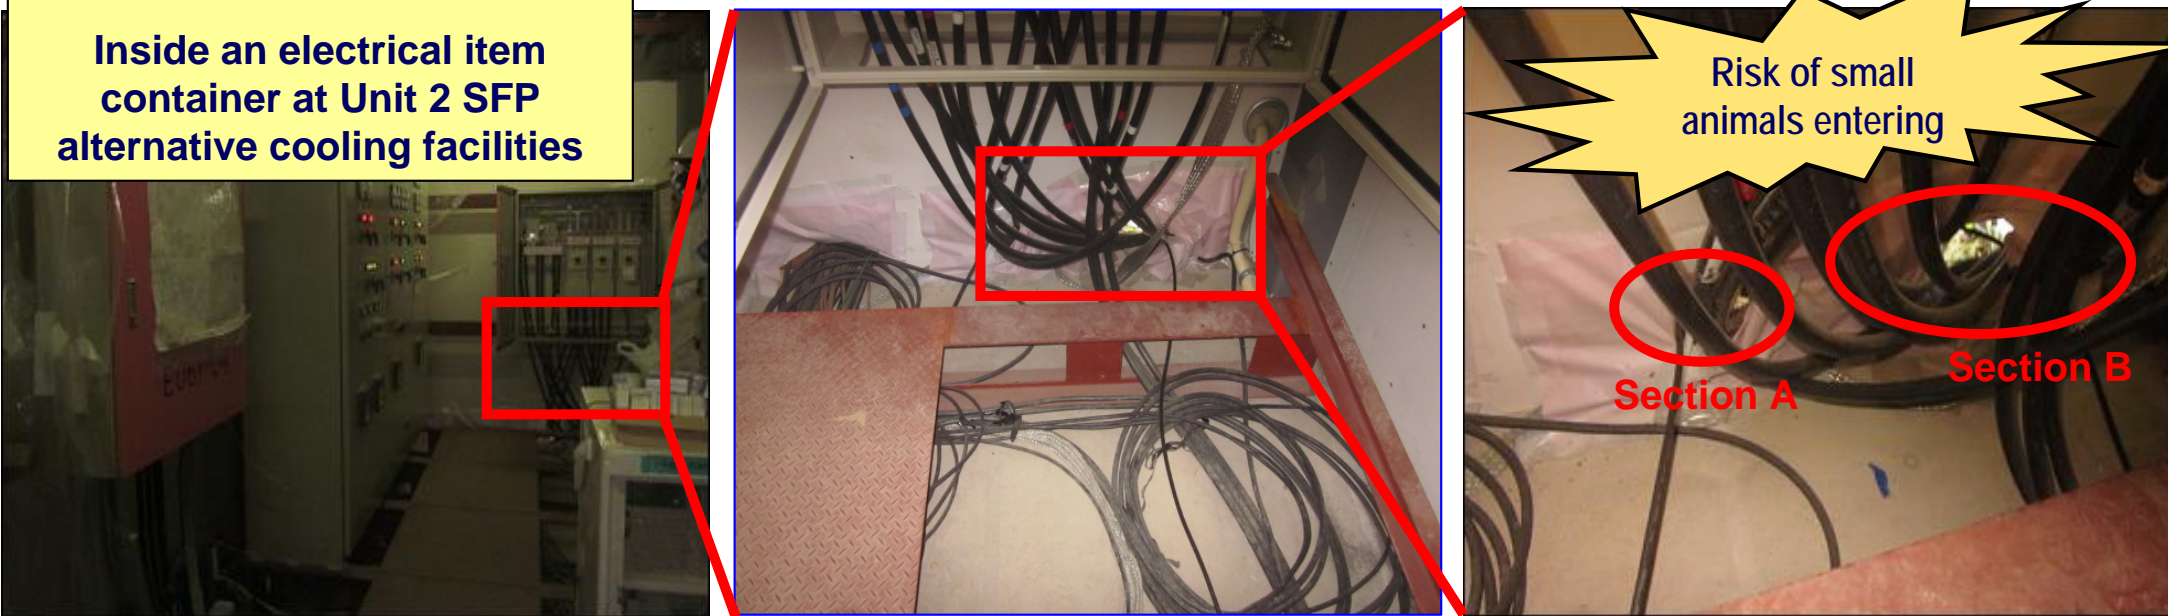
Response result at Section A

Inside an electrical item container at Unit 2 SFP alternative cooling facilities

Emergency responses that can be performed immediately have already been implemented.

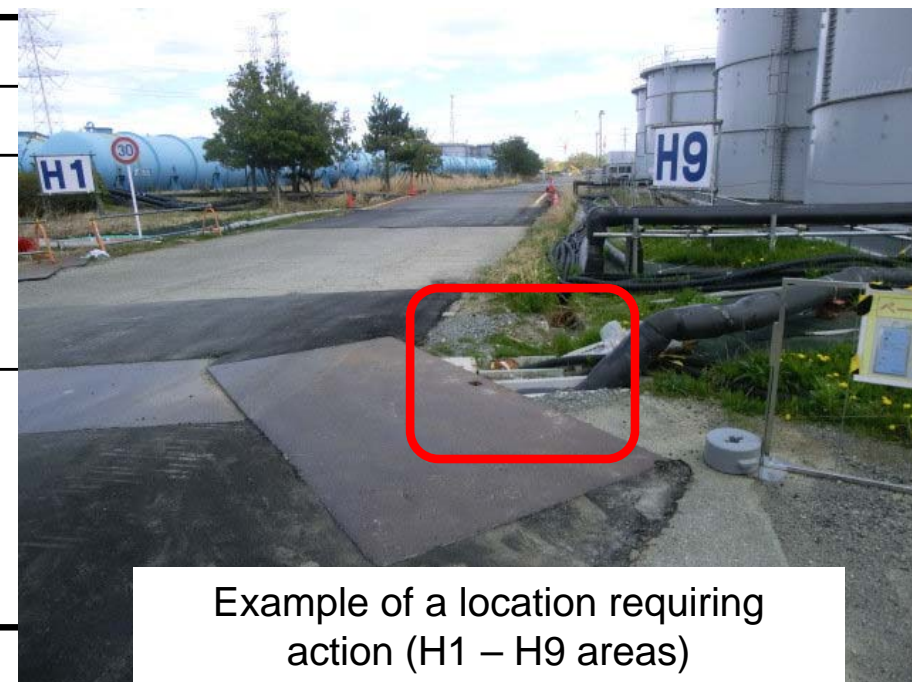
Tasks	<p>Contaminated water transfer facilities had areas with no protection (e.g. guardrails) at locations where they are crossing a road or running near a road.</p> <p>A car accidentally driving into such a location could damage the facility and suspend the transfer of contaminated water, potentially losing the water treatment function. (There is also a risk of contaminated water leaking into surrounding soil.)</p>
Countermeasures	<p>Install makeshift guardrails, etc. at applicable locations to raise caution to passing vehicles and protect the facilities from damage at the same time. There are 12 locations that require countermeasures, according to on-site checks so far.</p> <p>Start the countermeasures from locations exposed to frequent traffic of large vehicles for completion by around the end of July.</p>

Implementing countermeasures

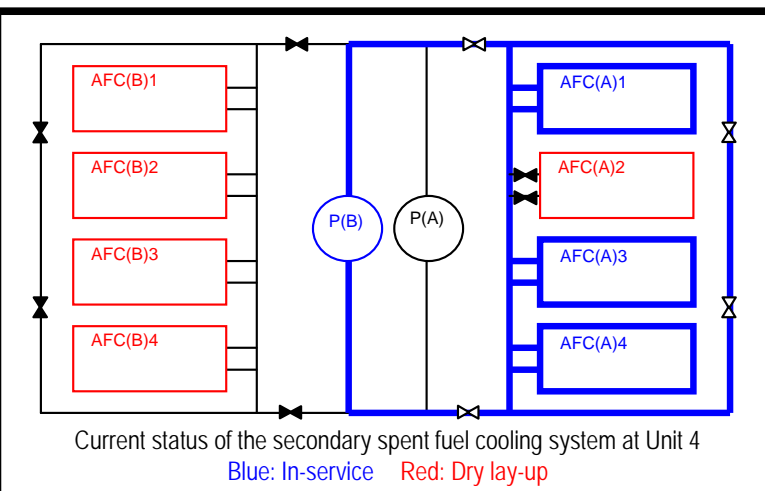
Objectives	Preventing the loss of functionality for fuel cooling facilities
Subject facilities	SFP cooling facilities
Countermeasure type	Facility formation (damage mitigation in the event of risk manifestation)
Tasks	The standby air fin cooler system at Units 1 / 4 are in dry lay-up to prevent freezing in winter months. If any issue develops with an operational air fin cooler, restoring the functions of the standby system requires substantial time, as the procedure must start from filling it with water.
Countermeasures	Since antifreeze solution is already added to prevent freezing, place the standby systems to wet lay-up. The introduction of wet lay-up can shorten their startup time in case of issues with the main system, and also accommodate periodical switchover between the main and standby systems to even out the extent of hardware deterioration.

Placing the standby system at Unit 4 to wet lay-up	
	Placing the standby system at Unit 1 to wet lay-up

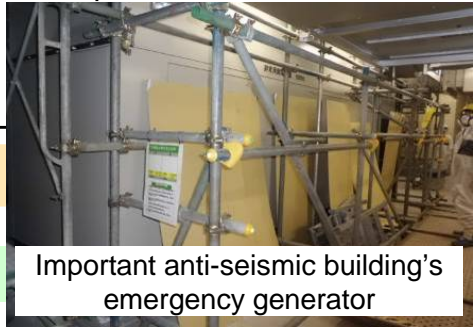
Objectives	Preventing power outage at important facilities							
Subject facilities	Important anti-seismic building's emergency generator							
Countermeasure type	Facility maintenance and management (Environment development and execution for appropriate maintenance and management)							
Tasks	<p>Due to insufficient maintenance and inspection under high radiation levels, the important anti-seismic building's emergency generator could have trouble starting up in power blackout, causing the building's power outage.</p> <p>Due to the difficulty in performing a disassembling inspection on the gas turbines for driving the generator, the emergency generator may not be able to undergo repair work for an extended period of time and become inoperative, causing the building's power outage.</p>							
Countermeasures	<p>In order to ensure continued use of the existing generator, increase the frequency of inspections, e.g. applying lubrication oil to the drive unit.</p> <p>In regard to the fluctuations of instrument readings and drive unit noise at the time of startup test, revamp maintenance and inspection with support from the Thermal Power department, which has knowledge on the gas turbine for driving the generator. (short- to mid-term measure)</p> <p>Consider and act on replacing the generator. (long-term measure)</p>

Implementing countermeasures	Revamping maintenance and inspection				Replacing the generator

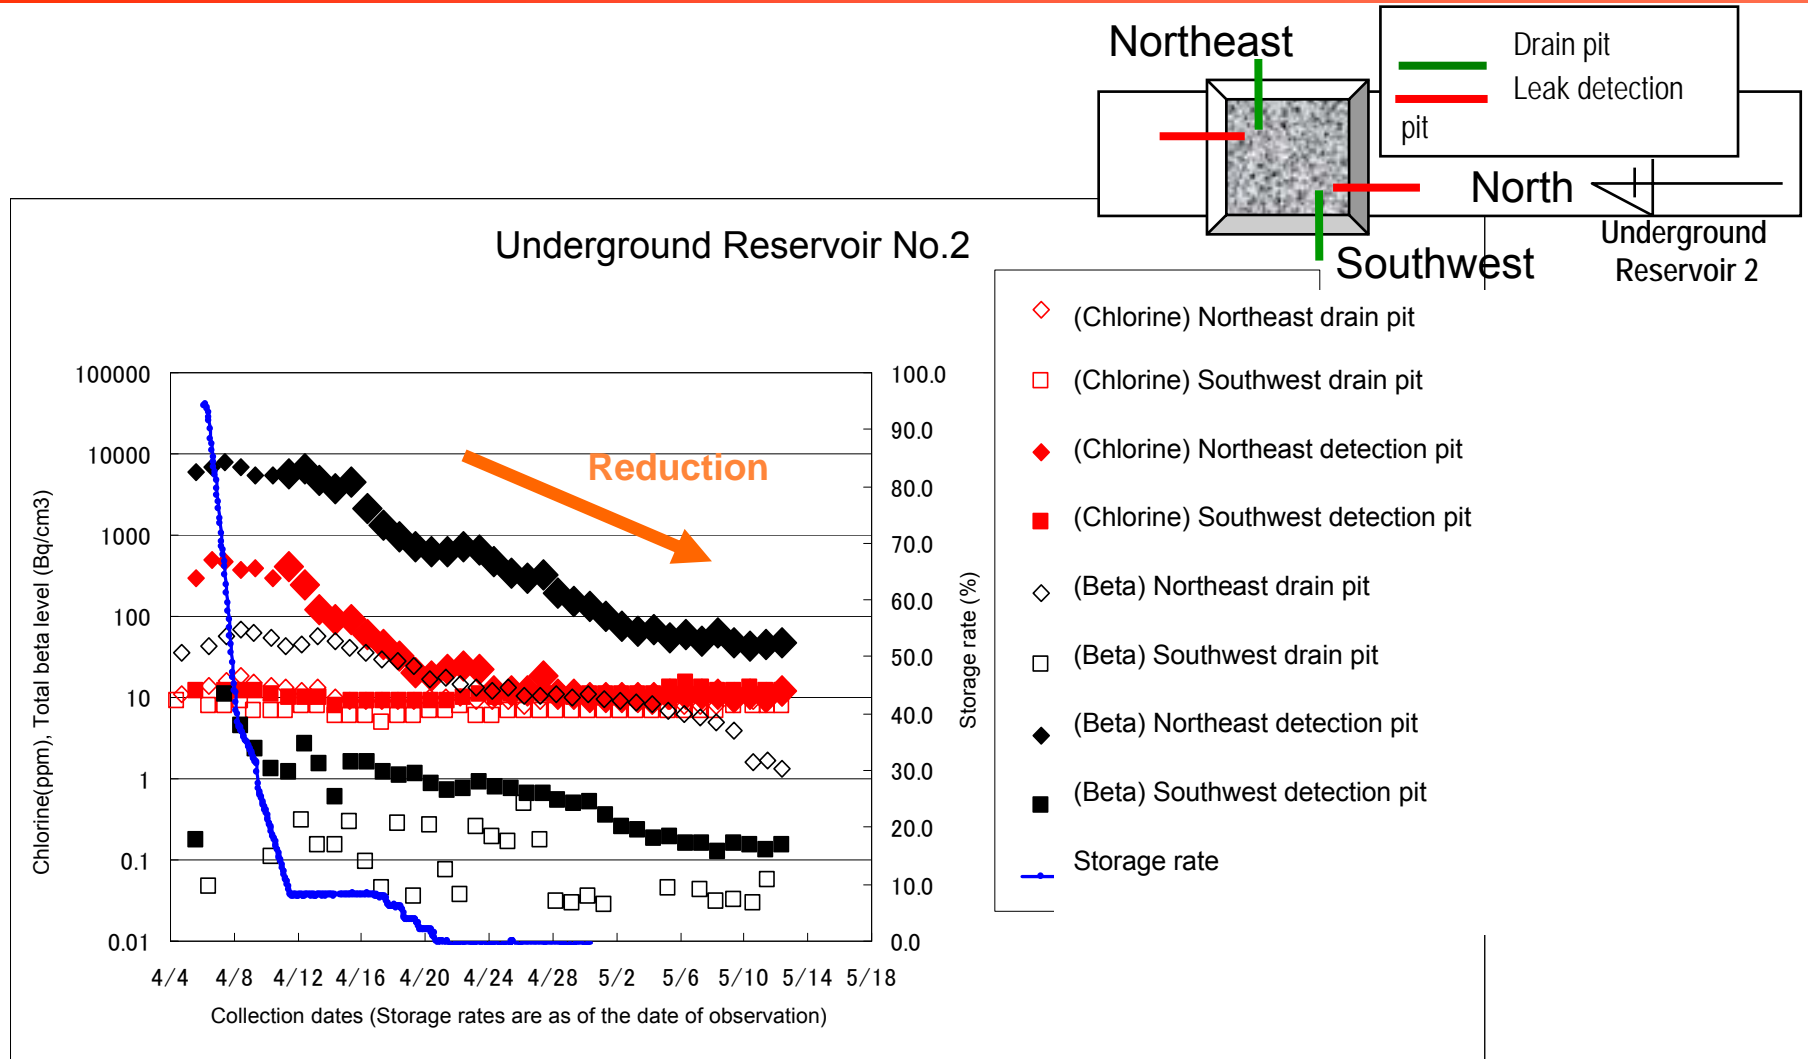
# 4. Water collection from leak detection pits and its analysis

The recovery of contaminated water from detection pits at the rate of 50 liters per day (several liters in raw water equivalent) dramatically reduced the contamination level, indicating that the original volume of leakage was small.

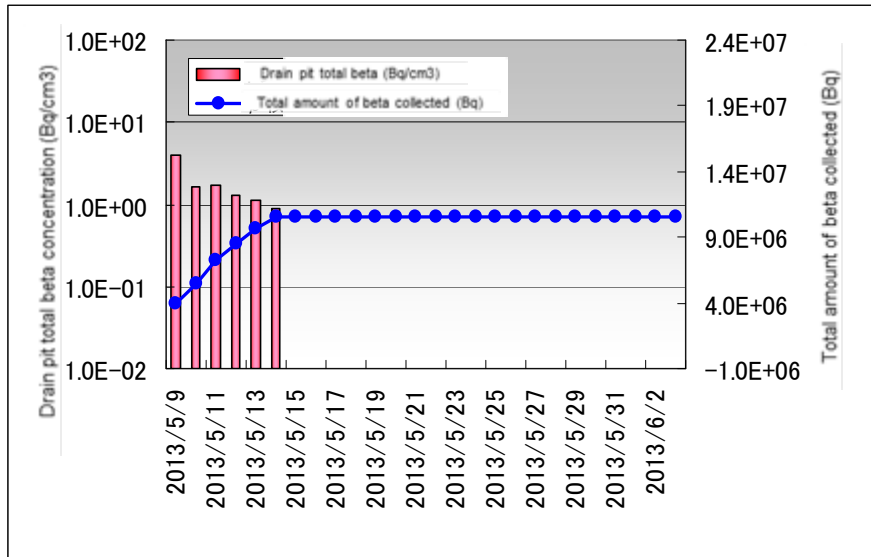
## Results of water collection from drain facilities

- Water collection from drain facilities began on May 9, 2013.
- As of May 14, 2013, 6 cubic meters of water has been collected (drain facilities' overall capacity: Approx. 17 cubic meters)
- Contamination level of collected water: Up to 3.9Bq/cm<sup>3</sup>
- Amount of radioactive materials collected:  $1.1 \times 10^7$  Bq**
- The fact that water with a high level of contamination was not found from drain facilities, where leaked water is most likely to stay, indicates that only a minute amount of contaminated water has leaked through the Bentonite sheet.

Collecting just 6m<sup>3</sup>(0.2 liters in raw water equivalent) has reduced the total beta concentration to around 1/4, suggesting that ***the volume of contaminated water is not large.***

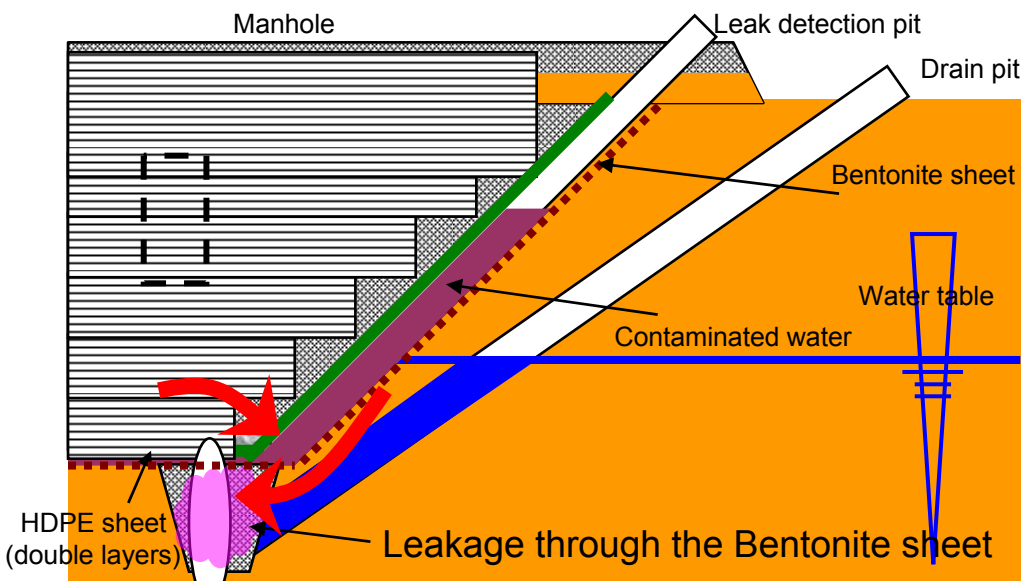
## 【Initial stage of leakage】

- Contaminated water leaked into the space between the HDPE sheet and the Bentonite sheet (in nonwoven cloth and gaps in leak detection pit).
- The pressure difference caused by the difference of water level in the leak detection pit and water table, led to the minor leakage of contaminated water through the Bentonite sheet.
- Since the subgrade is stabilized on the base and slope surfaces, the water leaked through the Bentonite sheet is believed to move toward the drain facility, which has a relatively high permeability.

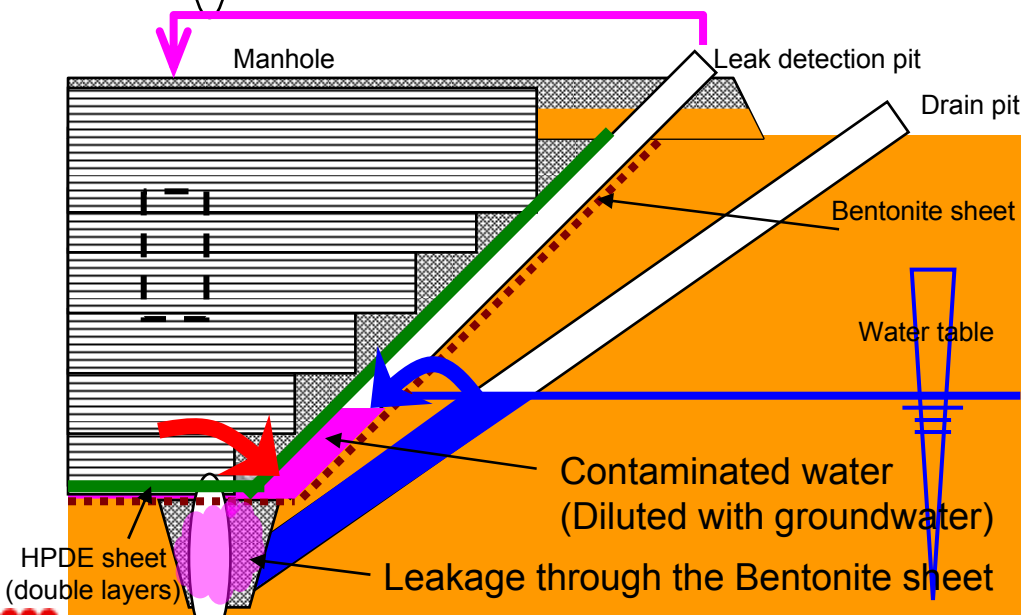
## 【When collecting contaminated water】

- The collection of contaminated water from the leak detection pit caused the water level in the pit to drop.
- A minute amount of groundwater permeated through the Bentonite sheet into the leak detection pit, diluting contaminated water.
- The diluted contaminated water was collected.
- This reduced and stopped the leakage of contaminated water through the Bentonite sheet.
