# Results of Soundness Inspection of Unit 2 TIP Guide Pipe (1st Day)

July 8, 2013

Tokyo Electric Power Company

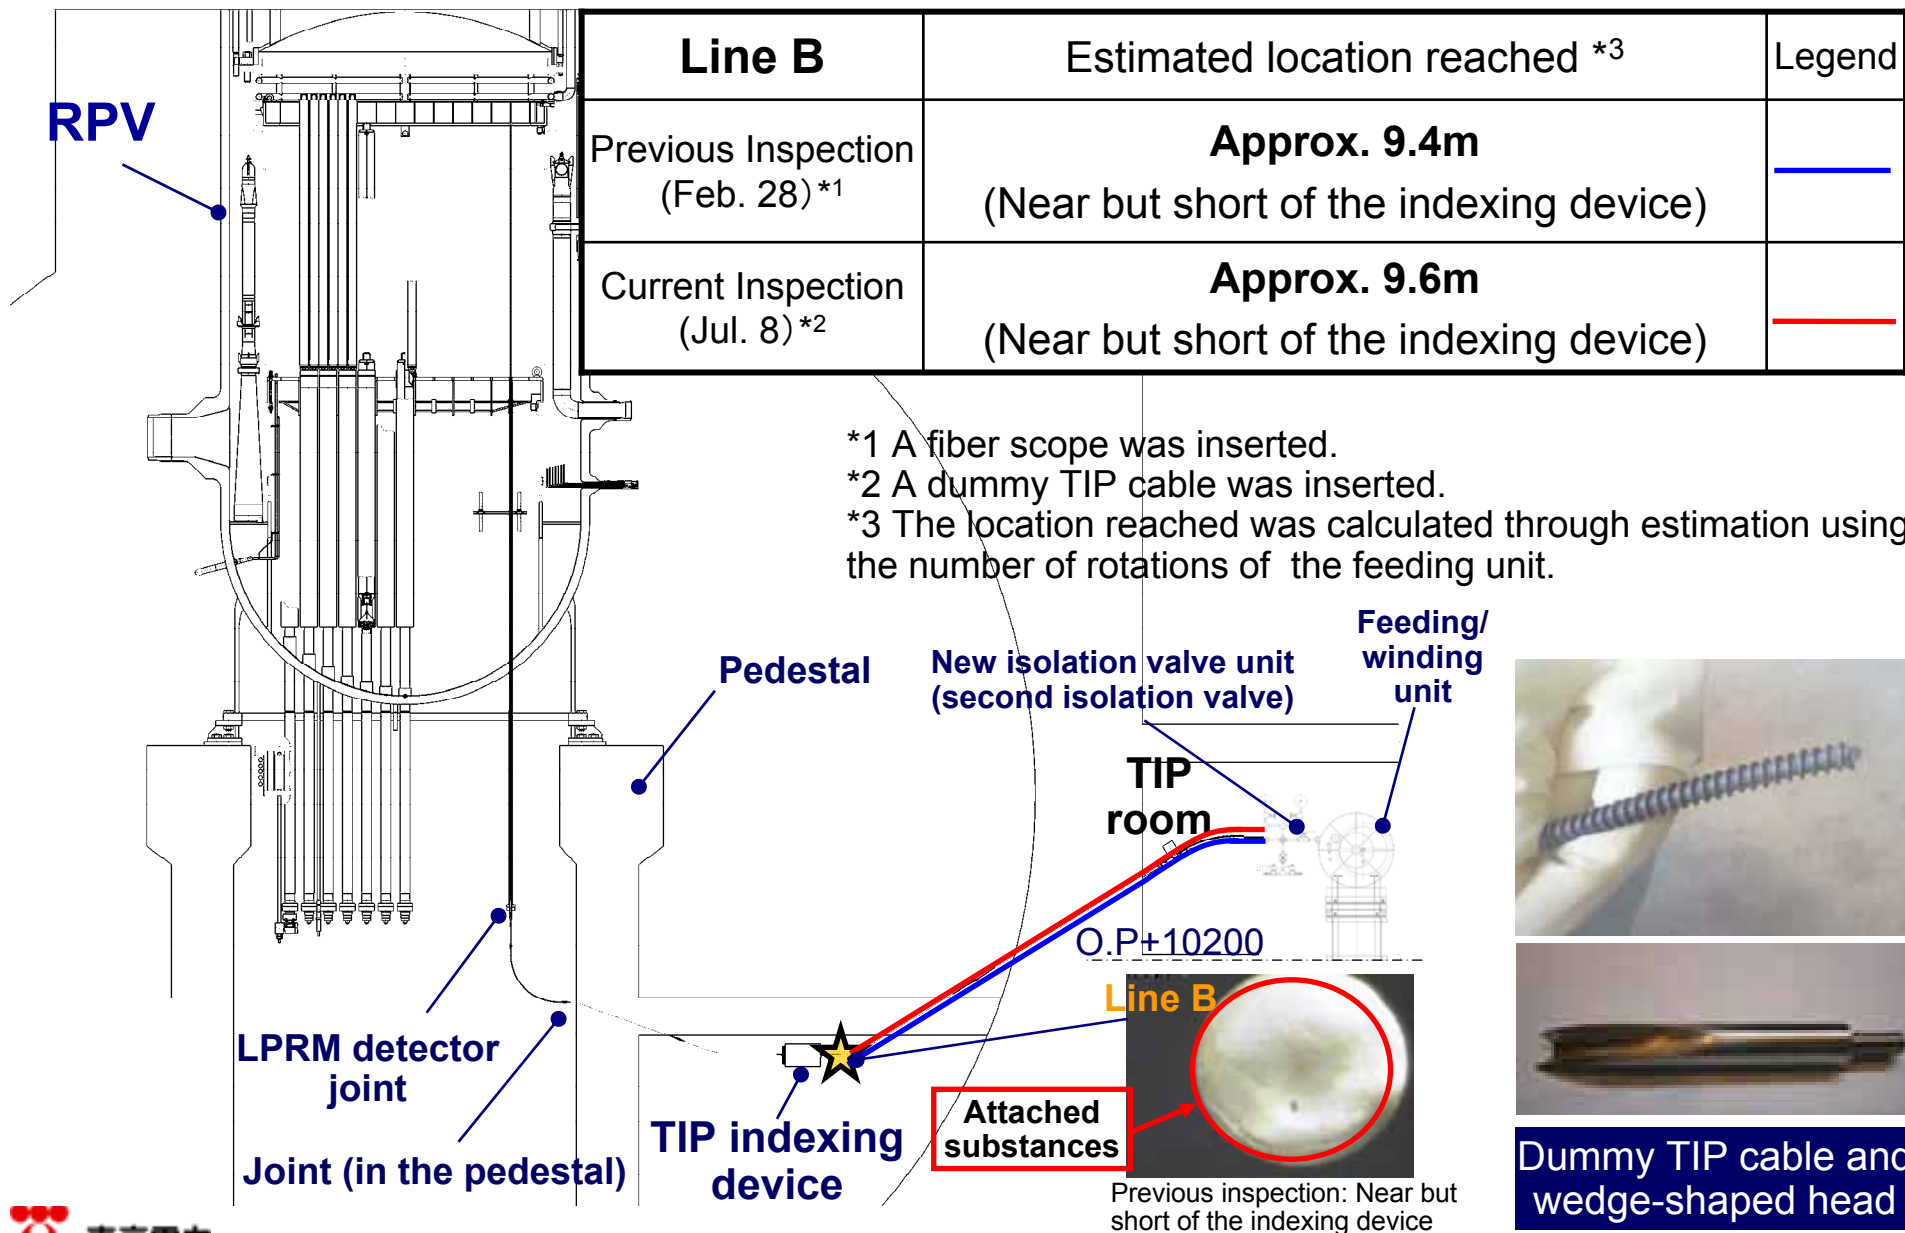
# 1-1. Contents of Work

- Radiation exposure received by workers  
Highest dose: 0.97mSV (Planned dose: 3mSV)
- Results
  - The dummy TIP cable was inserted and reached approx. 9.6m from the second isolation valve inlet flange of Line B. Insertion of the cable became impossible at the same location as in the previous inspection.
  - After the dummy TIP cable was pulled out, attached substances were found on the head.  
( $\gamma$ -ray: 5.0mSv/h,  $\beta$ - and  $\gamma$ -rays: 200mSv/h)
  - Inspection of Line B was completed. Inspection of Line D will be conducted tomorrow.
