# Countermeasures against the Uplift of the Underground Reservoirs

August 21, 2013

Tokyo Electric Power Company

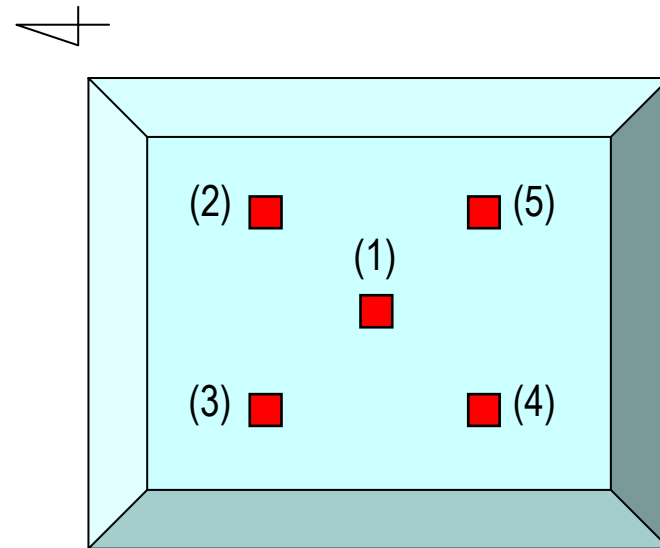
Measurement points  
on the underground reservoir No.3

- Measurement management during construction  
To check for any abnormality of the uplift condition caused by adding crushed stone for equalization and evaluate the effect of the countermeasure, measurement will be conducted at 5 points on the top surface of the underground reservoir.
