# Results of the Sixth Soundness Inspection of Unit 4 Reactor Building at Fukushima Daiichi Nuclear Power Station

August 28, 2013

Tokyo Electric Power Company

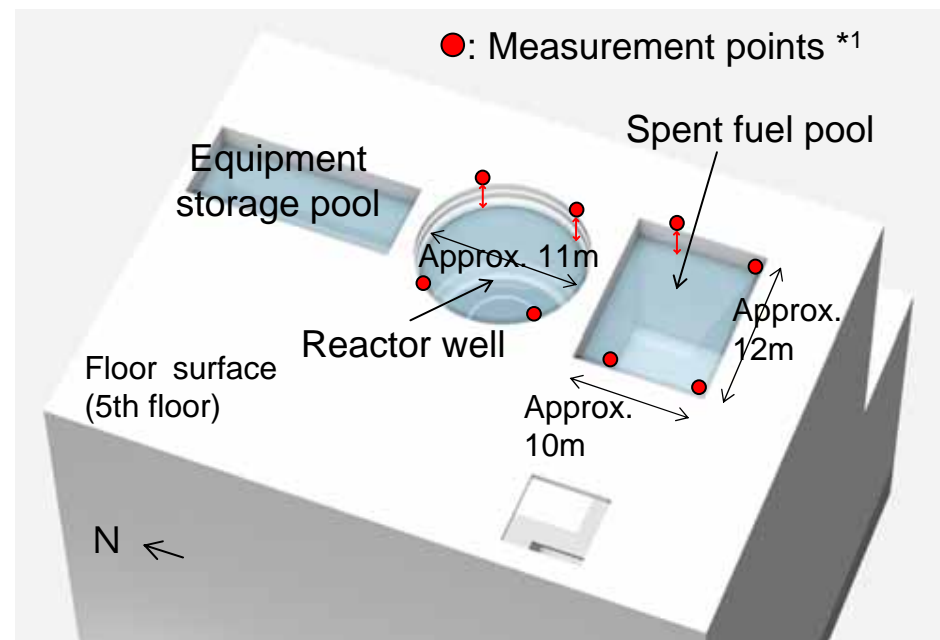
Measurement points (Floor surface of the 5th floor)

Considering that the water level measurement values on the four corners were about the same, it has been concluded that the 5th floor surface and the water surfaces of the spent fuel pool and the reactor well are parallel and the building is not tilted similarly to the past results.

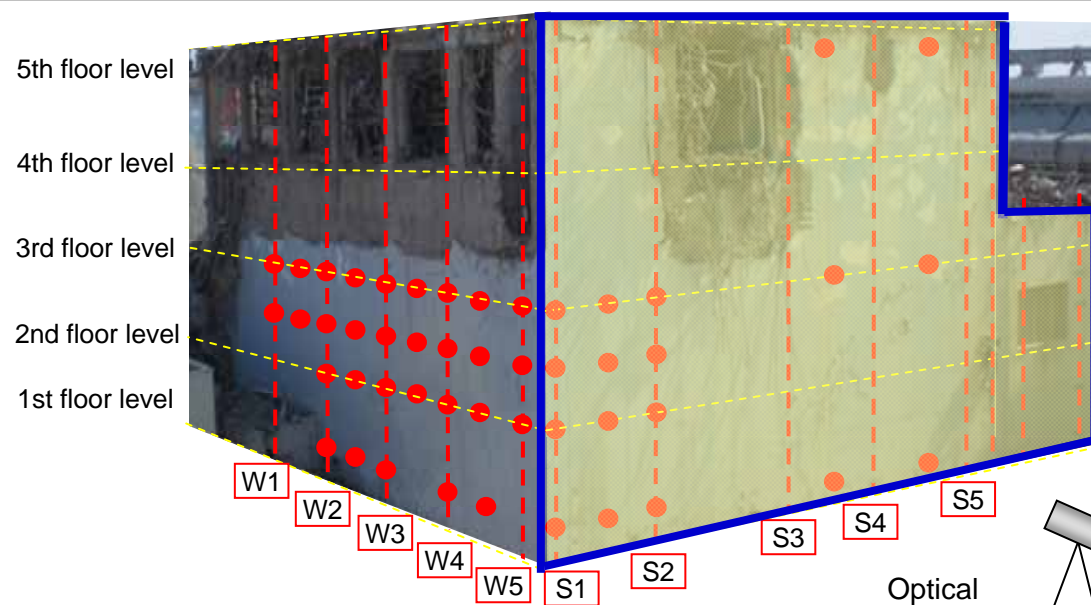
Measurement points

- The horizontal differences\*1 of the outer walls were measured by an optical equipment (with fixed points set on the upper and lower sides of the walls) and the deformation characteristics of the outer walls were evaluated.
- The south wall was excluded from the measurement due to interference with the cover for fuel removal.
- 7 points of the third floor level were excluded from the measurement due to interference with deterioration prevention equipment of the Reactor Building.

Though partial bulge was found on the outer walls, it has been confirmed that the building itself is not tilted based on the results of the first regular inspection (May 2012), detailed inspection of outer walls (June 2012), and second to fifth regular inspections (August and November 2012, February and May 2013).

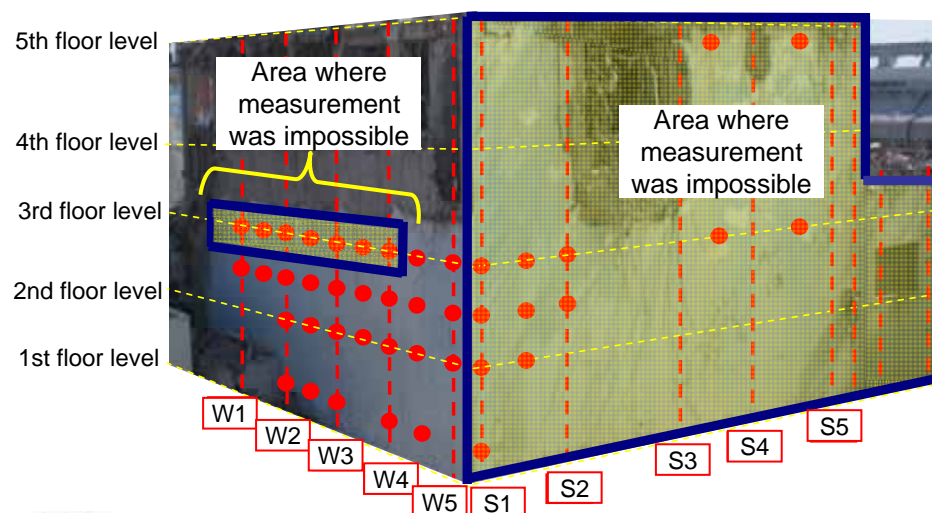
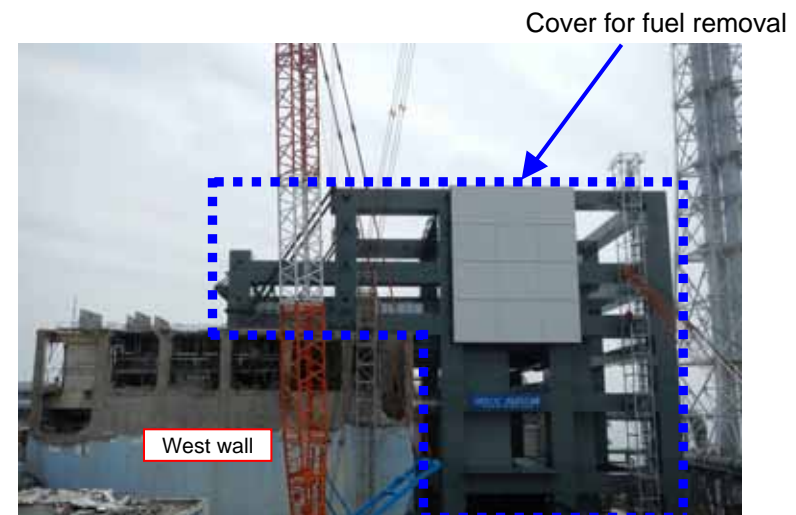
- The horizontal differences measured this time were about the same as those in the first to fifth inspections, and the deformation characteristics on the measurement points were also similar.

- The small difference from the previous measurement results may be due to factors such as error of the optical equipment (Measurement error of  $\pm 2\text{mm}$  may cause approx. 4mm (Max.) error in horizontal difference) and thermal expansion of concrete (thermal expansion coefficient: Approx.  $7-13 \times 10^{-6}/$  ) which may cause approx. 4-7mm error because of the difference of average monthly temperatures between May and August.

- The south wall was excluded from the present and future measurements due to interference with the cover for fuel removal. However, we consider that no significant change would be found with the measurement on the outer surface of the south wall, since no significant change was found with measurement results on the west wall and the inspection results for the other three inspection items.

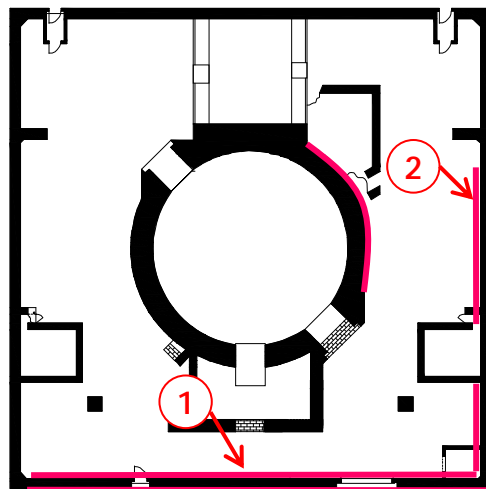
First floor

Since no crack of a width of 1mm or more or with possible rebar corrosion was found as a result of visual inspection (similarly to the past results), it has been concluded that there is no hazardous deterioration of structural durability.
