Efforts for Decommissioning of Unit 1 to 4 Reactors in TEPCO Fukushima Daiichi Nuclear Power Station

September 13, 2013

Tokyo Electric Power Company, Inc.

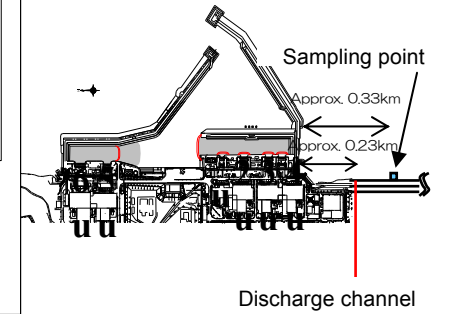
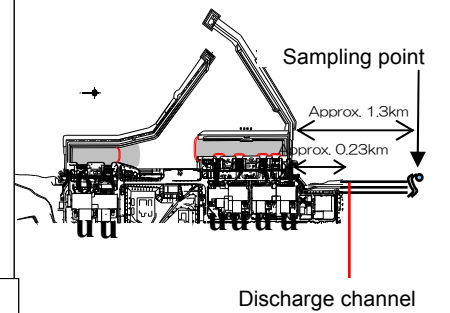
The concentration of the total β in the seawater around both of the southern and northern water discharge outlet monitored below the detection limit. Therefore, the impact to the outer sea had been minimal.

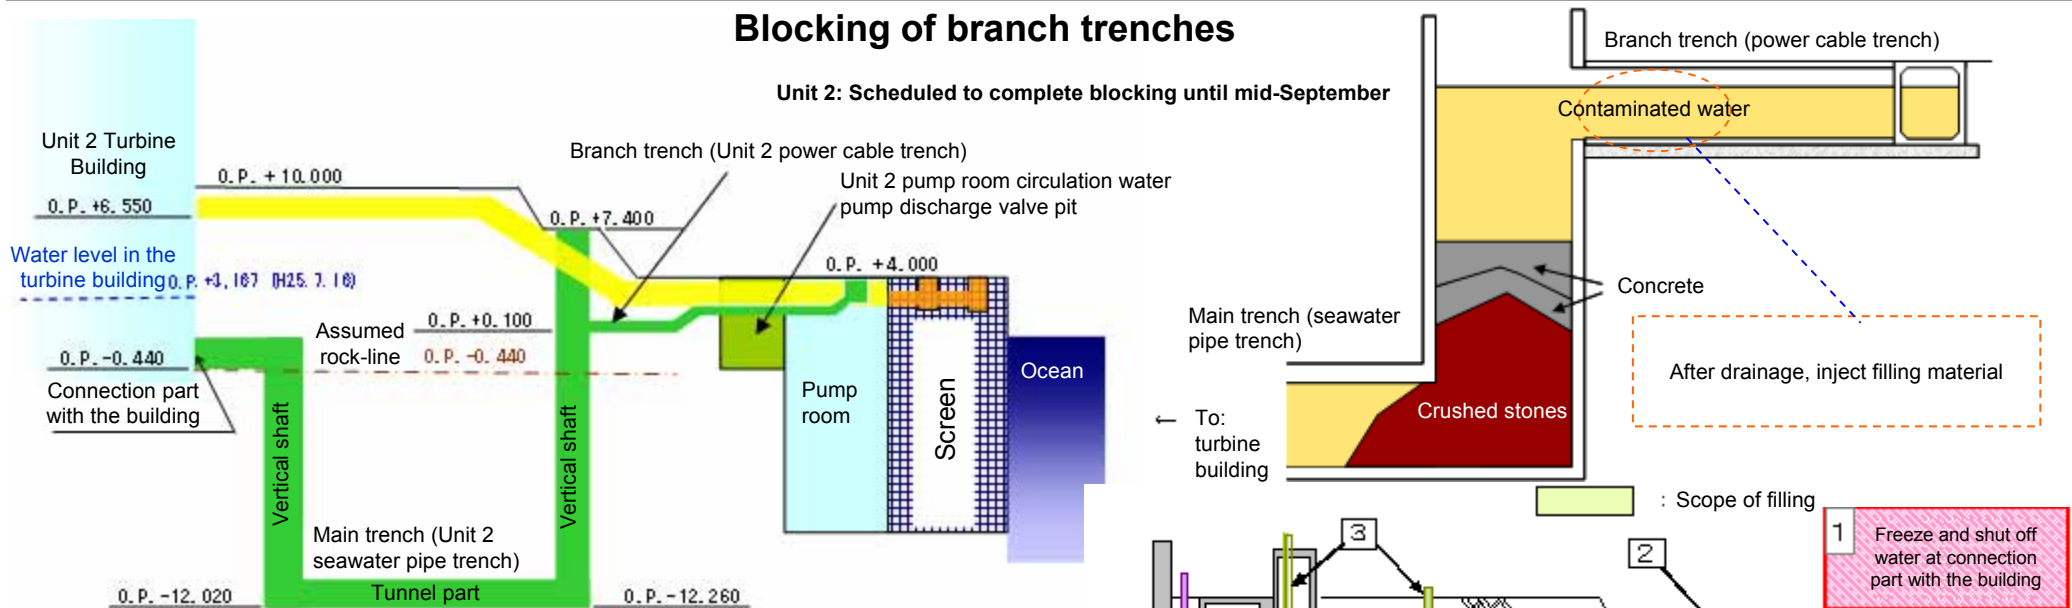
Trench structure (Example of Unit 2)

- ✓ In order to remove the highly contaminated water remaining in the trenches, drain the contaminated water from the branch trench and inject filling material, and drain the contaminated water in the main trench as well after purification. *

Unit 2: Scheduled to complete blocking until mid-September
