<Reference>
October 7, 2013
Tokyo Electric Power Company

Seismic Safety Evaluation of Fukushima Daiichi NPS Units 1 and 2 Exhaust Stack Having Damaged Components

Inspection of Units 1 and 2 Exhaust Stack

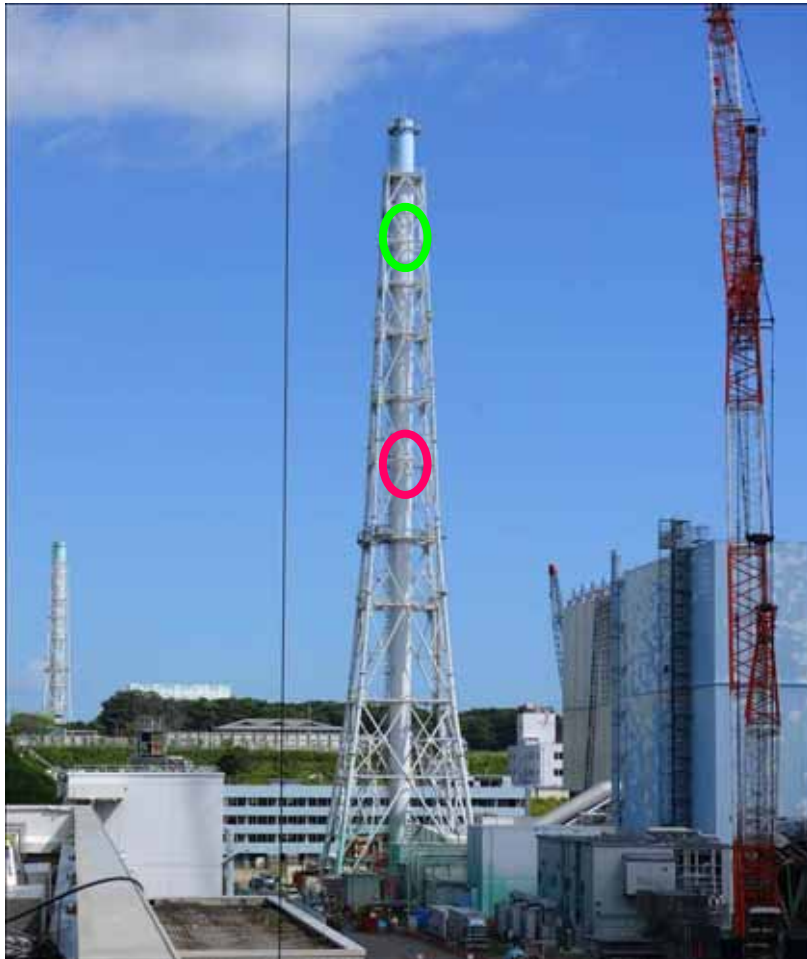
Full view of the stack photographed from its south side

- Breakage: 5 locations (2 on the north side, 2 on the south side, and 1 on the west side)

- Deformation: 3 locations (2 on the east side and 1 on the south side)

All of the above locations are found at the joint sections of the diagonal bracings near 66 m above ground (O.P. +76 m).

- Example of a sound location
- Example of a location of breakage
- Example of a location of deformation

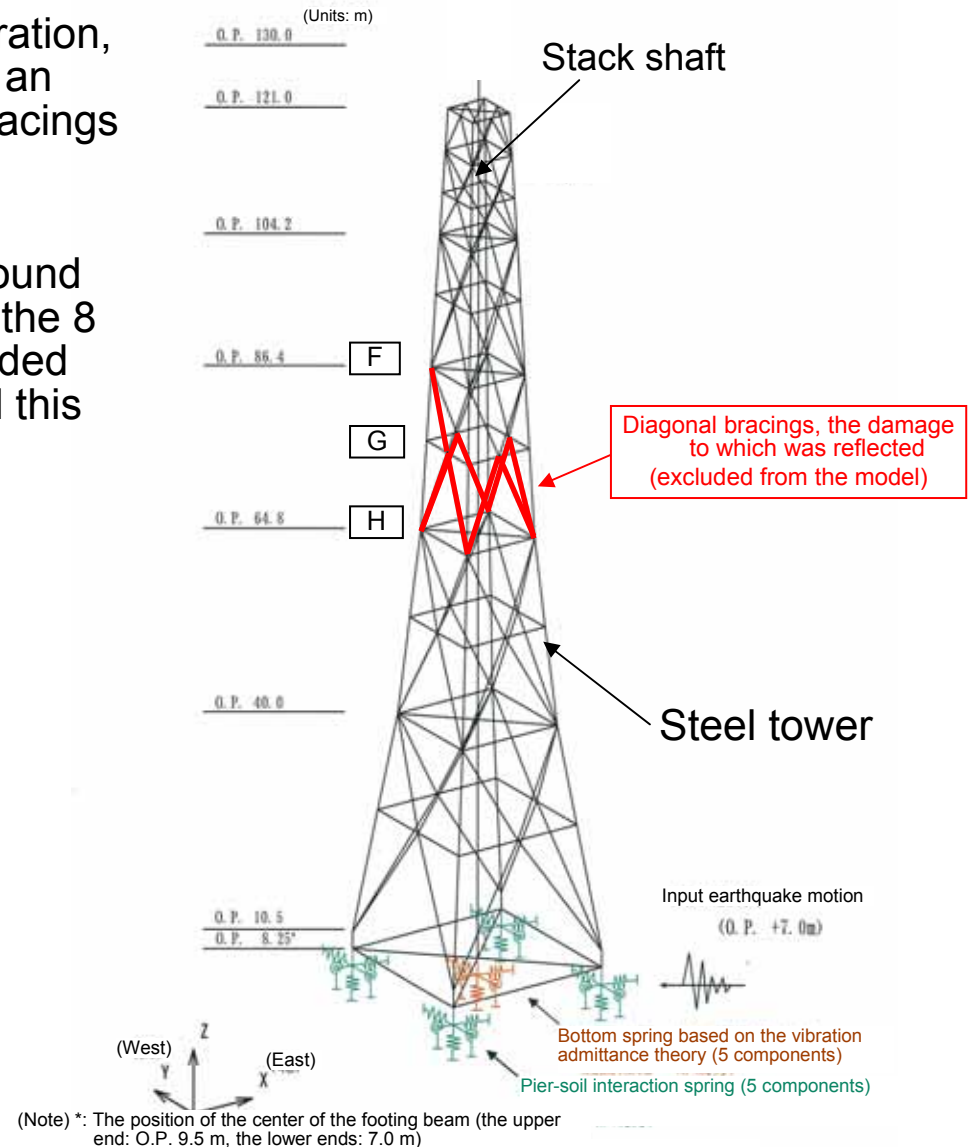
Illustration of the analytical model

Note that, although there are 7 diagonal bracings found broken or deformed between levels G and H, all of the 8 diagonal bracings between these levels were excluded from the analytical model in the analysis conducted this time to make the analysis conservative.

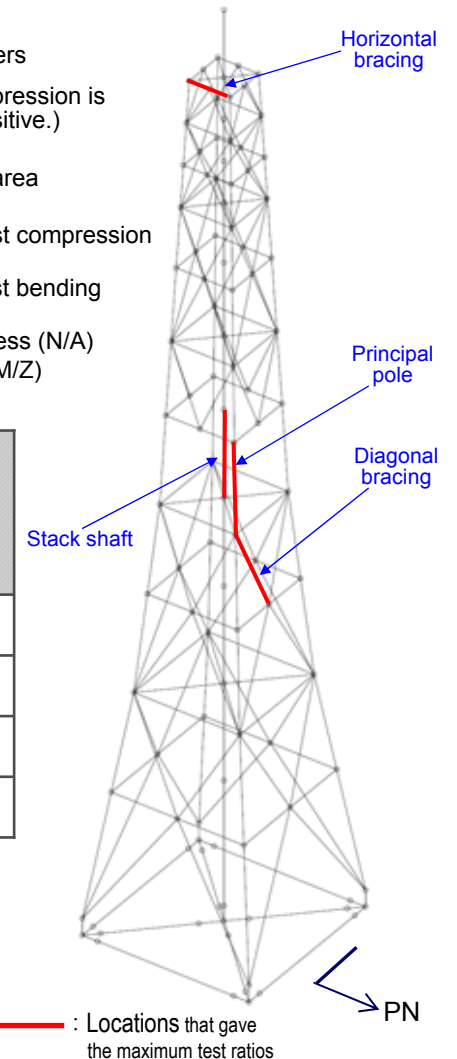
Sections covered in the stress evaluation

Note that plasticization of the entire cross section of a post or bracing does not necessarily result in immediate collapse of the exhaust stack.
