<Reference>  
November 15, 2013  
Tokyo Electric Power Company

# Results for the Effectiveness Confirmation of Corrosion Prevention at the System C in the Multi-Nuclide Removal Equipment

# Inspection points of corrosion prevention effectiveness at System C

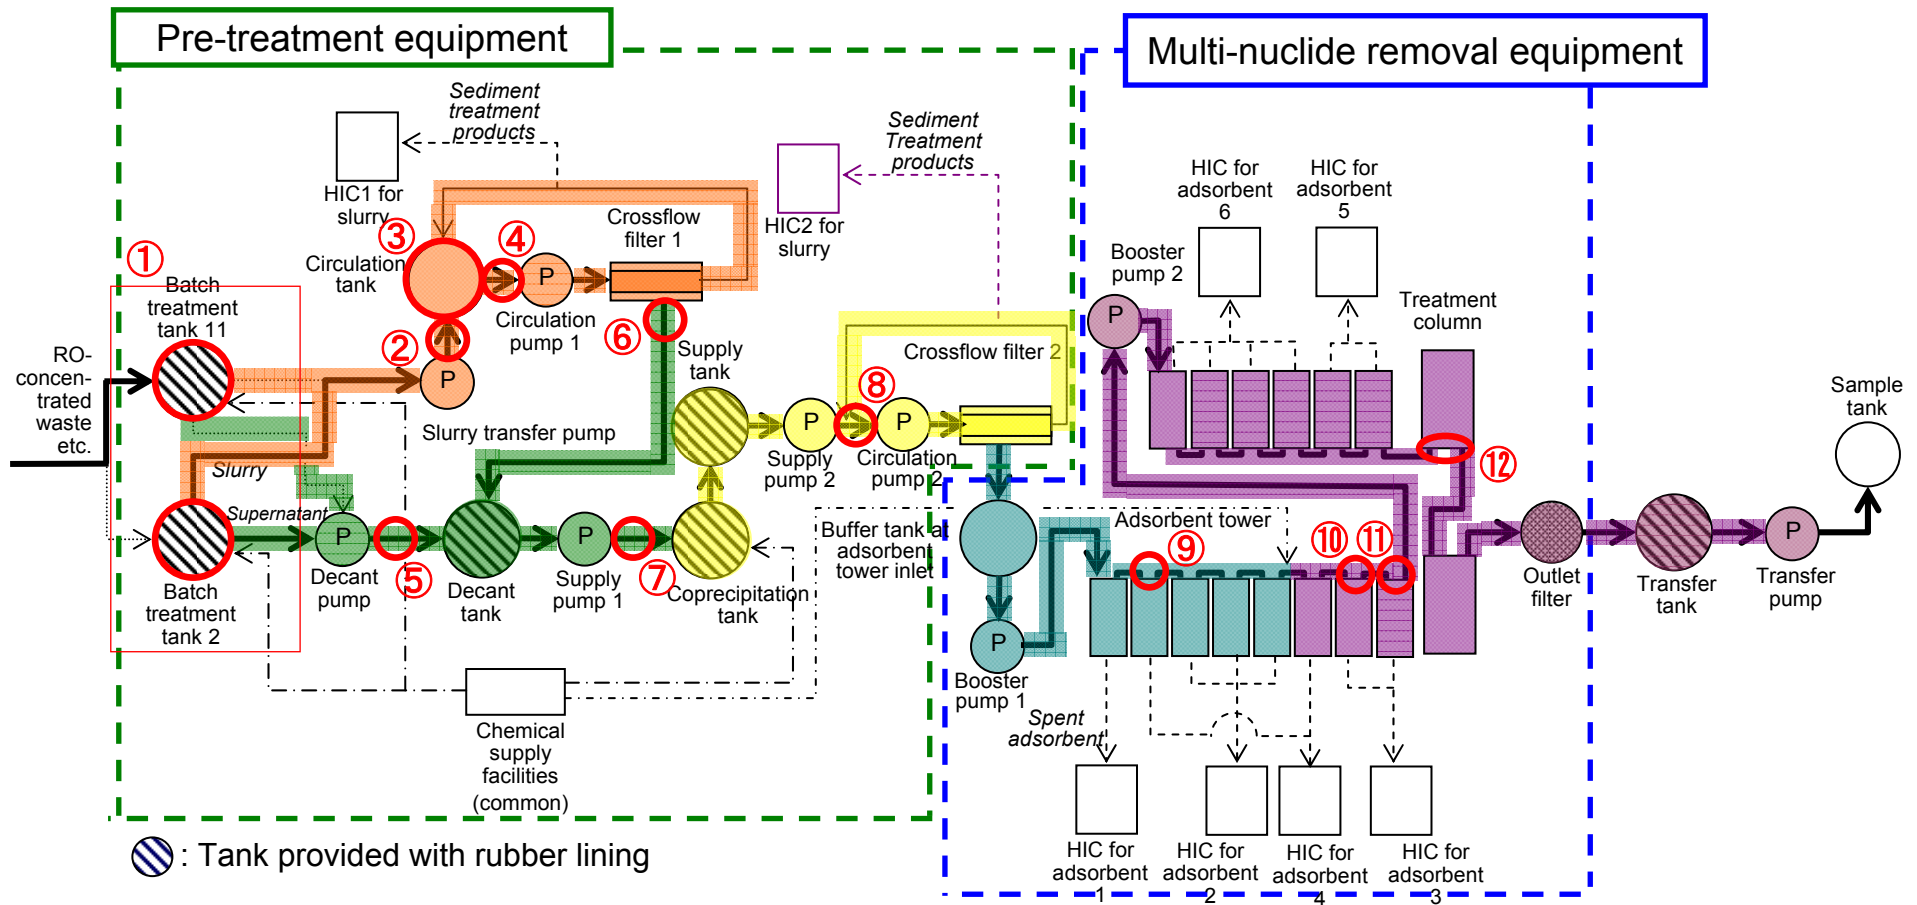
- Inspection points of corrosion prevention effectiveness (○) are described below.

- Batch treatment tanks: Whether there is a significant defect/exfoliation with linings, or not.
- Weld line and flange surface: How much corrosion a sacrificial positive electrode has or whether there is a significant corrosion, or not
