## Water Leak From Gland Part of Entrance Valve of Waste Liquid Receiving Tank in Desalination System (Reverse Osmosis Membrane) No.2 at Fukushima Daiichi NPS

# Leakage Location of Desalination System (Reverse Osmosis Membrane) No.2

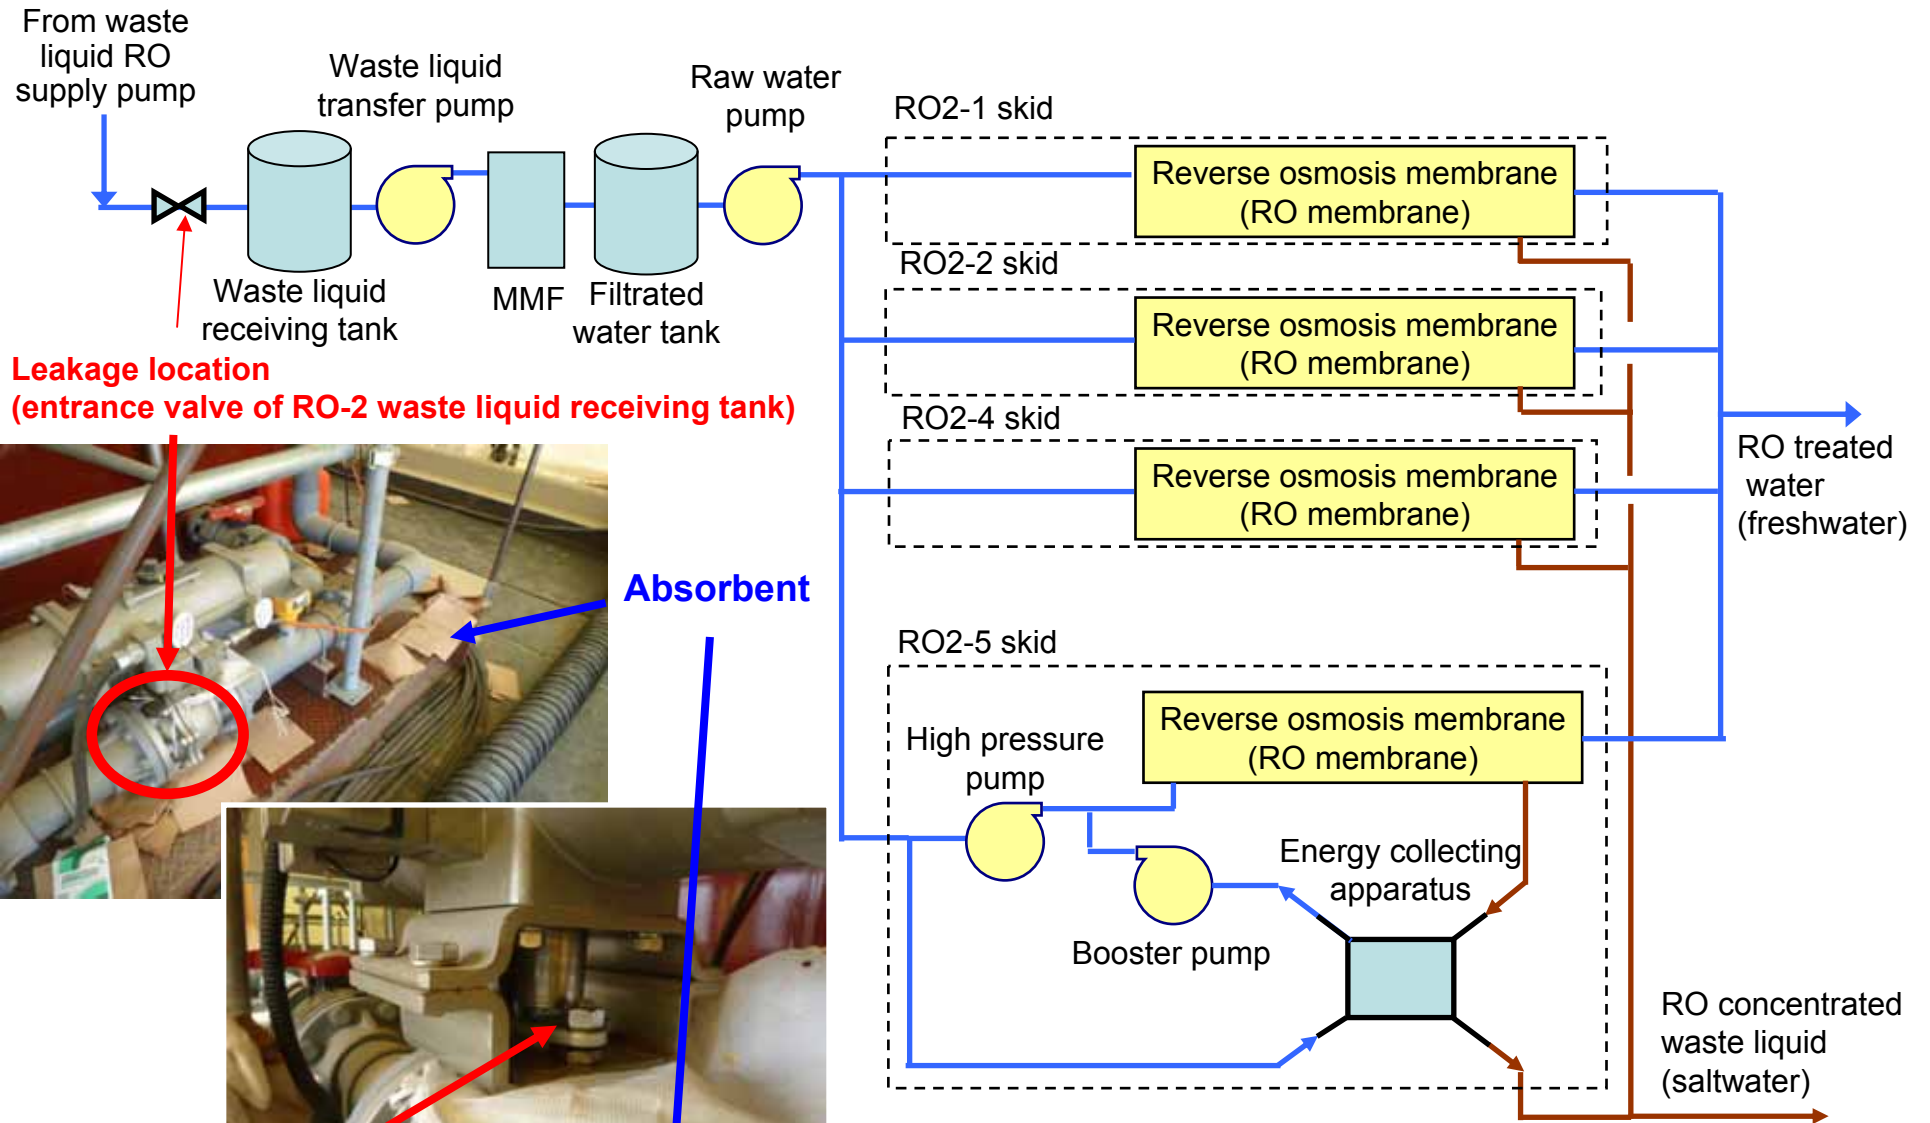
- 9:40 AM A TEPCO employee, who entered the temporary warehouse in order to check the site condition after activation of RO-2, found water leaking at the pace of 1 drop per second from the air controlled valve gland part at the entrance part of a waste liquid receiving tank (entrance valve of RO-2 waste liquid tank).

- Estimated cause: Deterioration of gland packing (the packing has been abraded slightly due to secular use of a valve)
- Future correspondence: Similar valves which are being switched ON/OFF repeatedly when desalination system is in operation, will be inspected regularly if they are tightened properly.

**Leakage location**  
**(entrance valve of RO-2 waste liquid receiving tank)**

- 9:42 AM RO-2 was suspended by hand.
  - Around 10: 00 AM The leakage was confirmed to be stopped after the gland part of this valve was tightened.
  - Around 11: 58 AM Operation check and leakage check under pressure was performed after this valve was protected, and no problem has been found.
