1. Investigation

We aim to clarify damages of building frames inside Unit 1 reactor building in Fukushima Daiichi NPS.

◆ **Work area** Building frames around the equipment hatch (from 2nd to 4th floors) at Unit 1 Reactor Building

◆ **Date** On December 4 (Wed.) and 5 (Thu.), 2013

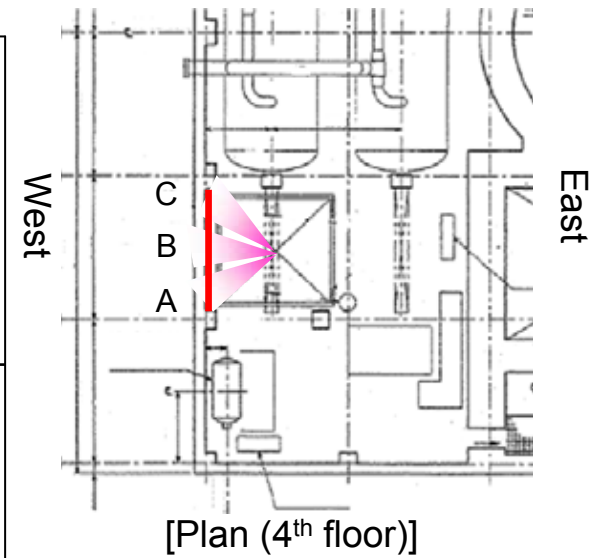
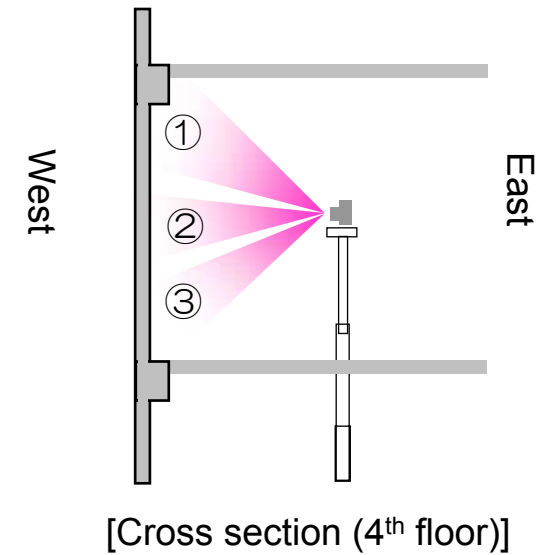
[4th floor equipment hatch walls in the west]

- After taking photos of the walls on each floor, no remarkable damage was found.
- These results will be reflected in the seismic resistance evaluation in future.
