**Mis-transportation of Accumulated Water to the Incinerator Workshop Building
in the Central Radioactive Waste Treatment Facility
of the Fukushima Daiichi Nuclear Power Station**

April 16, 2014

Tokyo Electric Power Company

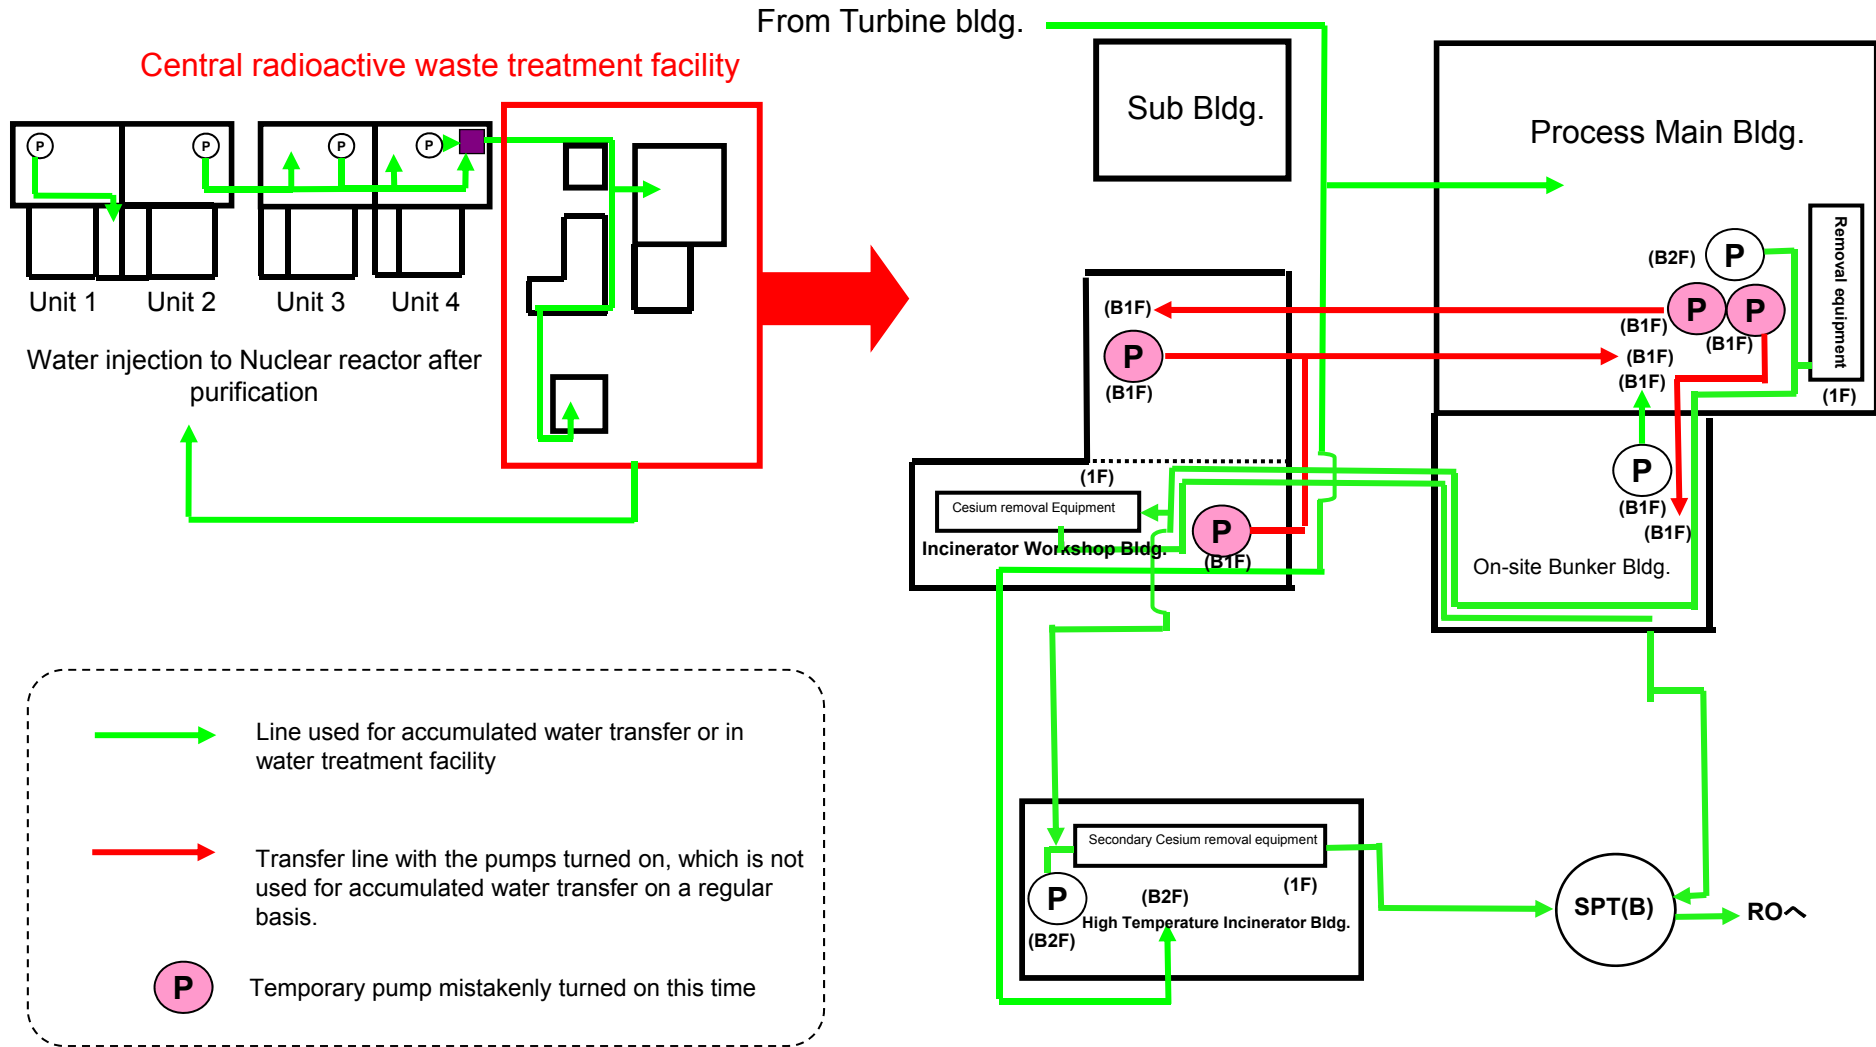
【Reference 1】 System layout

* All of the Process main Bldg., the On-site bunker Bldg., and the High temperature incinerator Bldg. have water accumulated in their buildings.
