Results of Investigation on Upper Parts of S/C (Suppression Chamber) of Unit 1 at Fukushima Daiichi NPS

May 27, 2014 Tokyo Electric Power Company

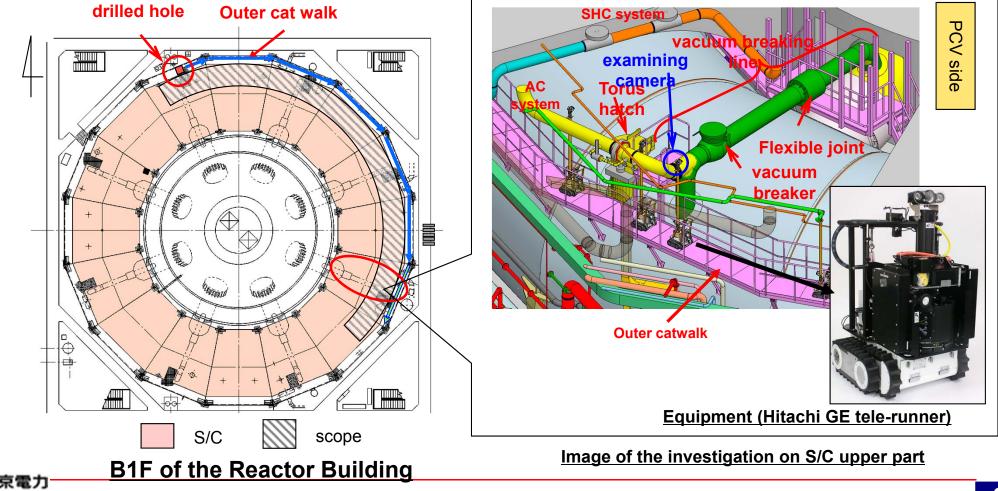
Equipment (under development for investigation and maintenance (water stop) for watering C/V) for investigation on upper part of S/C was put in from the drilled hole in northwest area, and investigation from outer cat walk was conducted.

- Confirmation of the leak point on S/C upper part (near X-5E)
- Inquire for leak on S/C upper Outboard * on Northern Outboard (May 27)
