# **“Development of a technology to investigate inside the Reactor Primary Containment Vessel (PCV)”**

**-- Site test “Investigation B1” on grating around the pedestal inside Unit 1 PCV -**

**April 13, 2015**

**Tokyo Electric Power Company**

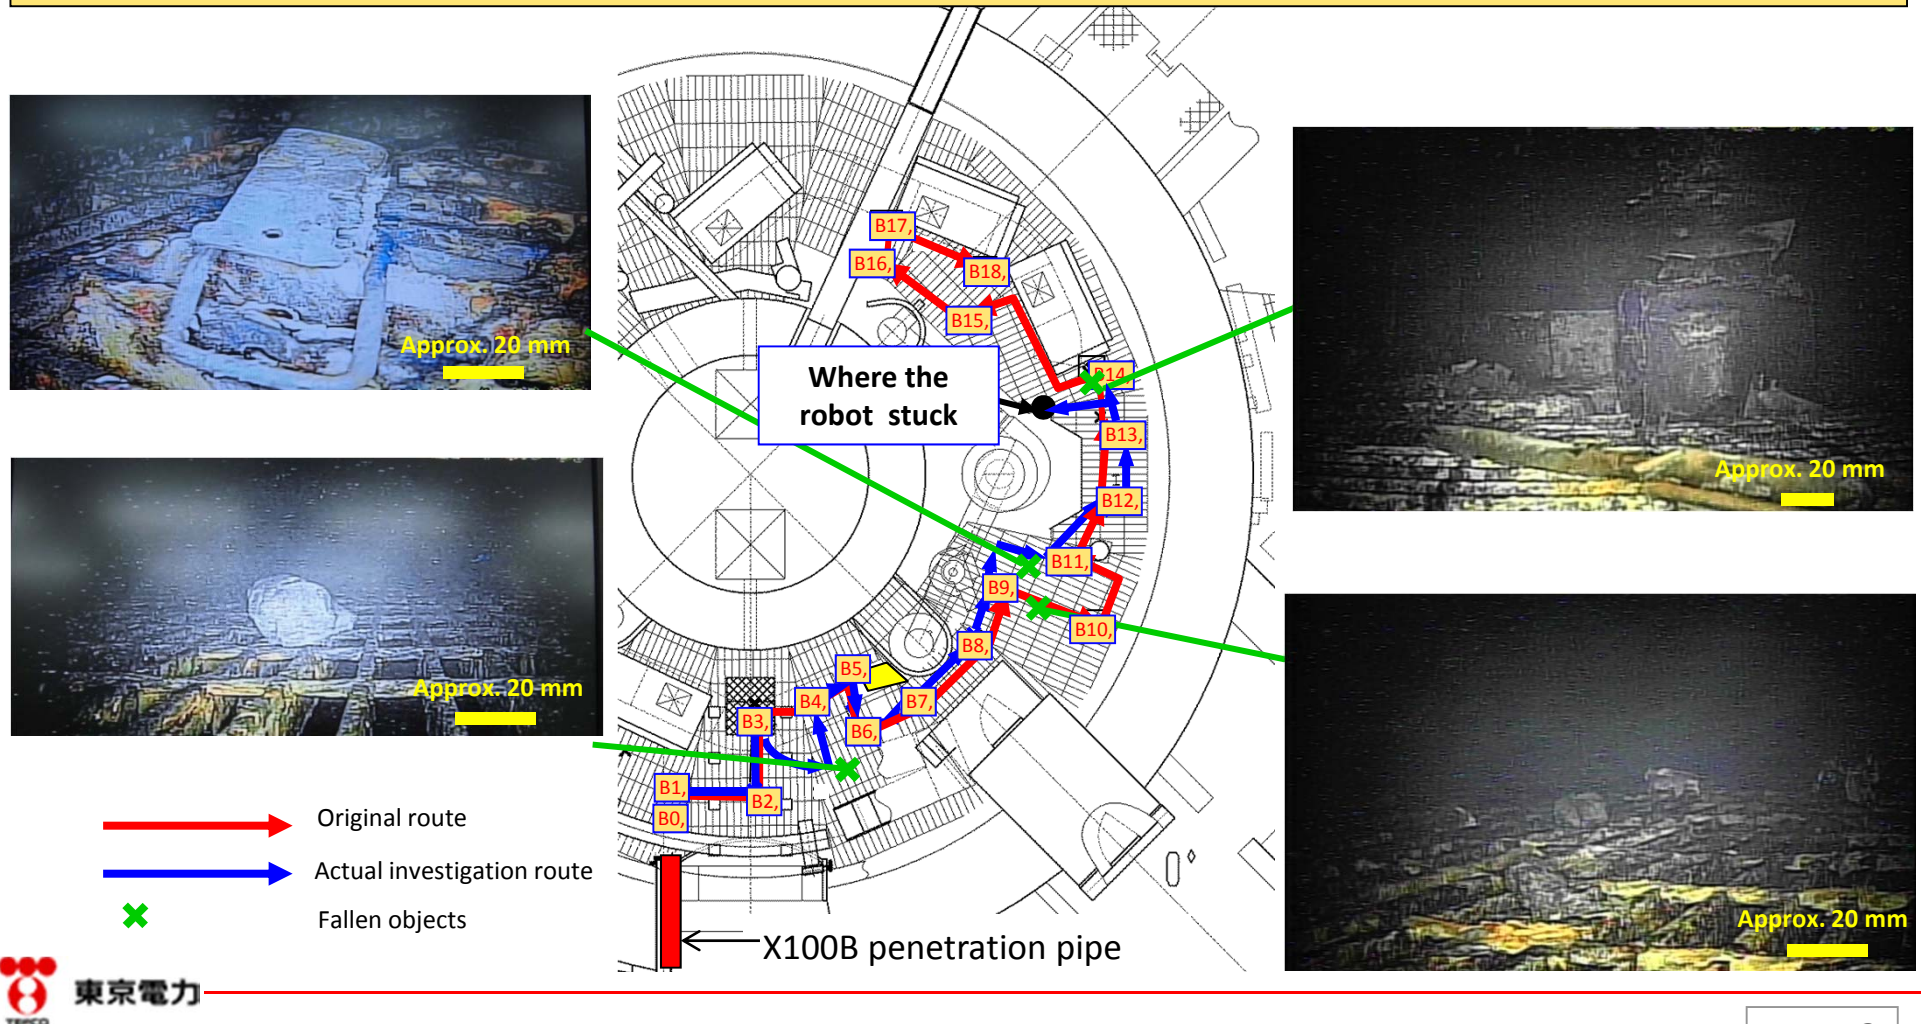
- The investigation was conducted taking on a different route as some objects were found to be fallen on the original access route planned.
- The robot was stuck on the route between B14 and B15.

- Object was found to be fallen on the planned route between B 14 and B 15 where was the narrowest part of it.
- Following the procedures, the investigation continued by choosing an another route avoidable the objects.

The robot got stuck with an existing pipe and some shut parts of the grating or uneven part at the joint, which resulted in making the route hard to run on.

Measures to be taken are under study.

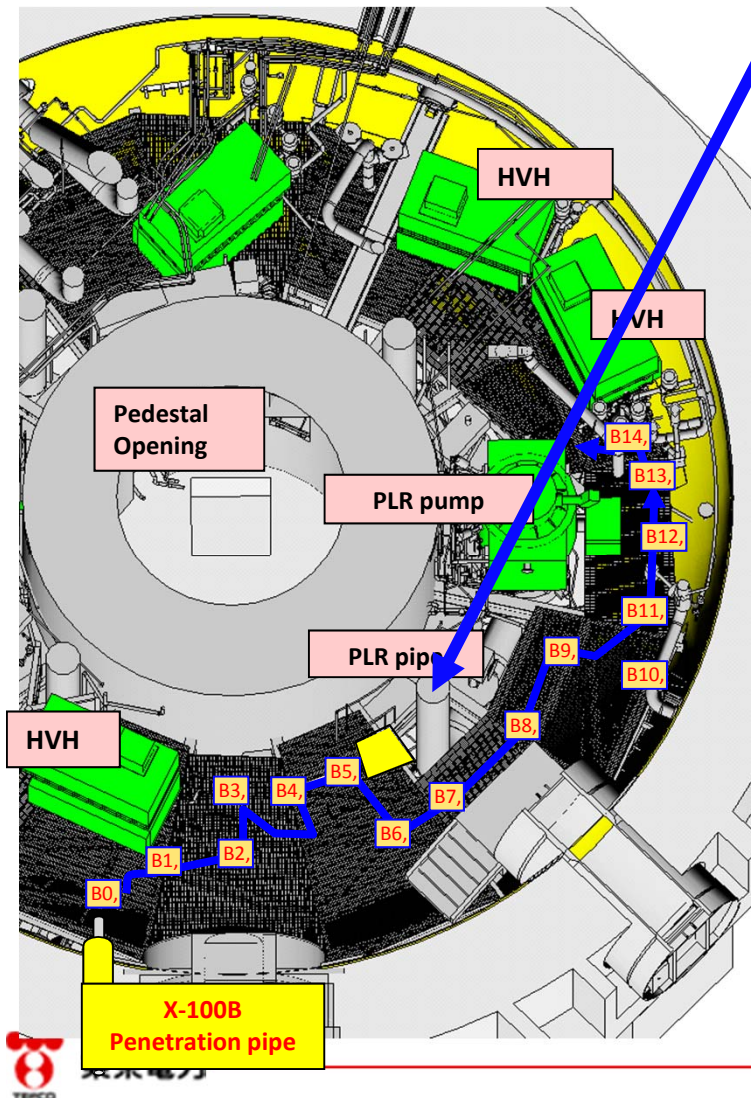
**B7**

- No significant damages were found on the PLR pipe (for heat retention).
- It was found that a part of the shield has been fallen off.

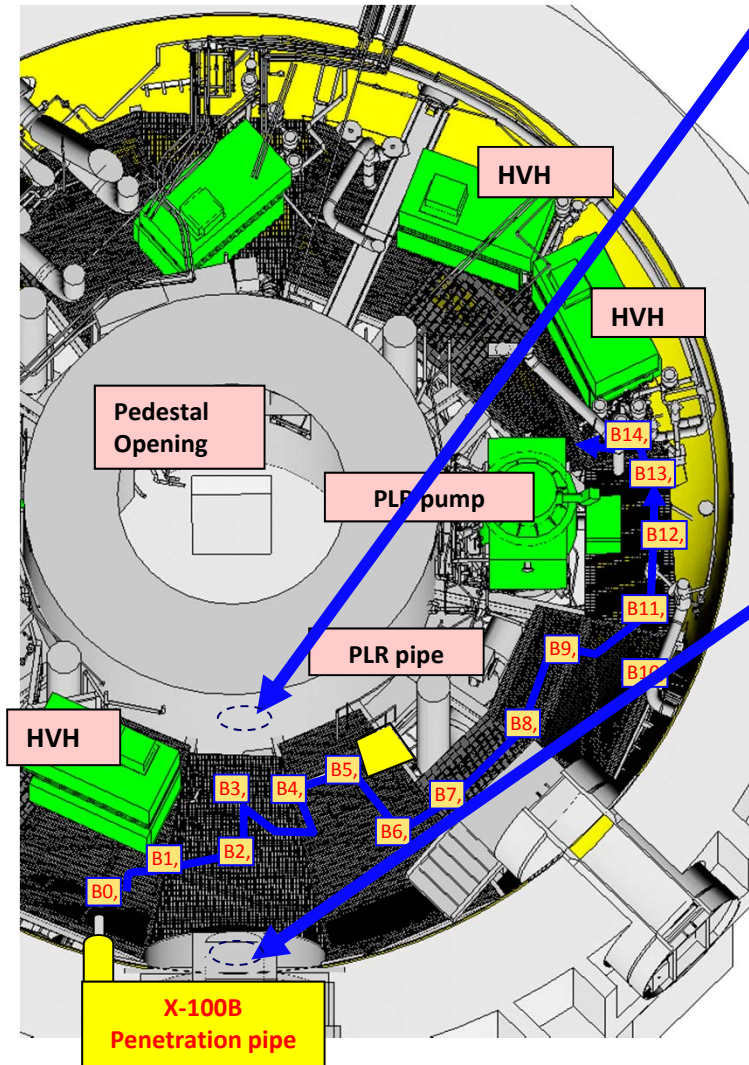
### B3 Exterior of the outer wall of the pedestal

No significant damages were found on the outer wall of the pedestal.

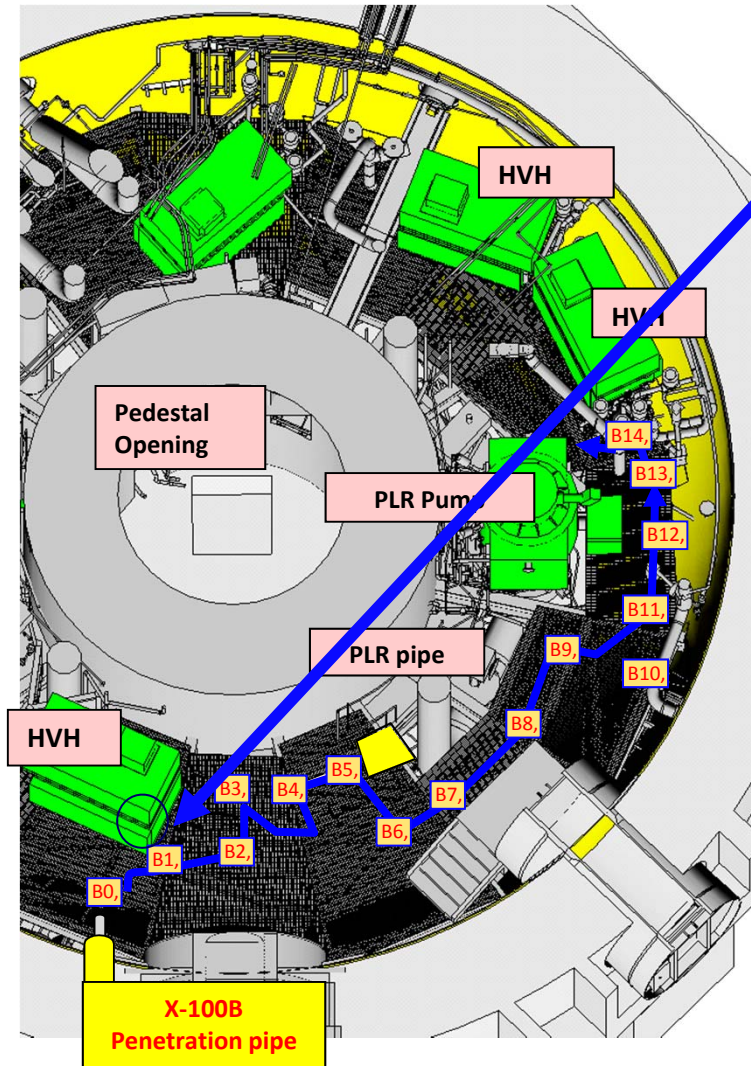
**B1**

No significant damages were found on HVH (D).

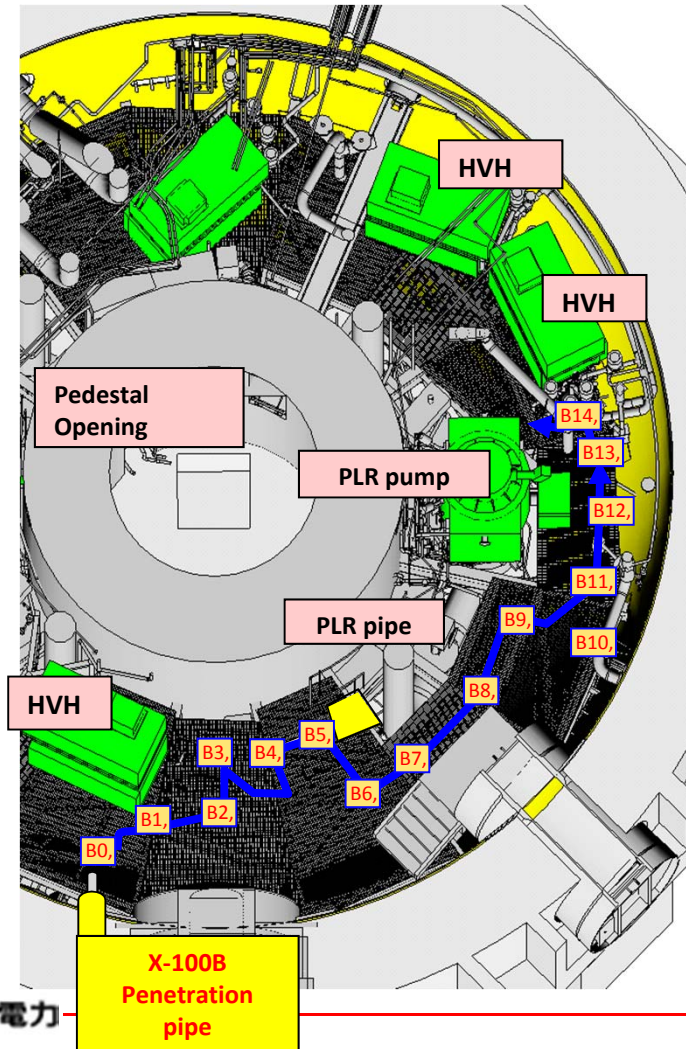
Dose rate (Sv/h)	Temperature (°C)
B3	<b>7.4</b>	<b>17.8</b>
B4	<b>7.5</b>	<b>19.2</b>
B5	<b>8.7</b>	<b>19.4</b>
B7	<b>7.4</b>	<b>19.5</b>
B11	<b>9.7</b>	<b>19.2</b>
B14	<b>7.0</b>	<b>20.2</b>
