# **“Development of a technology to investigate inside the Reactor Primary Containment Vessel (PCV)”**

**- Results of follow up check after the site test -**

**[For April 18 and 19, 2015]**

**Tokyo Electric Power Company**

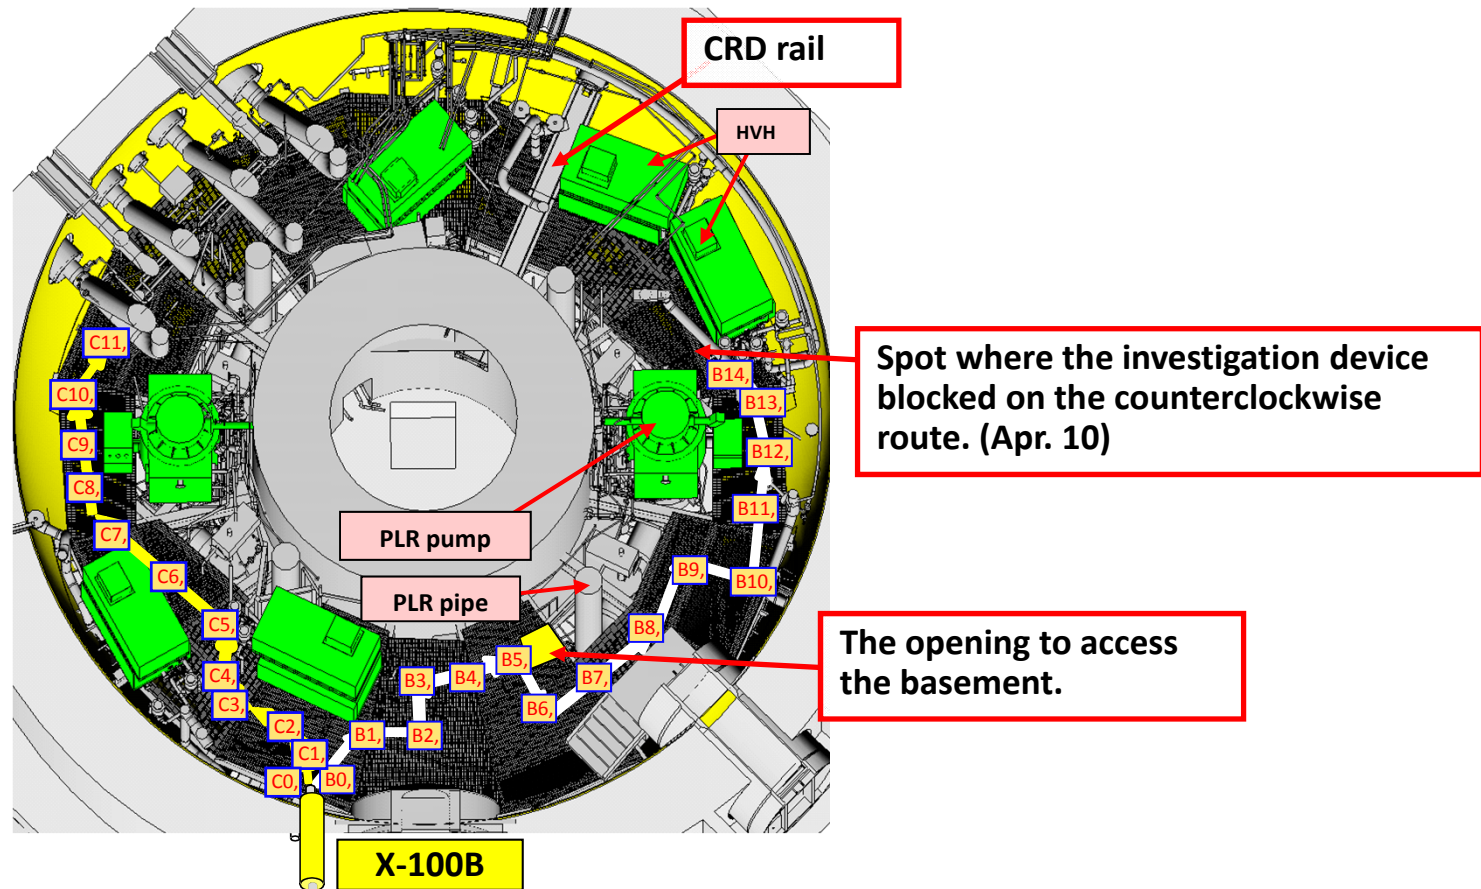
The following items were checked on the counterclockwise route.

- Route of remaining cable,
- Degree of interference of remained cables at the opening to access the basement,
- Status of the investigation device blocked in the vessel, and
- Access route to the CRD rail.
