**Comprehensive Risk Review of all the possible risks
which might have an impact outside the site
boundary of the Fukushima Daiichi Nuclear Power
Station**

～ Result of Comprehensive Risk Review ～

April 28, 2015

Tokyo Electric Power Company

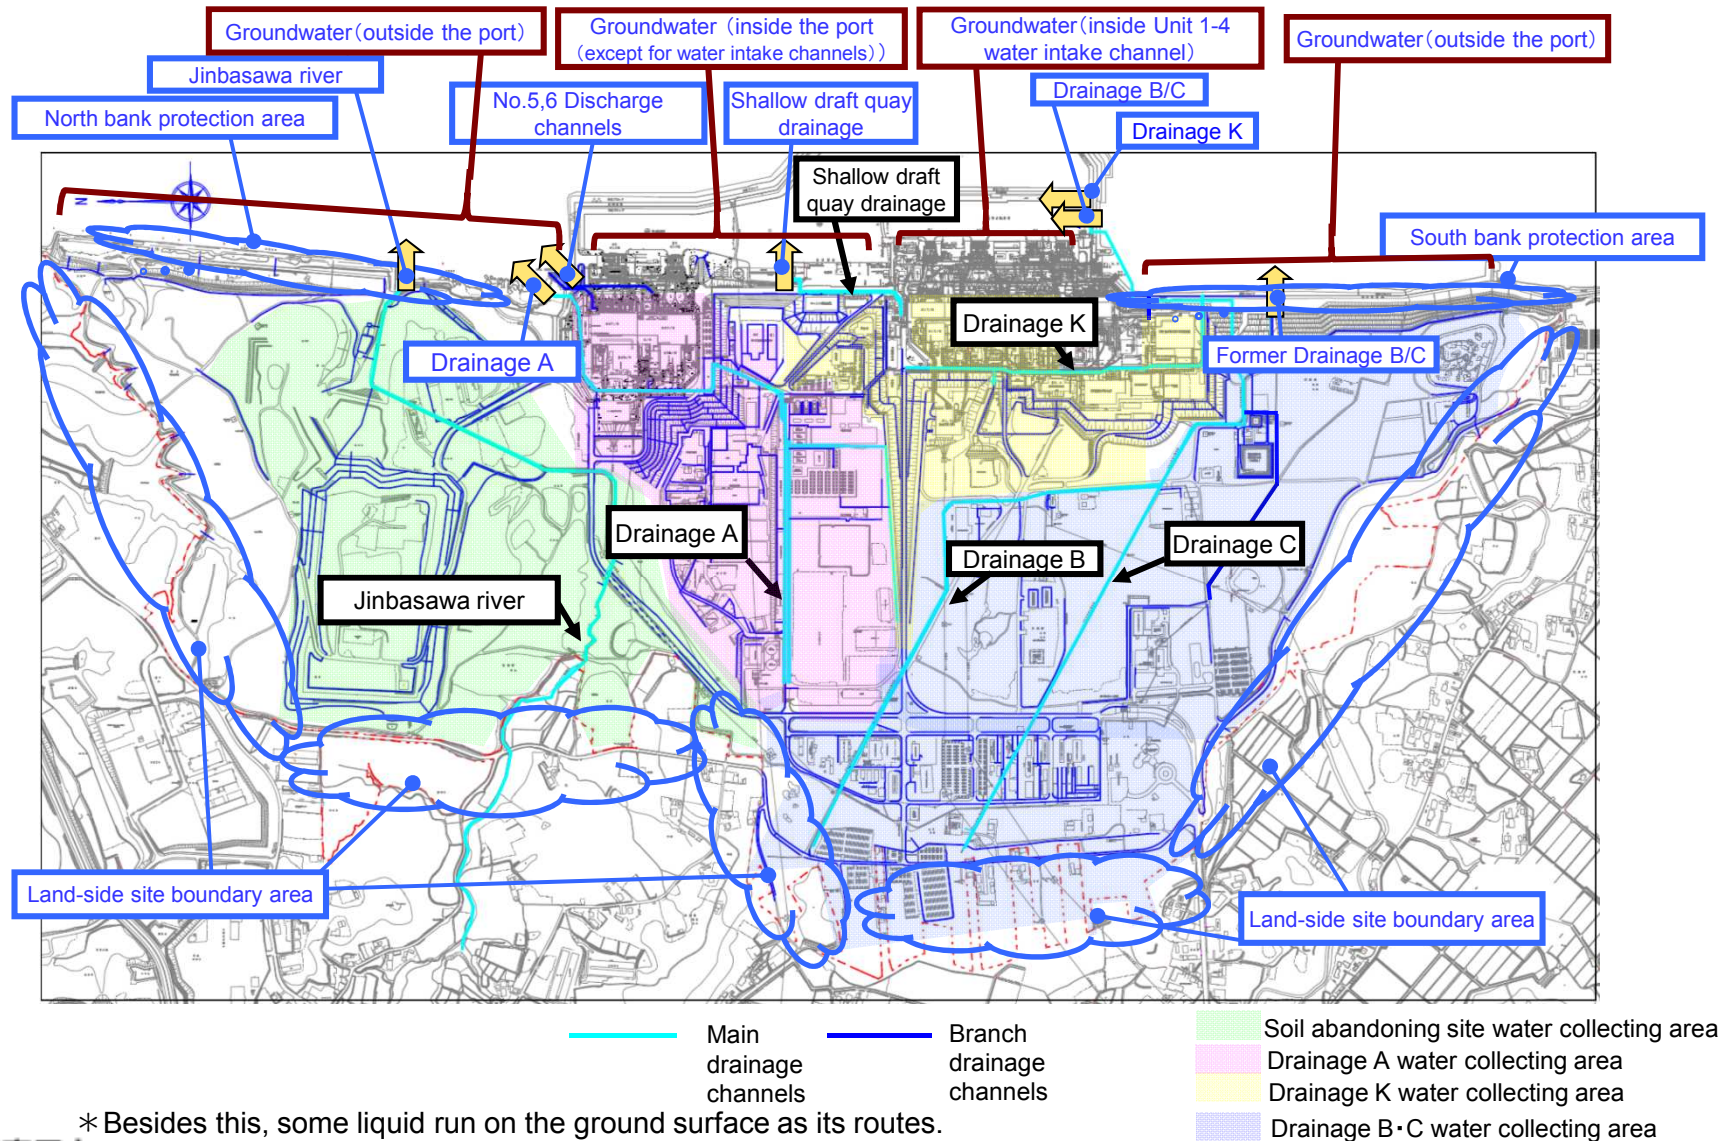
■ For the leakage paths, drains around the site were also examined based on field verification.

* Besides this, some liquid run on the ground surface as its routes.

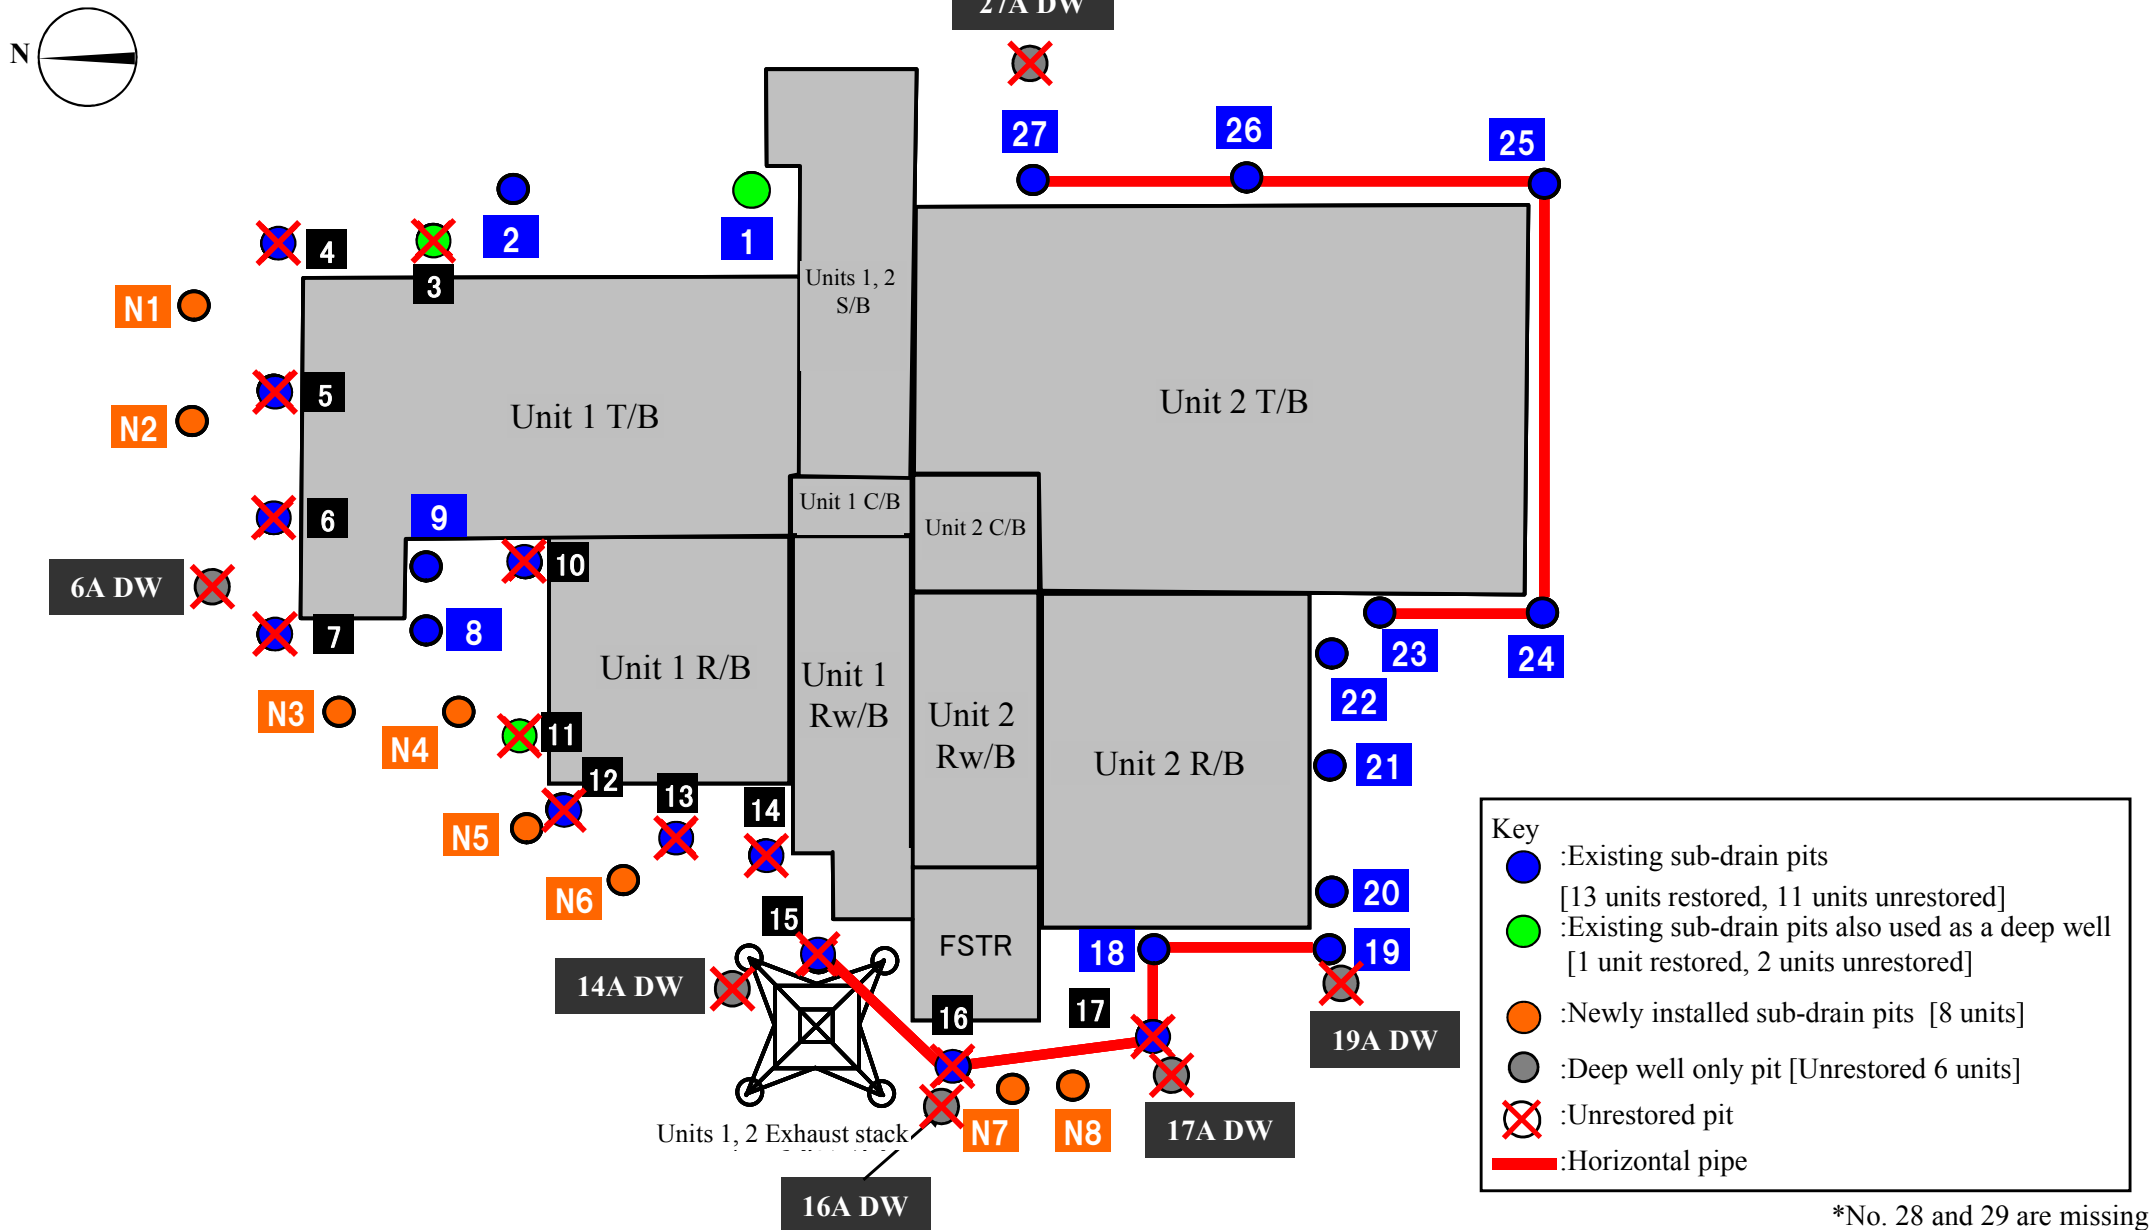
Positioning of sub-drain pits / deep wells (around Units 1 and 2)

*No. 28 and 29 are missing

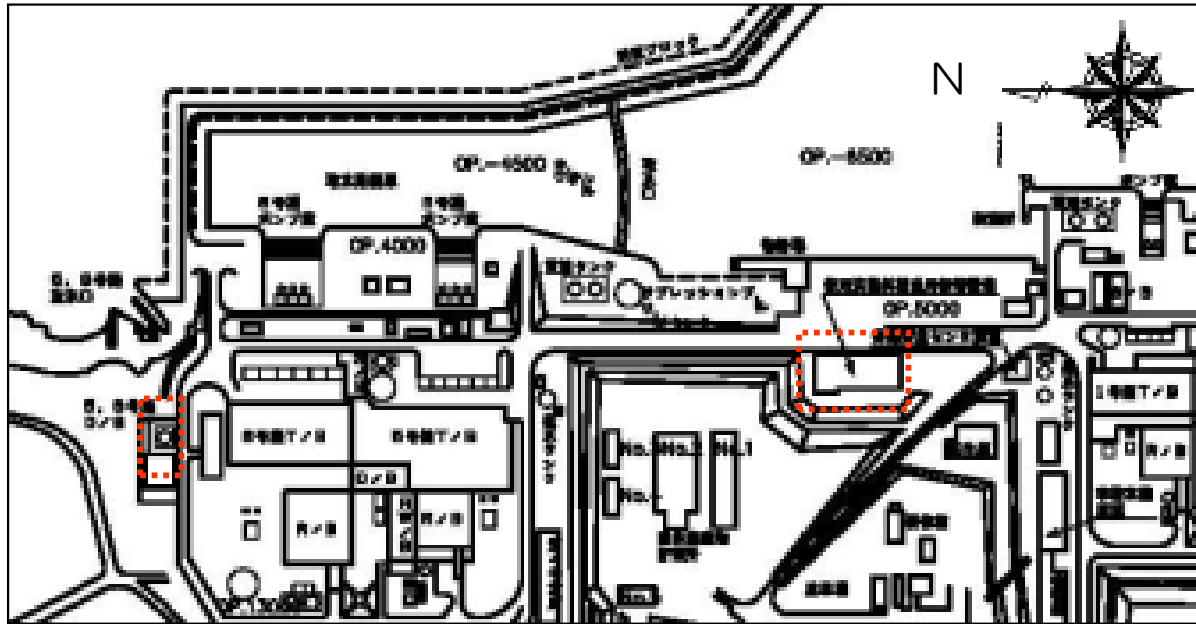
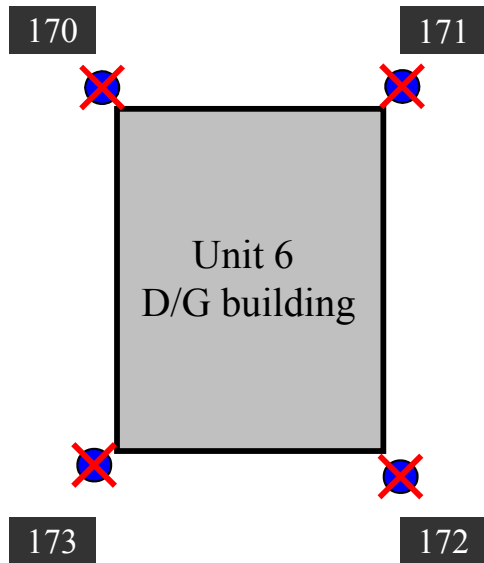
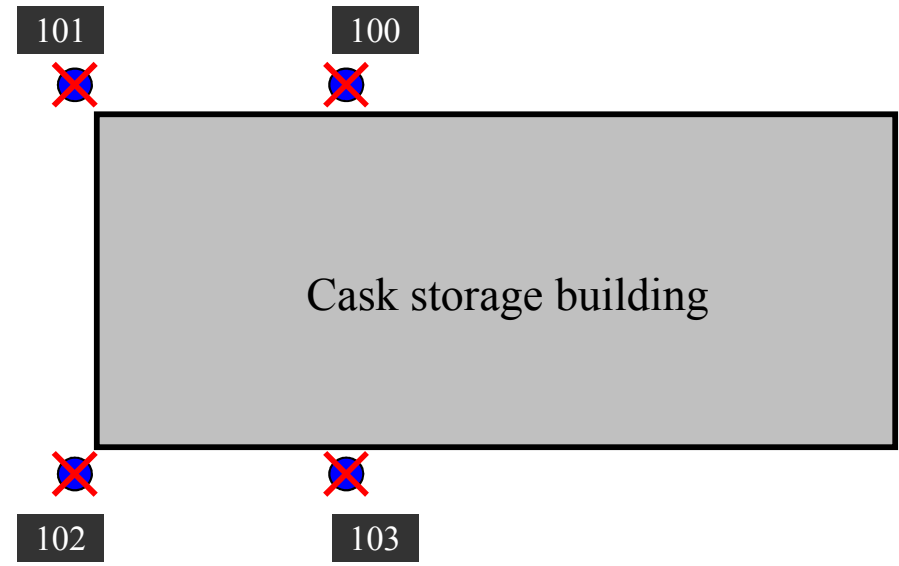
Sub-drain pit positioning diagram (other)

: Existing sub-drain pits [4 units unrestored]

: Existing sub-drain pits [4 units restored]
