# **Investigation Results of the Inside of Unit 3's Primary Containment Vessel (PCV)**

**(Prompt report as of October 20)**

October 20, 2015

Tokyo Electric Power Company

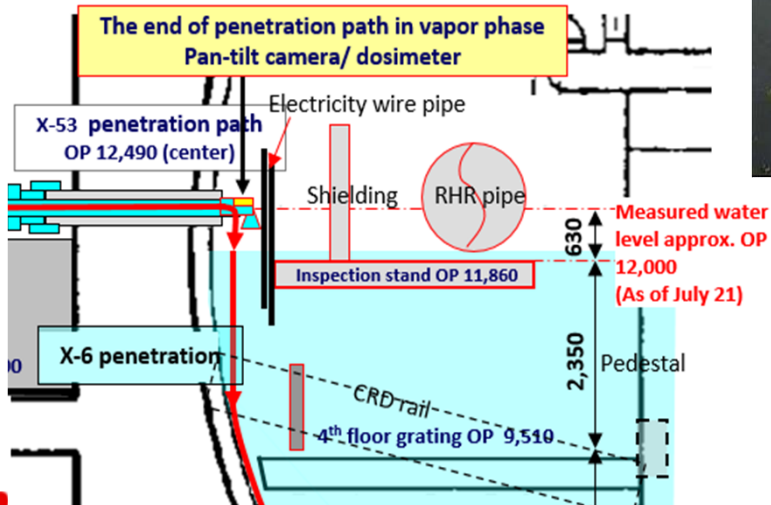
- No damage of the structures inside the PCV (RHR pipe, D/W spray sparger, interior lights) and the PCV's inner wall was found within the investigation range.
- The most radiation dose measured in vapor phase inside the PCV was approximately 1 Sv/h.

RHR pipe

PCV's inner wall

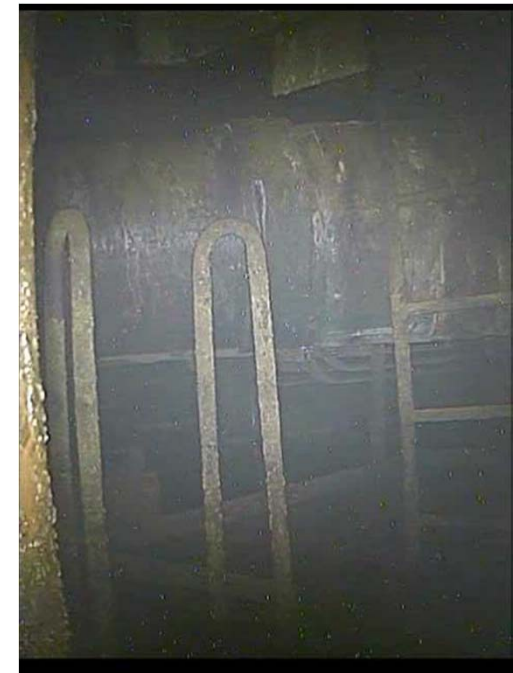
RHR pipe

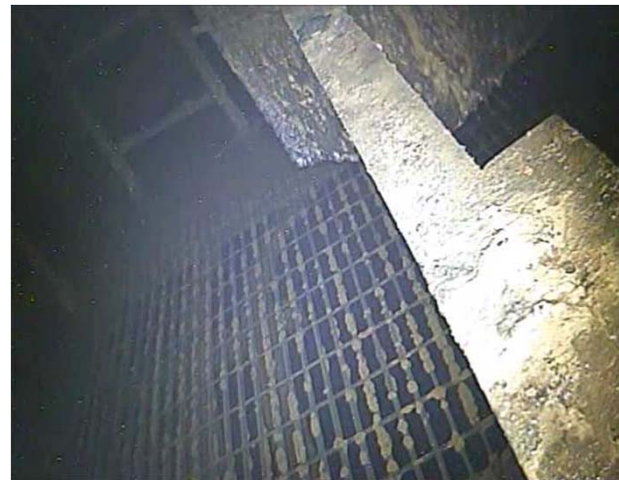
Support of shielding

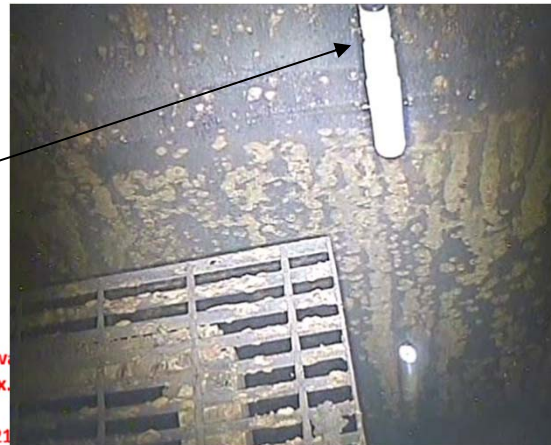
"a" part

- The investigation was conducted from the X-53 penetration path to the 1<sup>st</sup> floor grating because the space between the 1<sup>st</sup> floor grating and the PCV's inner wall was narrow and filled with sediments.
- No damage on the PCV's inner wall was found within the investigation range.
