Unit 2 Primary Containment Vessel Investigation
at Fukushima Daiichi Nuclear Power Station
(By the self-propelled investigation device)

Tokyo Electric Power Company Holdings, Inc.

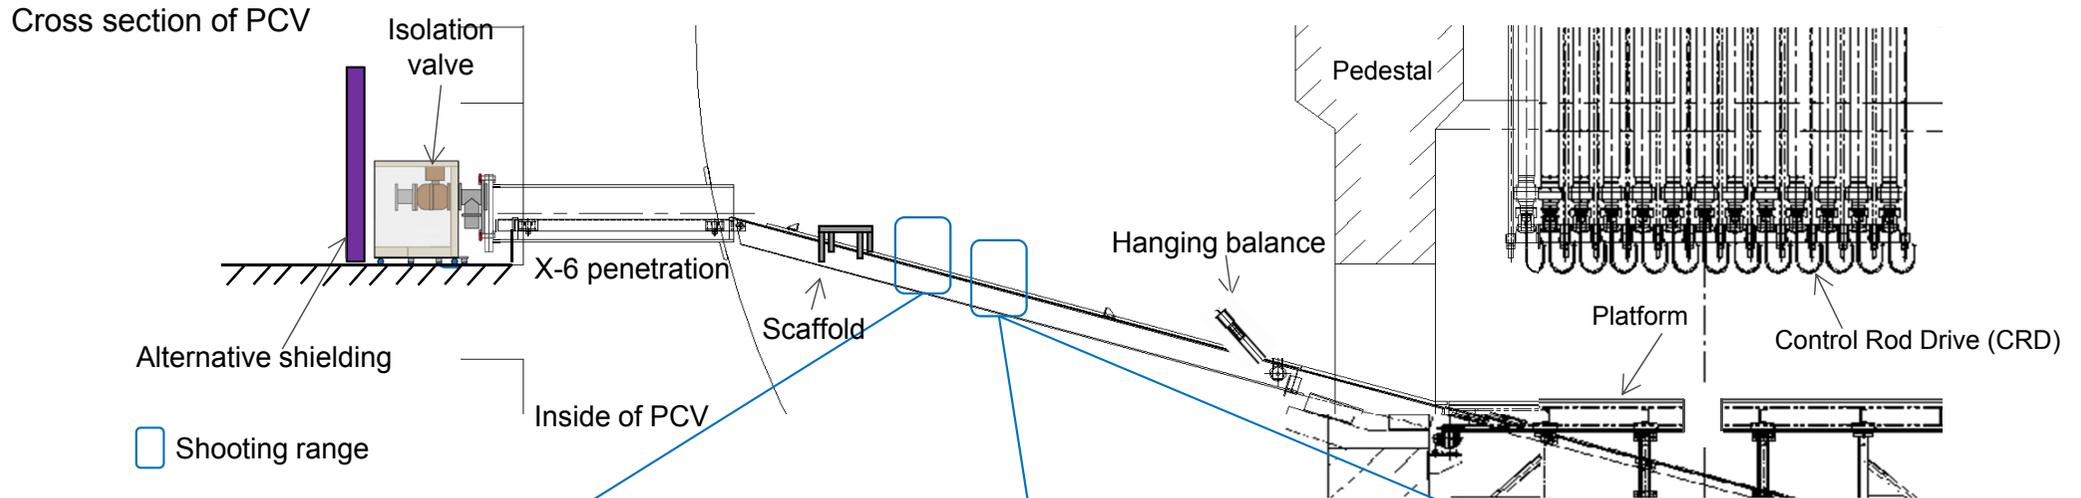
Images from guiding pipe camera

- The deposits on the CRD rail was the mixture of black paste and thin pieces of or gravel-sized materials.
- The deposits on the upper part of the CRD rail was soft but it adhered more to the lower part of the rail.
- The deposit removal device could get on the deposits but could not run on them for some parts.

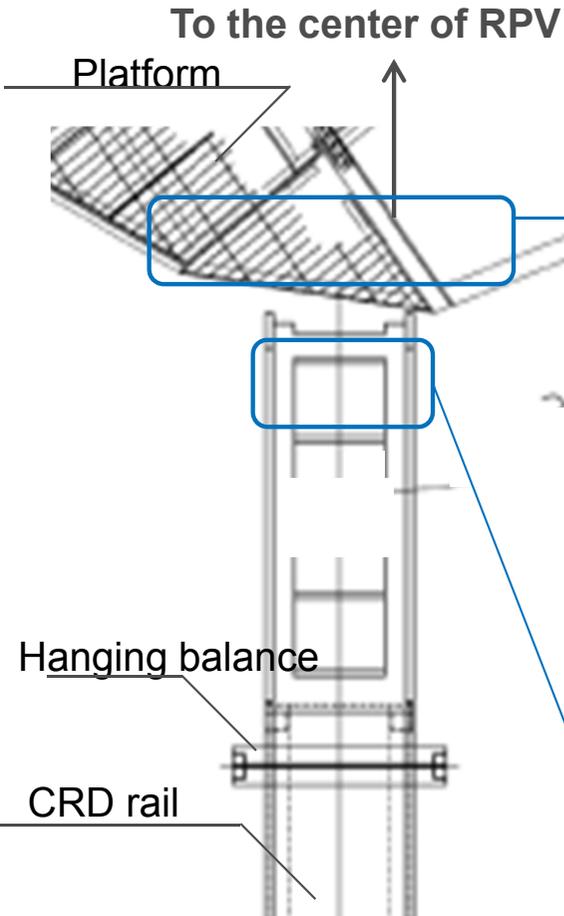
Plan view of PCV

- There was a gap (about 150 to 40mm) between the CRD rail and platform as expected.
- There were some deposits on the platform.

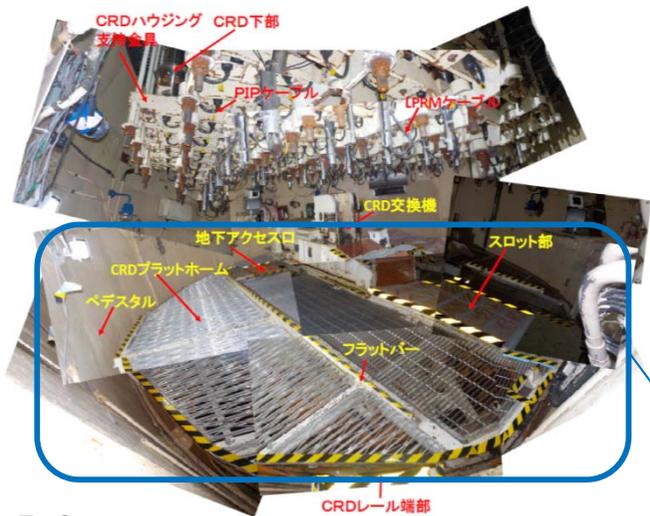
Reference:
Inside the Unit 5 pedestal
