# 1. Progress of Unit 1 PCV internal investigation

(Preliminary report of March 19 investigation) 1/2

Reference  
March 21, 2017

Tokyo Electric Power Company Holdings, Inc.

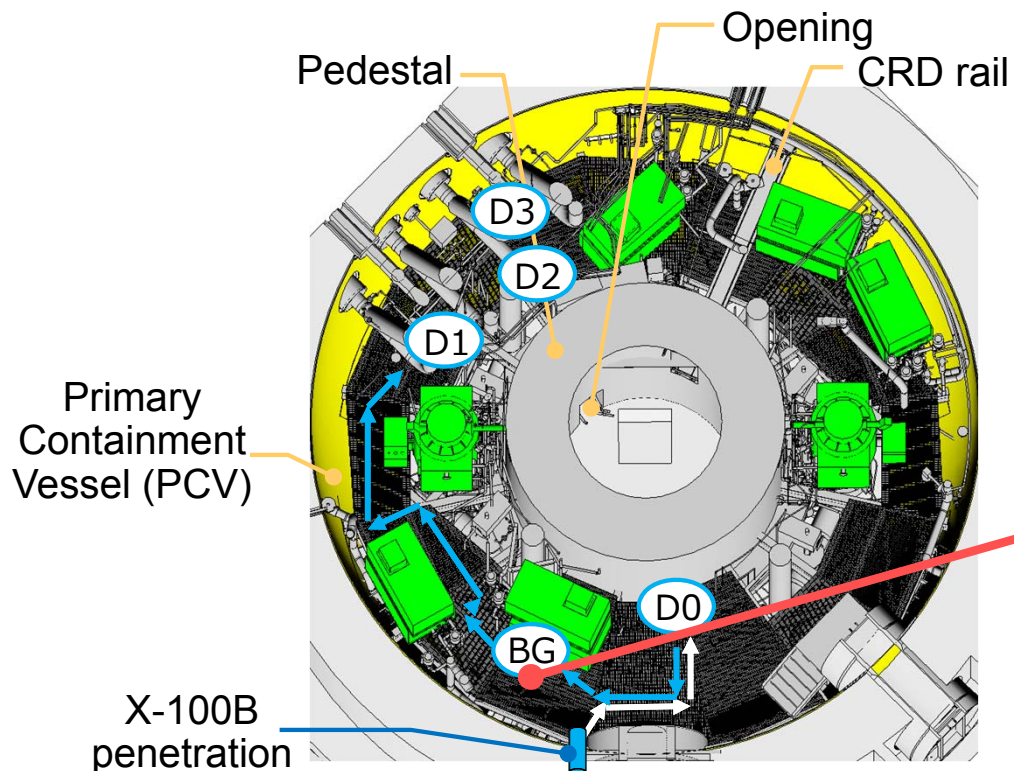
Cross section of 1<sup>st</sup> floor PCV

→ Access route for March 19 investigation

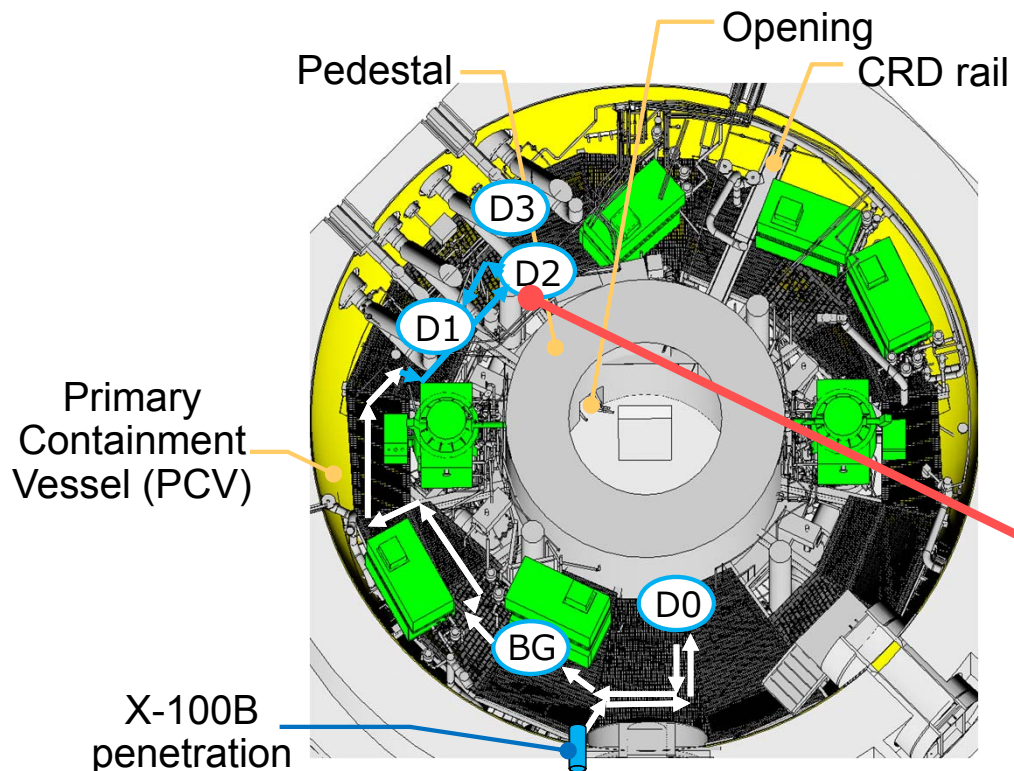
Cross section of 1<sup>st</sup> floor PCV

→ Access route for March 20 investigation

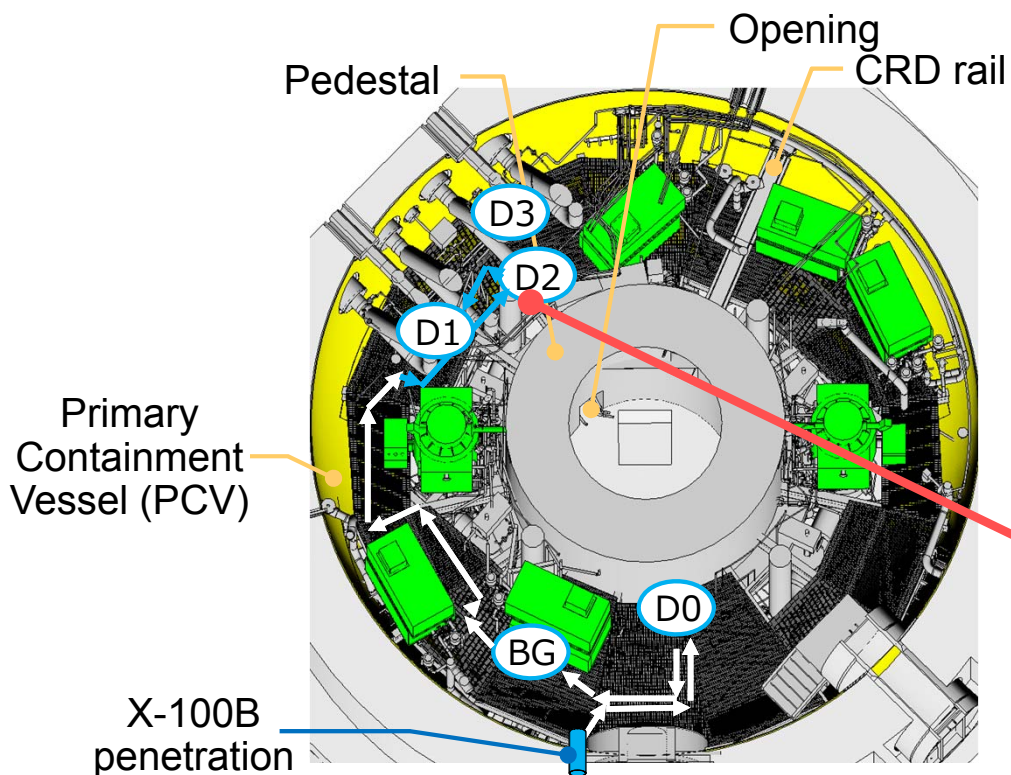
Cross section of 1<sup>st</sup> floor PCV

➡ Access route for March 20 investigation

Radiation dose at measurement point BG

(Provisional values)  
 • On metal grating: 12 Sv/h  
 • The lowest point: 6.3 Sv/h (About 1m above the PCV basement floor\*)

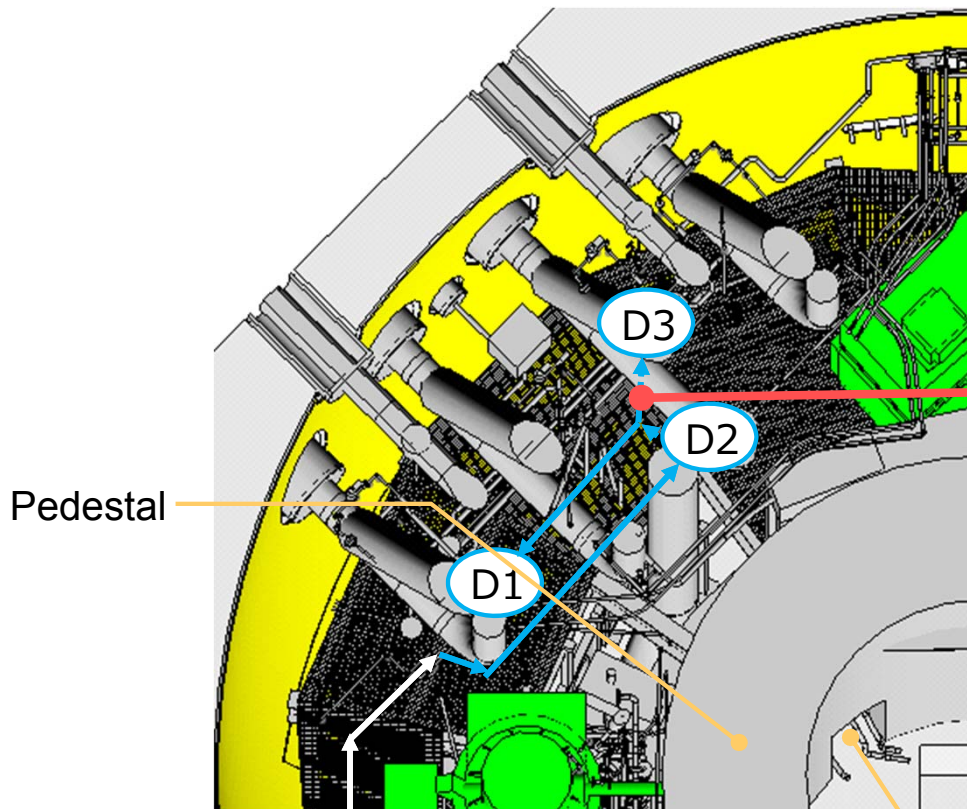
Cross section of 1<sup>st</sup> floor PCV

- The investigation device moved to the measurement point D1 because the access route between the measurement points D2 and D3 was narrow and there was a risk that the device cannot go through.
- The measurement point D3 will be prioritized on March 21 because it is close to the pedestal opening. The device will move to the measurement points D3 and then D1 to investigate those places.

→ Access route for March 20 investigation

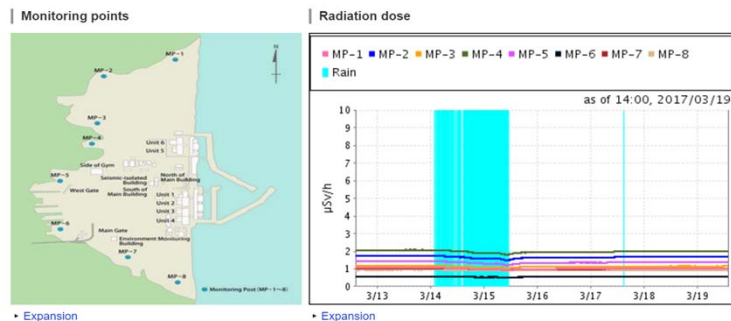
##### Monitoring post (MP1 - MP8)

○Measurement value (2017/03/19 14:00)

MP-1	MP-2	MP-3	MP-4	MP-5	MP-6	MP-7	MP-8	Wind Direction	Wind Velocity	Rain
1.037	1.703	1.155	2.006	1.390	0.549	1.005	0.935	east-southeast	3.3	No

As of 11:30 a.m. on March 21, 2017: about 0.5-2.0 μSv/h

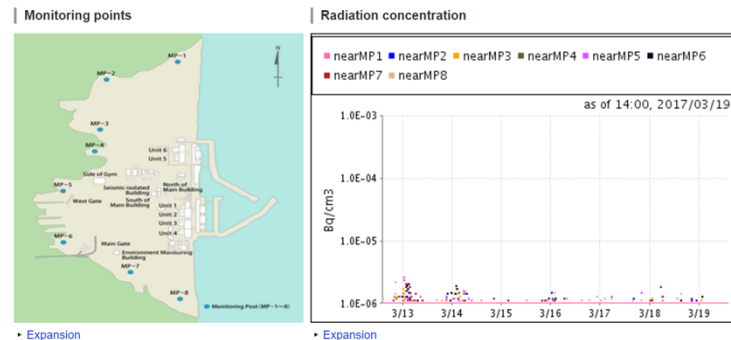
#### Radioactive Concentration measured at Dust Monitors near the Site Boundary of Fukushima Daiichi Nuclear Power Station

○Measurement value (2017/03/19 14:00)

nearMP1	nearMP2	nearMP3	nearMP4	nearMP5	nearMP6	nearMP7	nearMP8	Wind Direction	Wind Velocity
1.0E-06	1.0E-06	1.0E-06	1.0E-06	1.0E-06	1.0E-06	1.0E-06	1.0E-06	east	1.9

As of 11:50 a.m. on March 21, 2017: 1.0E-06Bq/cm<sup>3</sup>

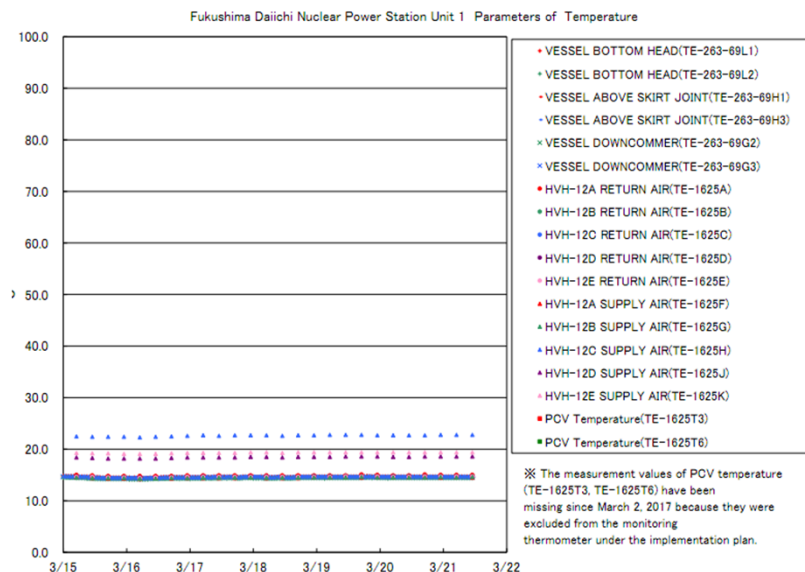
Fukushima Daiichi Nuclear Power Station Plant Parameters  
As of 11:00 on March 21 2017

Unit 1	Unit 2	Unit 3	Unit 4
Status of water injection to the reactor	FDW line 1.5t/h CS line 1.8t/h (as of 11:00, 3/21)	FDW line 1.5t/h CS line 1.8t/h (as of 11:00, 3/21)	FDW line 1.5t/h CS line 1.4t/h (as of 11:00, 3/21)	
Temperature at the bottom of RPV	VESSEL BOTTOM HEAD (TE-263-69L1) : 14.7°C VESSEL ABOVE SKIRT JOINT (TE-263-69H1) : 14.6°C VESSEL DOWNCOMMER (TE-263-69G2) : 14.5°C (as of 11:00, 3/21)	VESSEL WALL ABOVE BOTTOM HEAD (TE-263-69H1) : 18.1°C RPV TEMPERATURE (TE-263-69H1) : 18.0°C (as of 11:00, 3/21)	VESSEL BOTTOM ABOVE SKIRT JOINT (TE-263-69H1) : 18.4°C VESSEL WALL ABOVE BOTTOM HEAD (TE-263-69H1) : 17.0°C (as of 11:00, 3/21)	
Temperature in PCV	HVH-12A RETURN AIR (TE-1625A) : 15.0°C HVH-12A SUPPLY AIR (TE-1625F) : 14.8°C (as of 11:00, 3/21)	RETURN AIR DRYWELL COOLER (TE-16+114B) : 19.8°C SUPPLY AIR D/W COOLER HVH-2+16B (TE-16+114E1) : 19.8°C (as of 11:00, 3/21)	RETURN AIR DRYWELL COOLER (TE-16+114A) : 19.2°C SUPPLY AIR D/W COOLER (TE-16+114E1) : 19.6°C (as of 11:00, 3/21)
