# 1. Progress of Unit 1 PCV internal investigation

(Preliminary report of March 21 investigation) 1/4

Reference  
March 22, 2017

Tokyo Electric Power Company Holdings, Inc.

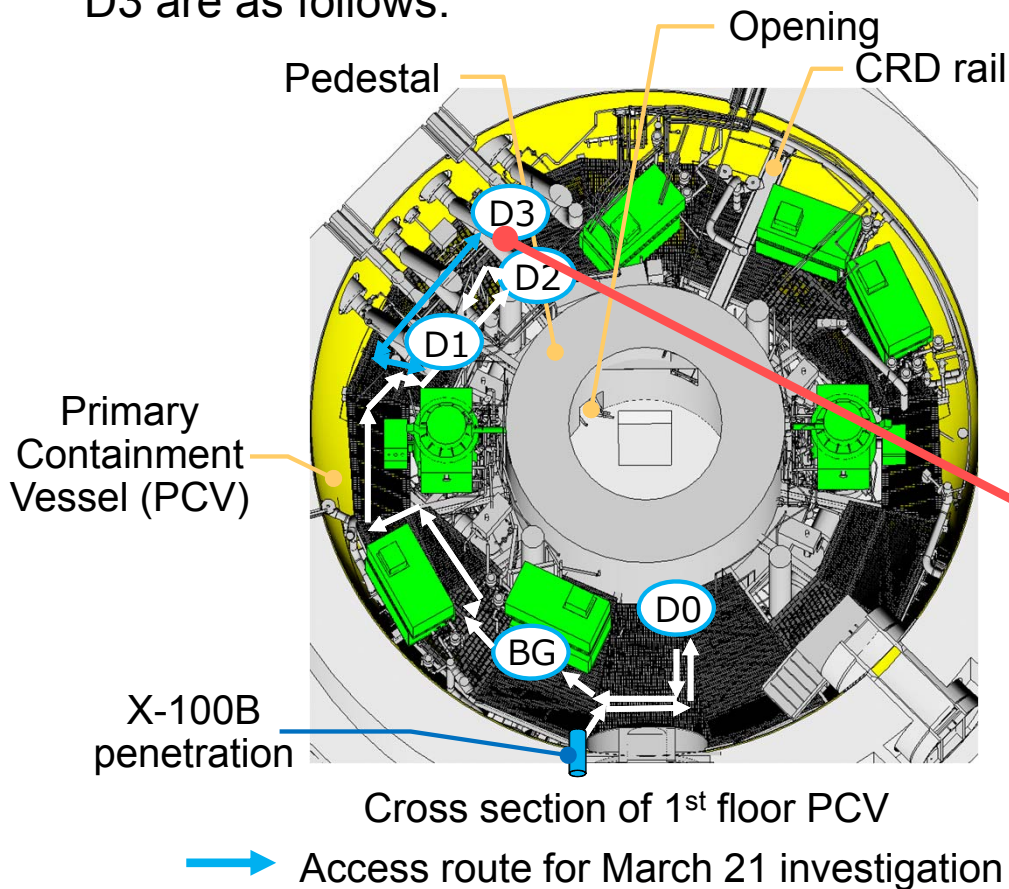
- Investigation results of the measurement point D3 are as follows.

Radiation dose at the measurement point D3 (Provisional values)

- On metal grating: 10 Sv/h
- The lowest point: 3.0 Sv/h (About 1.6m above the PCV basement floor\*)

The conditions of PCV basement will be evaluated after organizing digital images and radiation data.

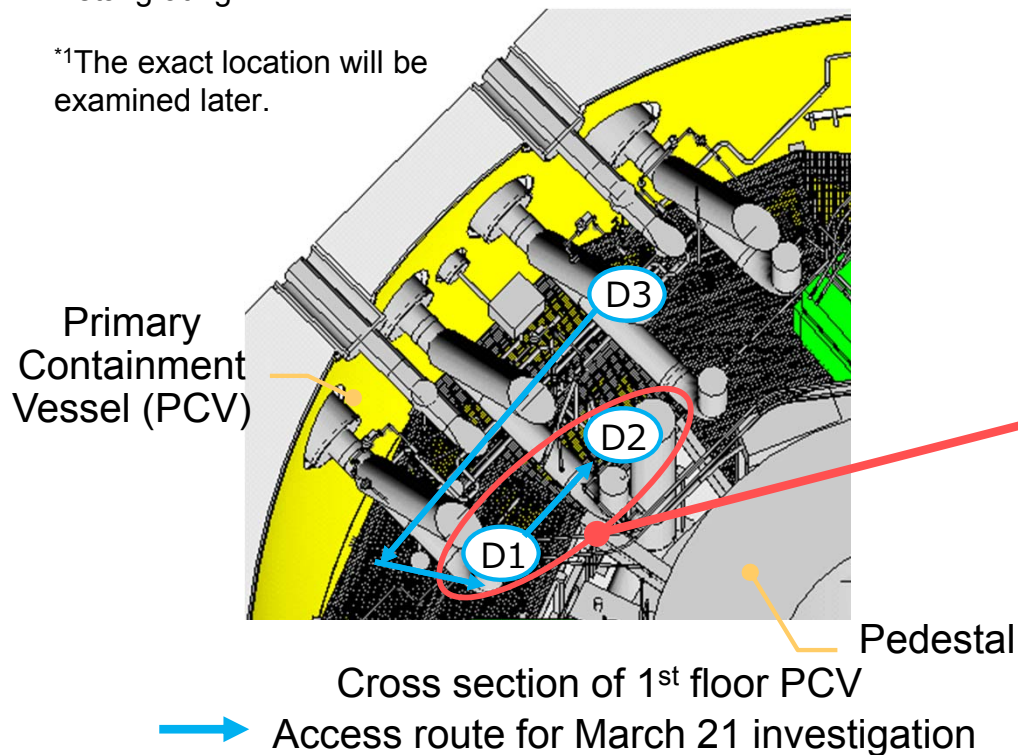
- Investigation results between the measurement points D1 and D2 are as follows.

Between the measurement points D1 and D2<sup>\*1</sup>, the device investigated the three points where it could drop the measurement unit below the metal grating.

Radiation dose between the measurement points D1 and D2 (Provisional values)

- On metal grating: 8.4 Sv/h
- The lowest point: 6.3 Sv/h (About 0.9m above the PCV basement floor<sup>\*2</sup>)

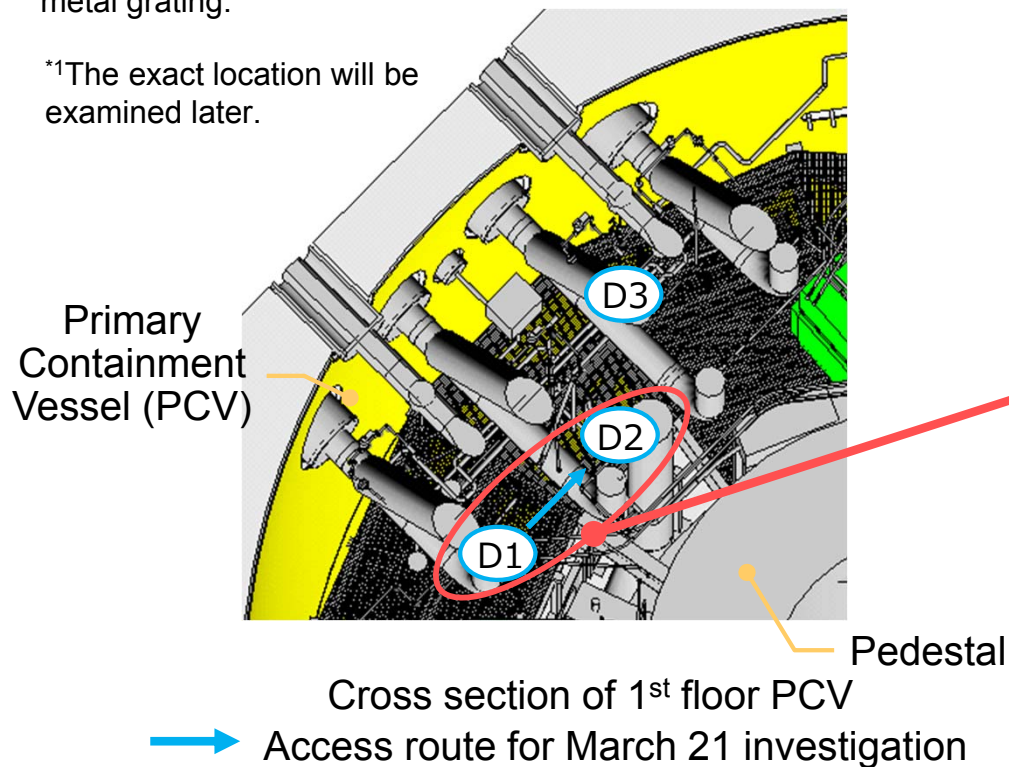
- Investigation results between the measurement points D1 and D2 are as follows.

Between the measurement points D1 and D2<sup>\*1</sup>, the device investigated the three points where it could drop the measurement unit below the metal grating.

Radiation dose between the measurement points D1 and D2 (Provisional values)

- On metal grating: 8.2 Sv/h
- The lowest point: 5.9 Sv/h (About 0.9m above the PCV basement floor<sup>\*2</sup>)

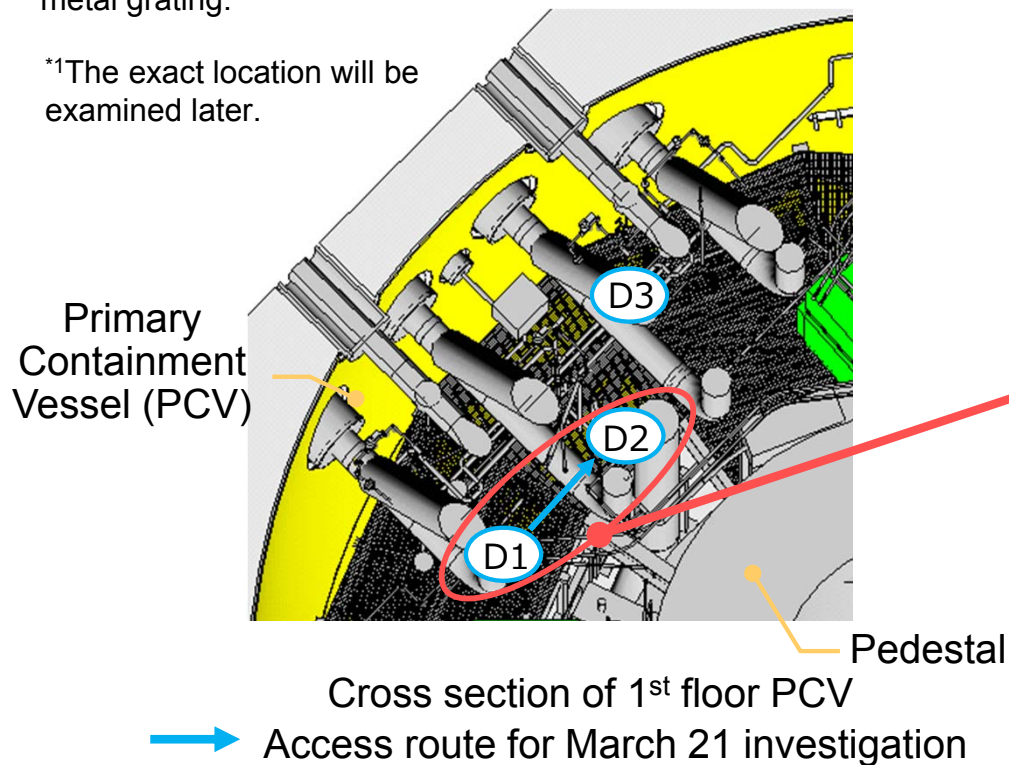
- Investigation results between the measurement points D1 and D2 are as follows.

Between the measurement points D1 and D2<sup>\*1</sup>, the device investigated the three points where it could drop the measurement unit below the metal grating.
