# 1. Progress of Unit 1 PCV internal investigation

(Preliminary report of March 22 investigation) 1/3

Reference  
March 23, 2017

Tokyo Electric Power Company Holdings, Inc.

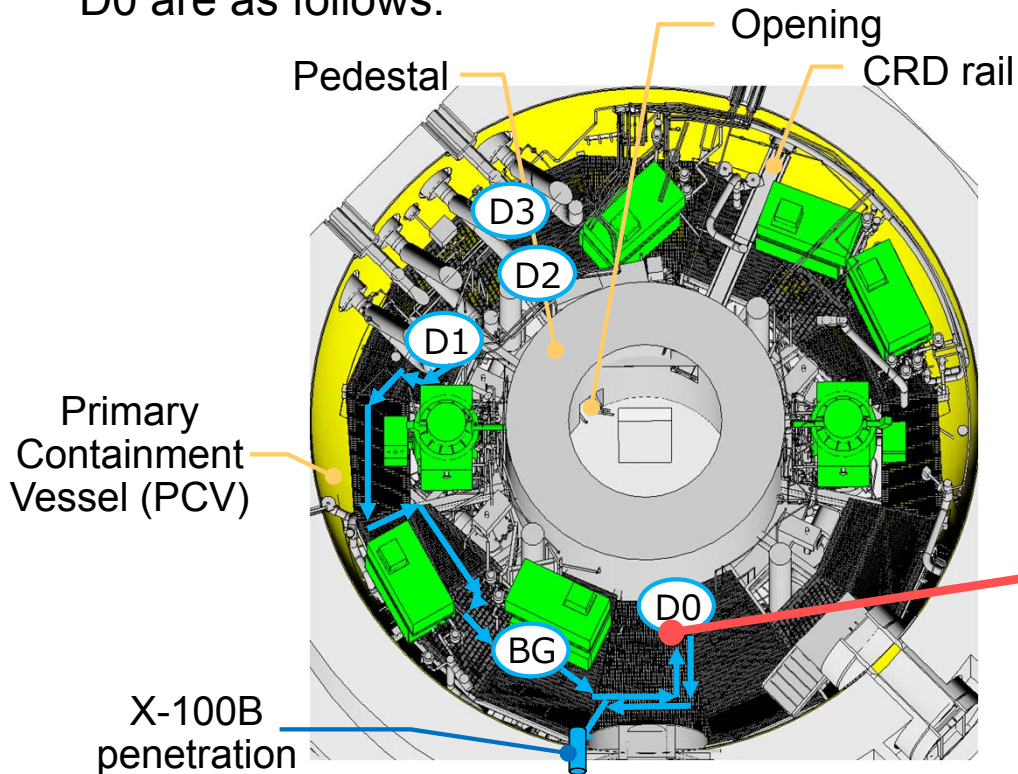
- Investigation results at the measurement point D0 are as follows.

Radiation dose at the measurement point D0 (Provisional values)

- On metal grating: 6.7 Sv/h
- The lowest point: 1.6 Sv/h (About 0.6m above the PCV basement floor\*)

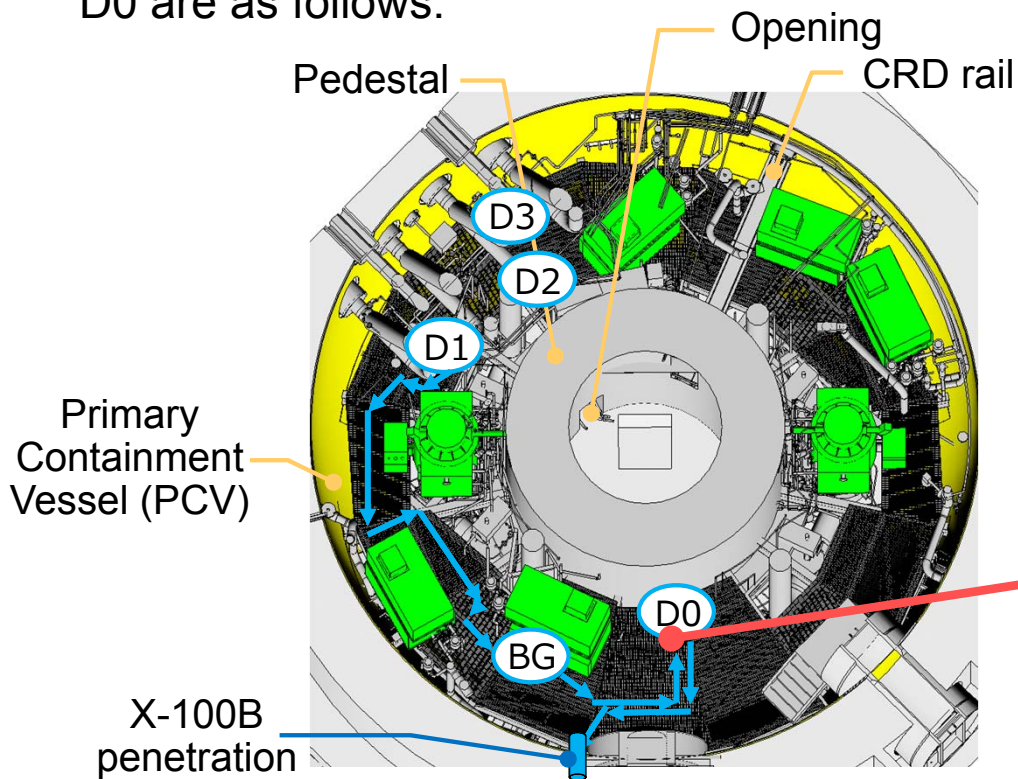
- Investigation results at the measurement point D0 are as follows.

Radiation dose at the measurement point D0 (Provisional values)

- On metal grating: 3.6 Sv/h
- The lowest point: 5.4 Sv/h (About 0.3m above the PCV basement floor\*)

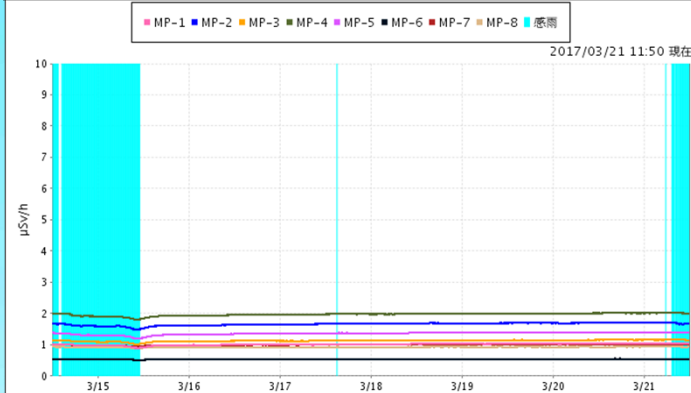
Monitoring posts

There are no changes in measurement values at the monitoring posts before and after the investigation.

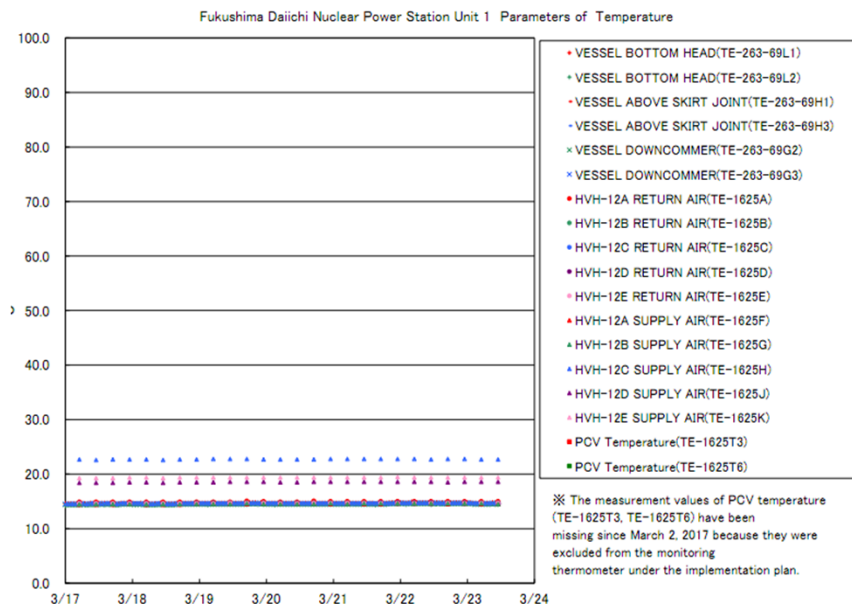
Fukushima Daiichi Nuclear Power Station Plant Parameters  
As of 11:00 on March 23 2017

- Plant parameters are monitored all the time during the investigation, and **no significant changes have been observed in the PCV internal temperatures after the investigation, compared to the before. The condition of cold shutdown has not been changed.**
