Unit 1 Primary Containment Vessel Internal Investigation

1. Overview of the Primary Containment Vessel (PCV) internal investigation

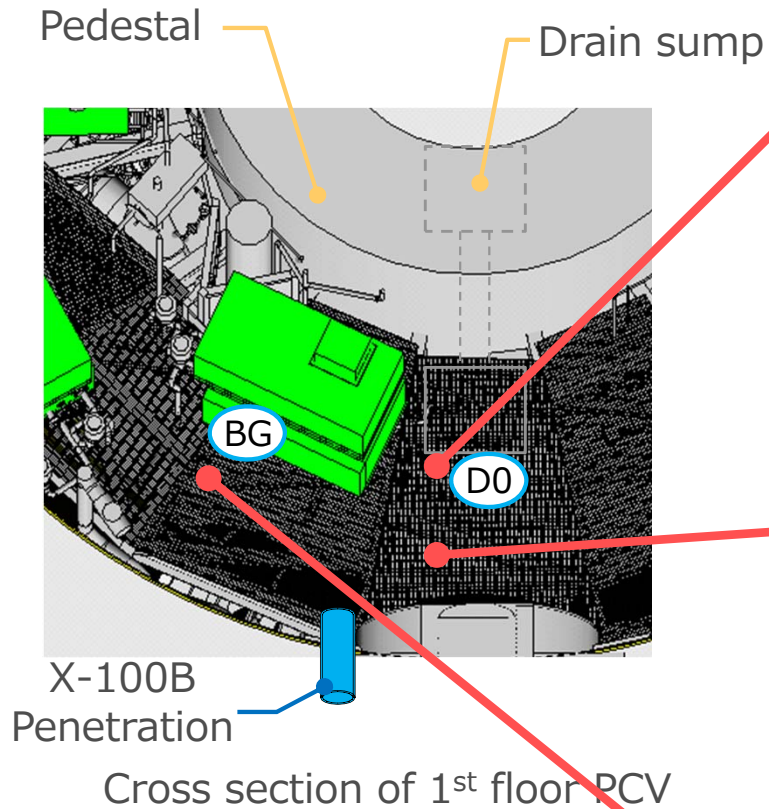
3/18 D0① Image near the lowest point

■ Typical shot images are as follows.

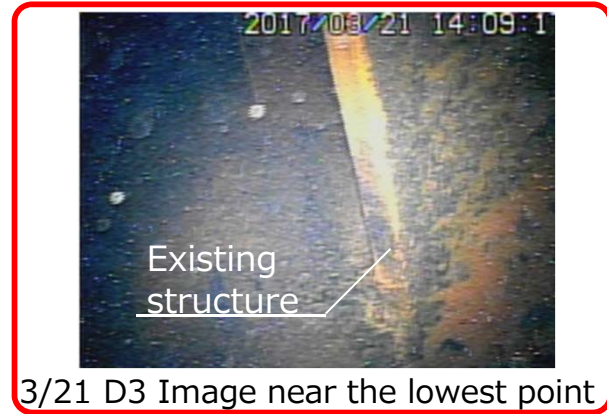
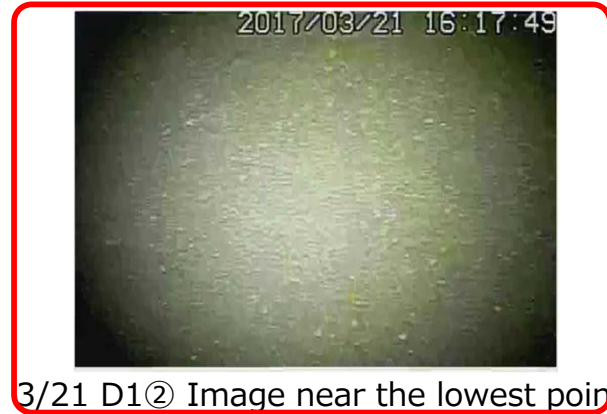
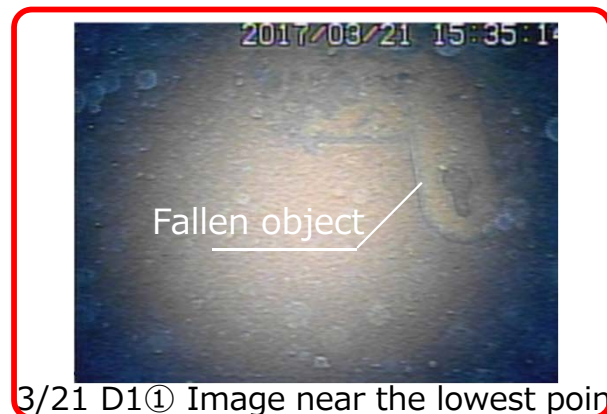
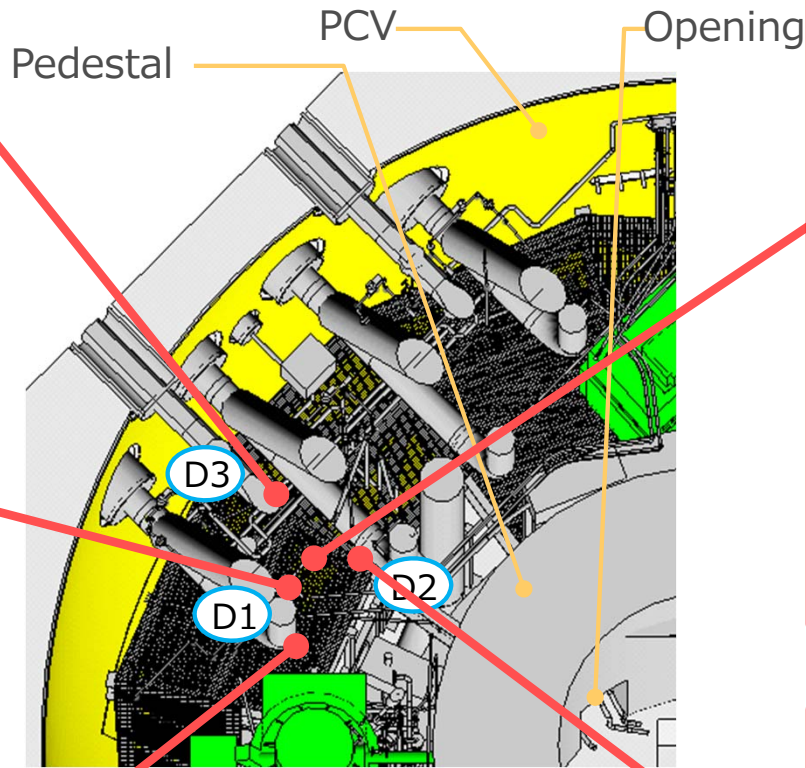
Cross section of 1st floor PCV

Typical shot images are as follows.

• Details of measurement point is now evaluated.

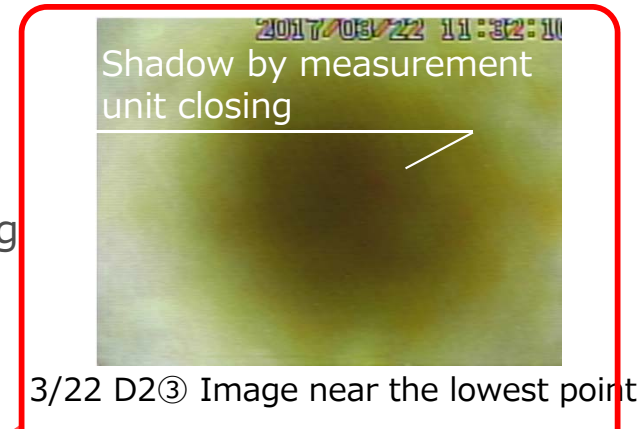
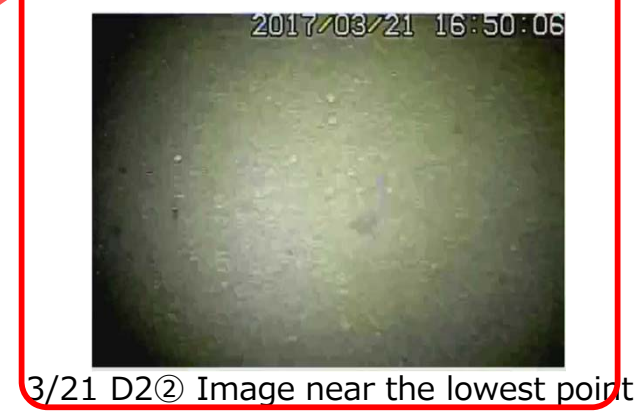
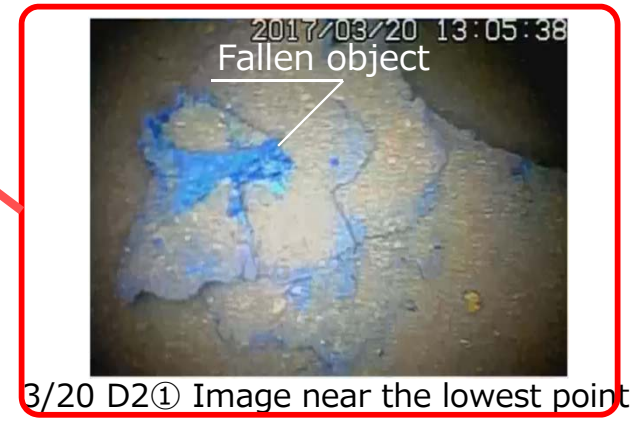
- Deposits were found at the bottom of the PCV and on piping. (The nature of the deposits will be analyzed by examining the images and taking samples of the deposits.)

- Images were taken near the D2 area deposits, and the deposit material was not churned up in the process so it is assumed that the deposit material has a certain amount of mass.

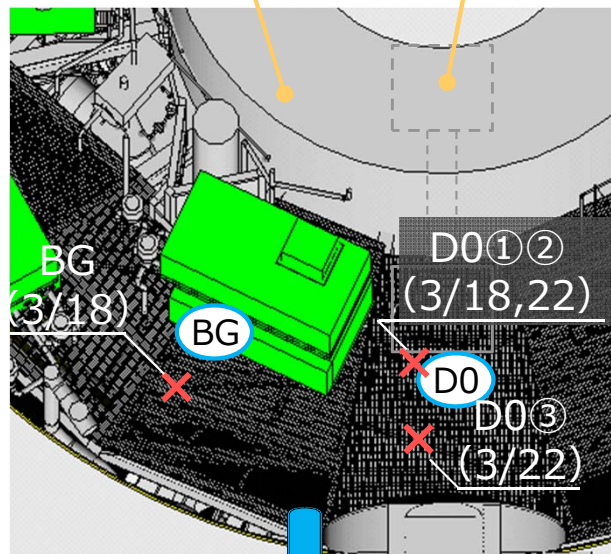
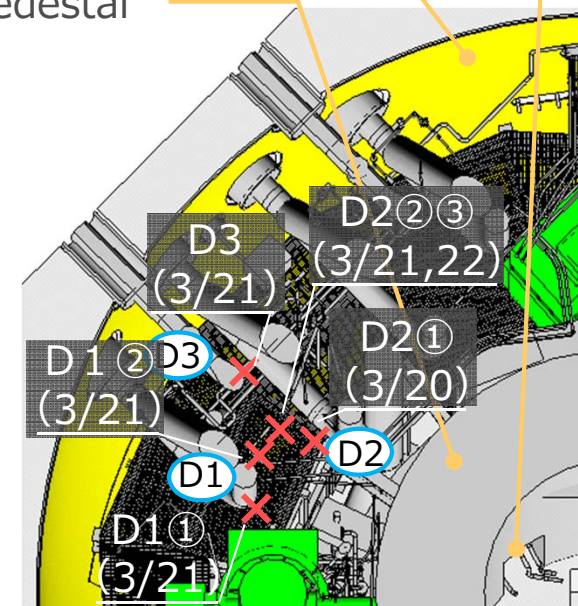
Pedestal Drain sump

Measurement Point (Measurement date)	BG (3/19)	D0			D1		D2			D3 (3/21)
		① (3/18)	② (3/22)	③ (3/22)	① (3/21)	② (3/21)	① (3/20)	② (3/21)	③ (3/22)	
Dose levels above the grating [Sv/h]	3.8	7.8	6.7	3.6	8.4	8.2	12	9.2	9.3	10
Dose levels at lowermost point [Sv/h] (Height from the floor)	11 (Approx. 0.3m)	1.5 (Approx. 1m)	1.6 (Approx. 0.6m)	5.4 (Approx. 0.3m)	6.3 (Approx. 0.9m)	5.9 (Approx. 0.9m)	6.3 (Approx. 1m)	7.4 (Approx. 0.9m)	9.4 (Approx. 0.9m)	3.0 (Approx. 1.6m)

- Dose levels decrease upon submerging into the water, but then rise again as the floor is approached.
- The height from the PCV floor at which dose levels begin to rise differs depending on the measurement point.(There are many possible causes for this. The deposits could be radiation sources, radiation sources under the deposits that have adhered to the underlying structures may be having an impact, or there may be melted fuel near the PCV floor, etc.)

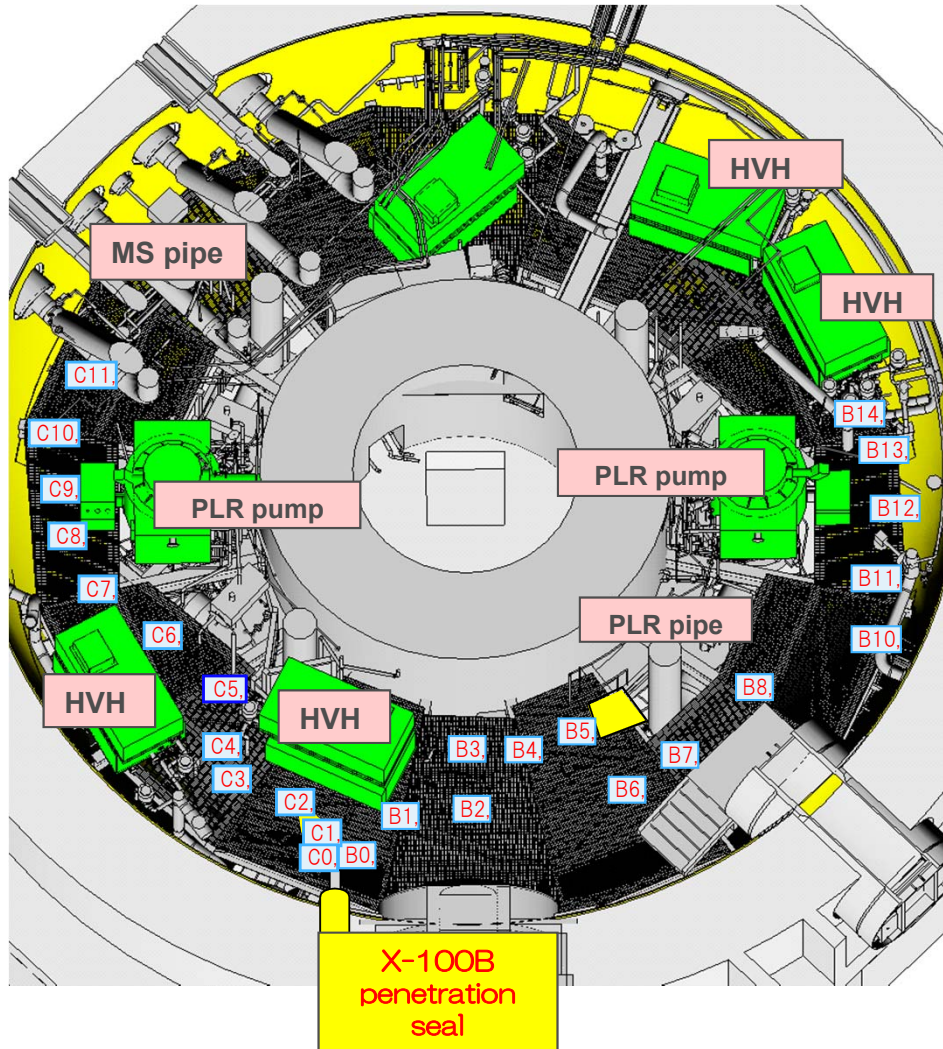
- There has been little change in dose levels above the grating compared to the last time the area was surveyed (April 2015) and no significant damage was found to existing structures.

Dose rate (Sv/h)
B3	7.4
B4	7.5
B5	8.7
B7	7.4
B11	9.7
B14	7.0
C2	6.7
C5	8.3
C6	7.7
C9	4.7
C10	5.3
C11	6.2

B3~B14 (Measurement date: April 10, 2015)

C2~C6 (Measurement date: April 15, 2015)

C9~C11 (Measurement date: April 16, 2015)

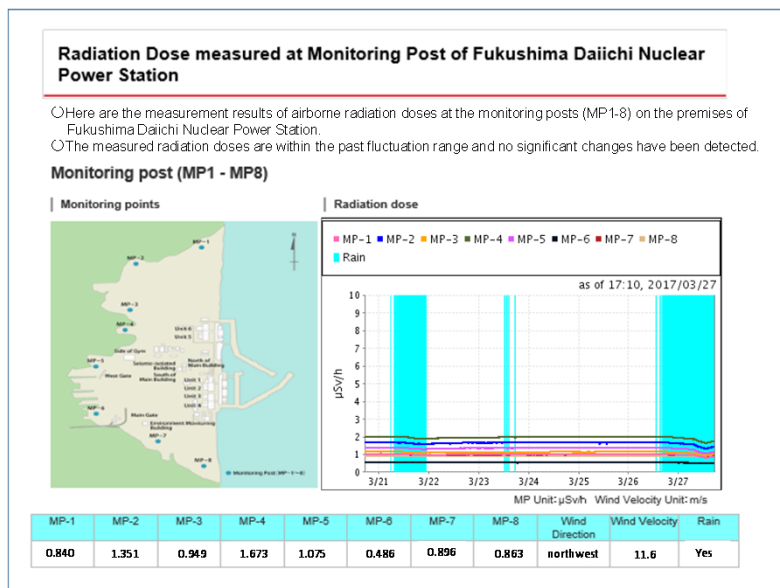
As of 0:30 p.m. on March 27, 2017: about 0.5-1.7 $\mu\text{Sv/h}$

*Radiation dose including the other influence than the PCV interior

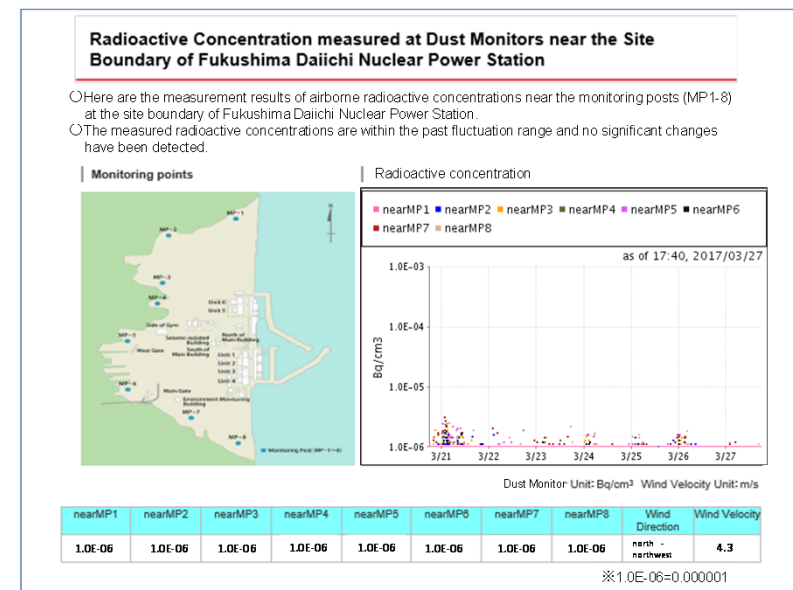
As of 0:30 a.m. on March 27, 2017: 1.0E-06Bq/cm³

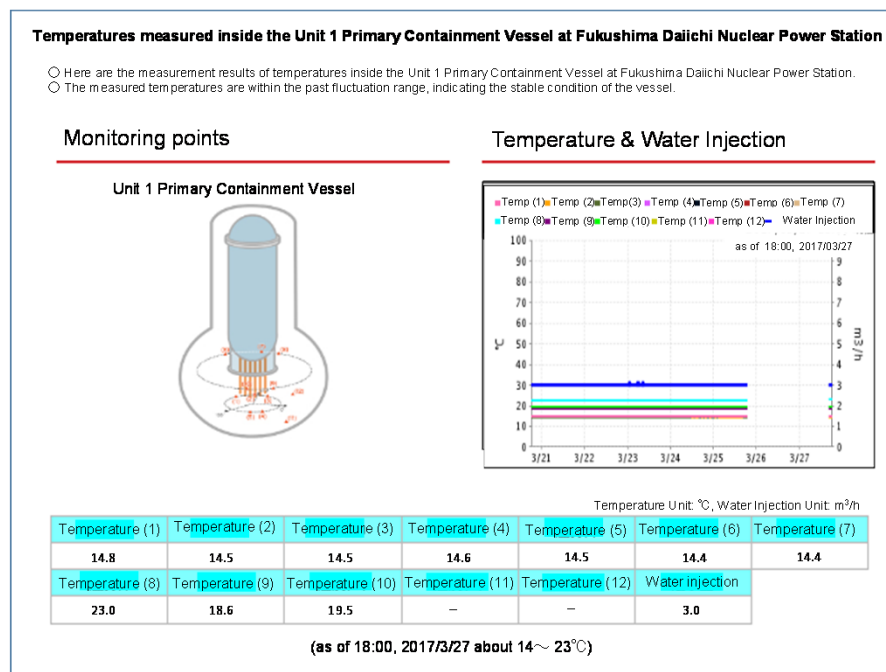
As of 6:00 p.m. on March 27, 2017: about 14-23 °C

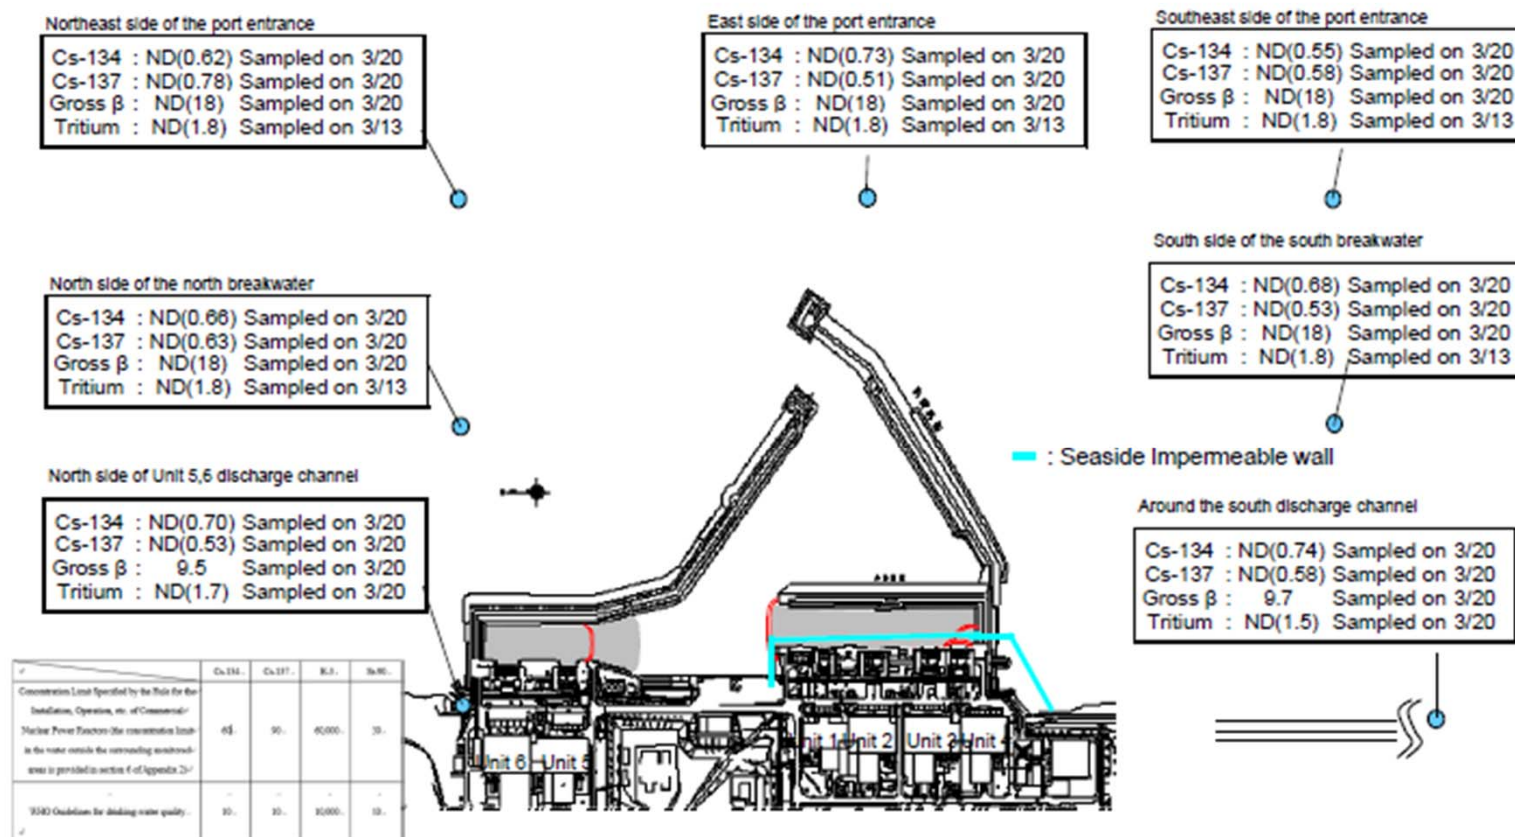
- Analysis results of radioactive materials in seawater are monitored, and **no significant changes have been observed after the investigation, compared to the before.**
- Analysis results of radioactive materials in seawater around the Fukushima Daiichi Nuclear Power Station are available on the website.
