1. Progress of Unit 3 PCV internal investigation (Preliminary report of July 21 investigation) (1/3)

July 21, 2017

Tokyo Electric Power Company
Holdings, Inc

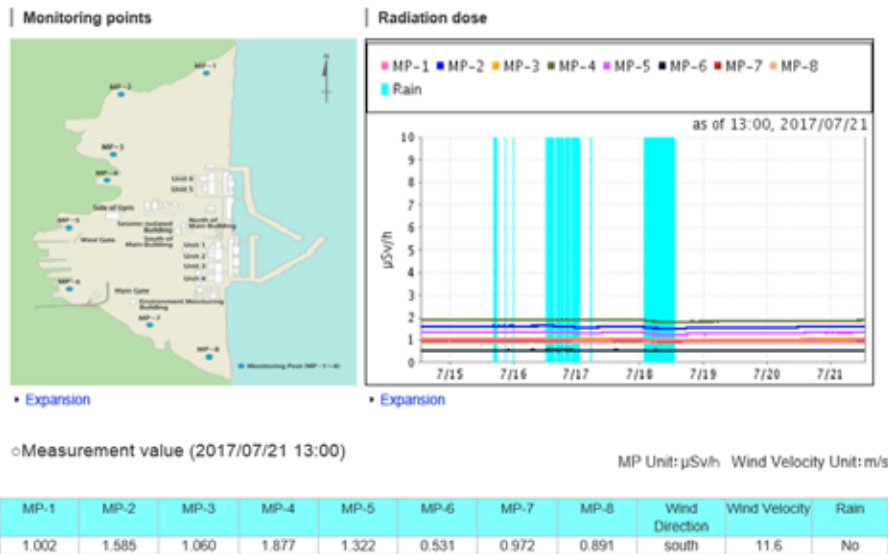
Monitoring post (MP1 - MP8)

(As of 1:00 p.m. on July 21, 2017 : approx. 0.5-1.9 μSv/h)

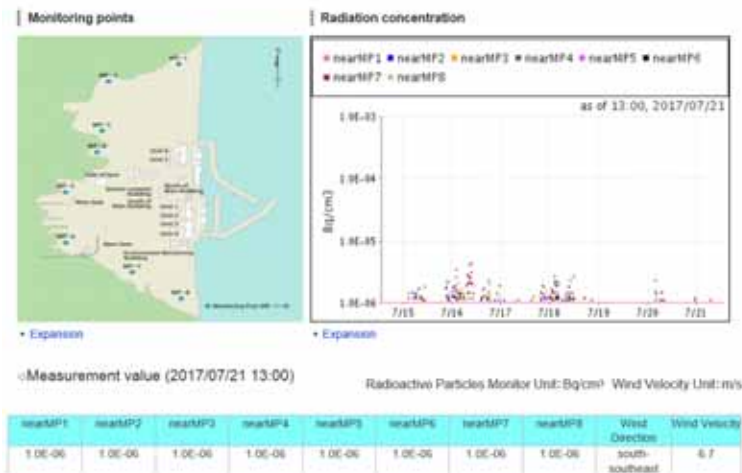
Radioactive Concentration measured at Dust Monitors near the Site Boundary of Fukushima Daiichi Nuclear Power Station

(As of 1:00 p.m. on July 21, 2017: 1.0E-06Bq/cm³)

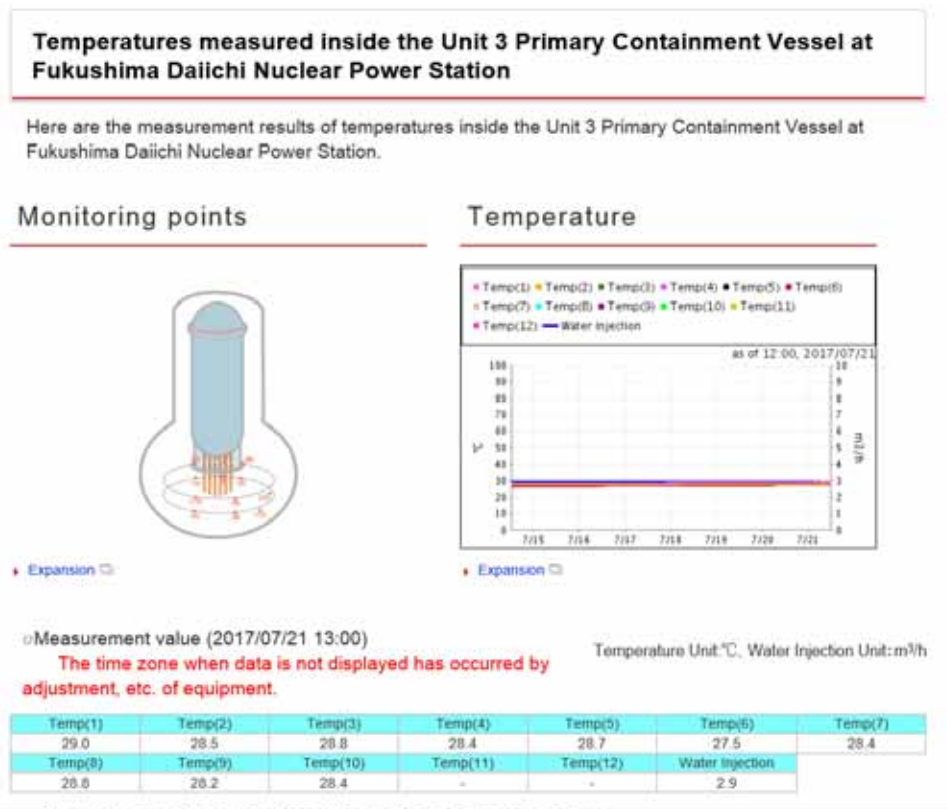
- Plant parameters are monitored all the time during the investigation, and no significant changes have been observed in the PCV internal temperatures after the investigation, compared to the before. The condition of cold shutdown has not been changed.
- Temperature data inside the PCV are available on the website.

(As of 1:00 p.m. on July 21, 2017 : about 27-29 °C)
